Stent Migration During Jailed Side Branch Wire Removal

KIM HEE WON
CHA Bundang Medical Center,
CHA University

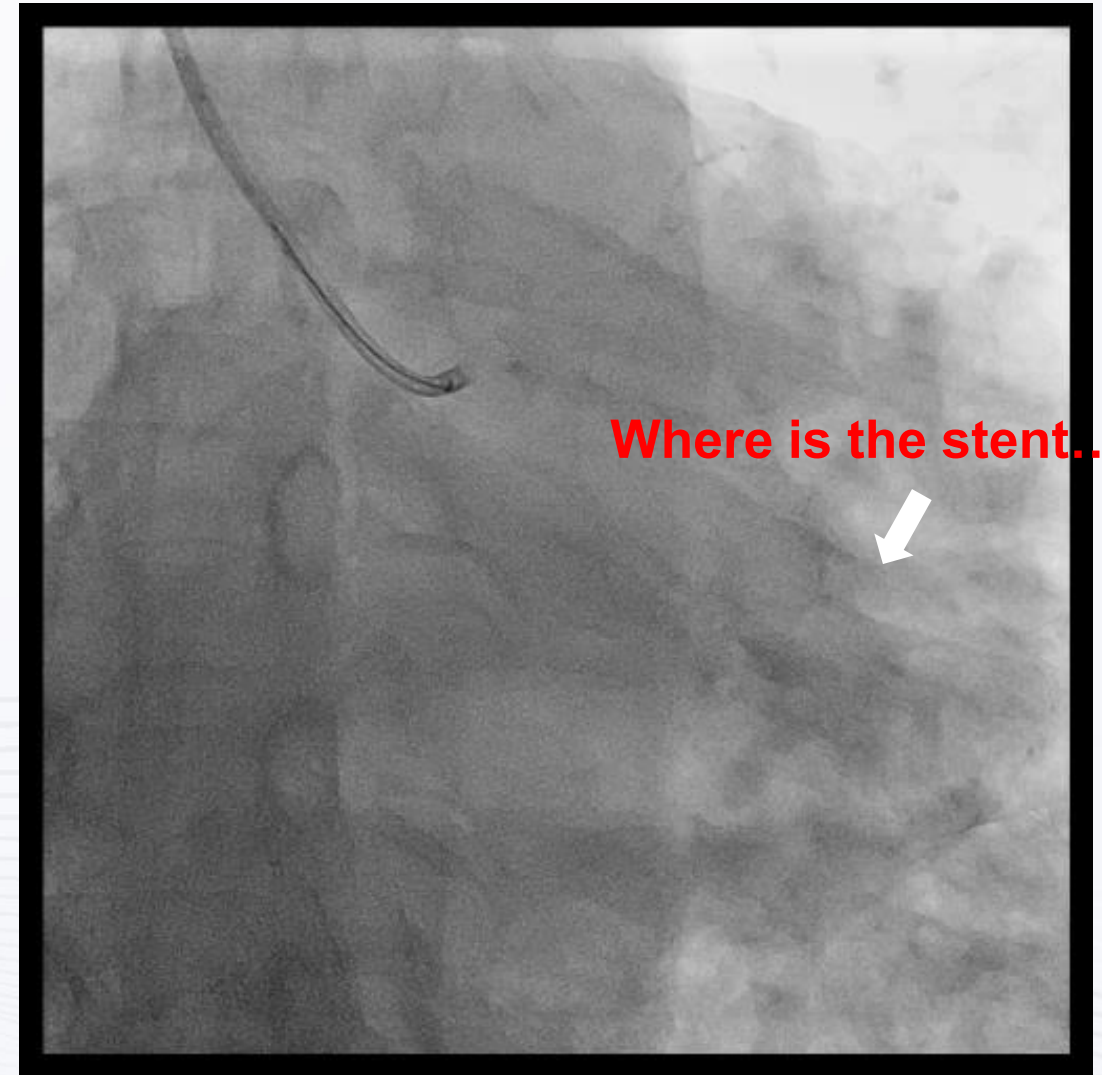
- During the extraction of the side branch wire (BMW), severe resistance occurred.
- After pulling the wire out, angiography was shown like this.
- All wires were gone
- Previously deployed stent was also migrated proximally resulting haziness at previous proximal stent area

- 1) Stent extraction → Possible injury at LM or LCx os
- 2) Stent compression
- 3) Other options?

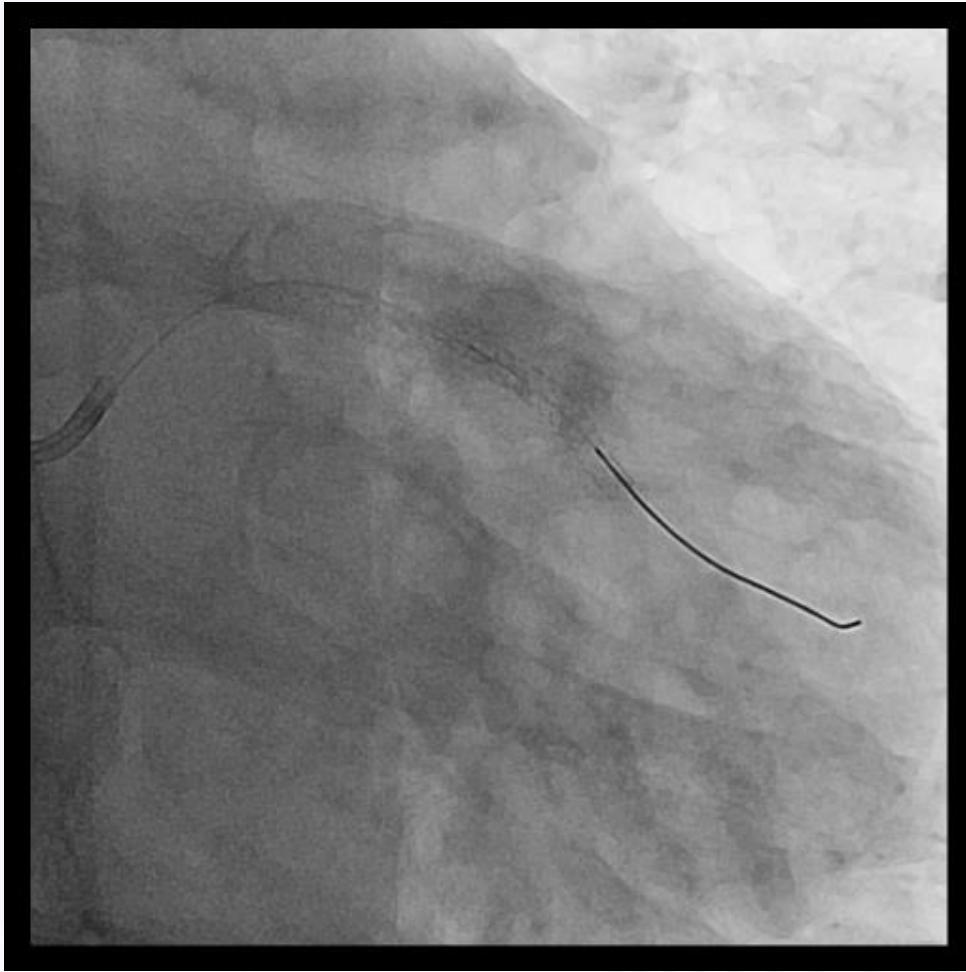
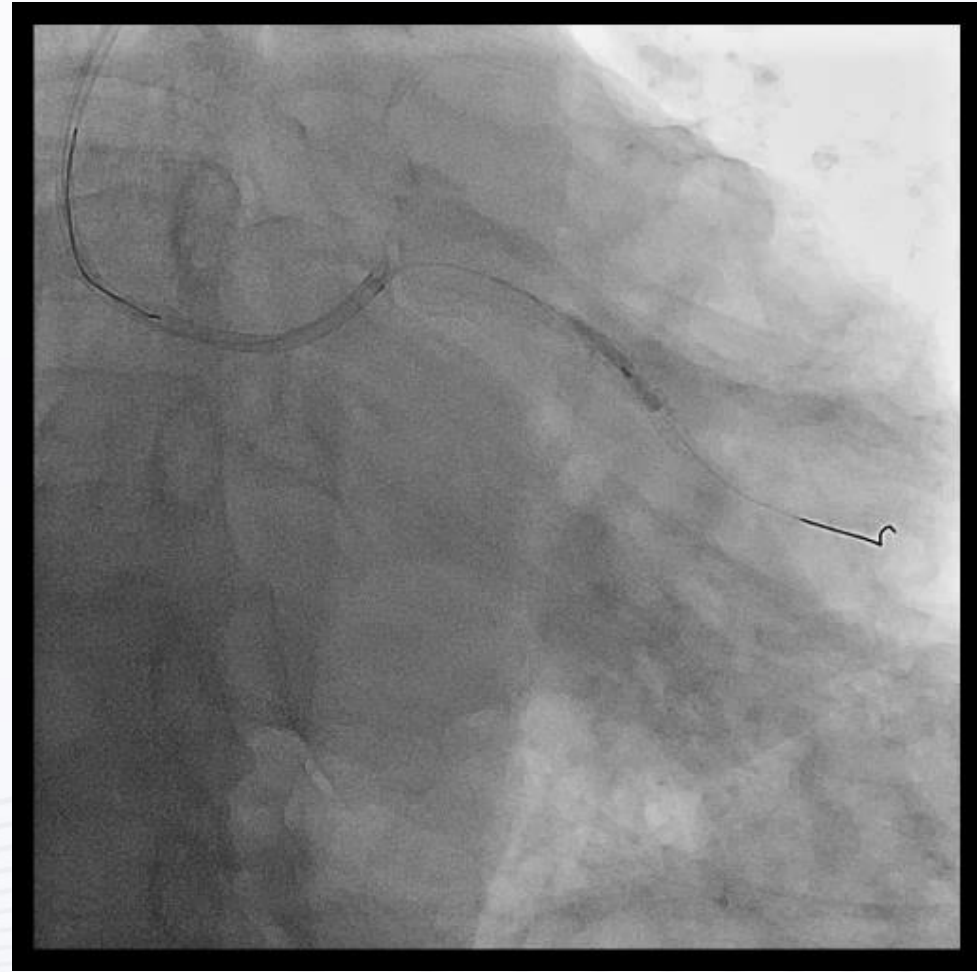
- We immediately tried to reinsert the wire in to the OM br. with Sion blue
- But 2.0 x 15 mm balloon and IVUS could not pass the proximal stent area
- We used 1.5 x 15 mm balloon for POBA allowing IVUS to pass

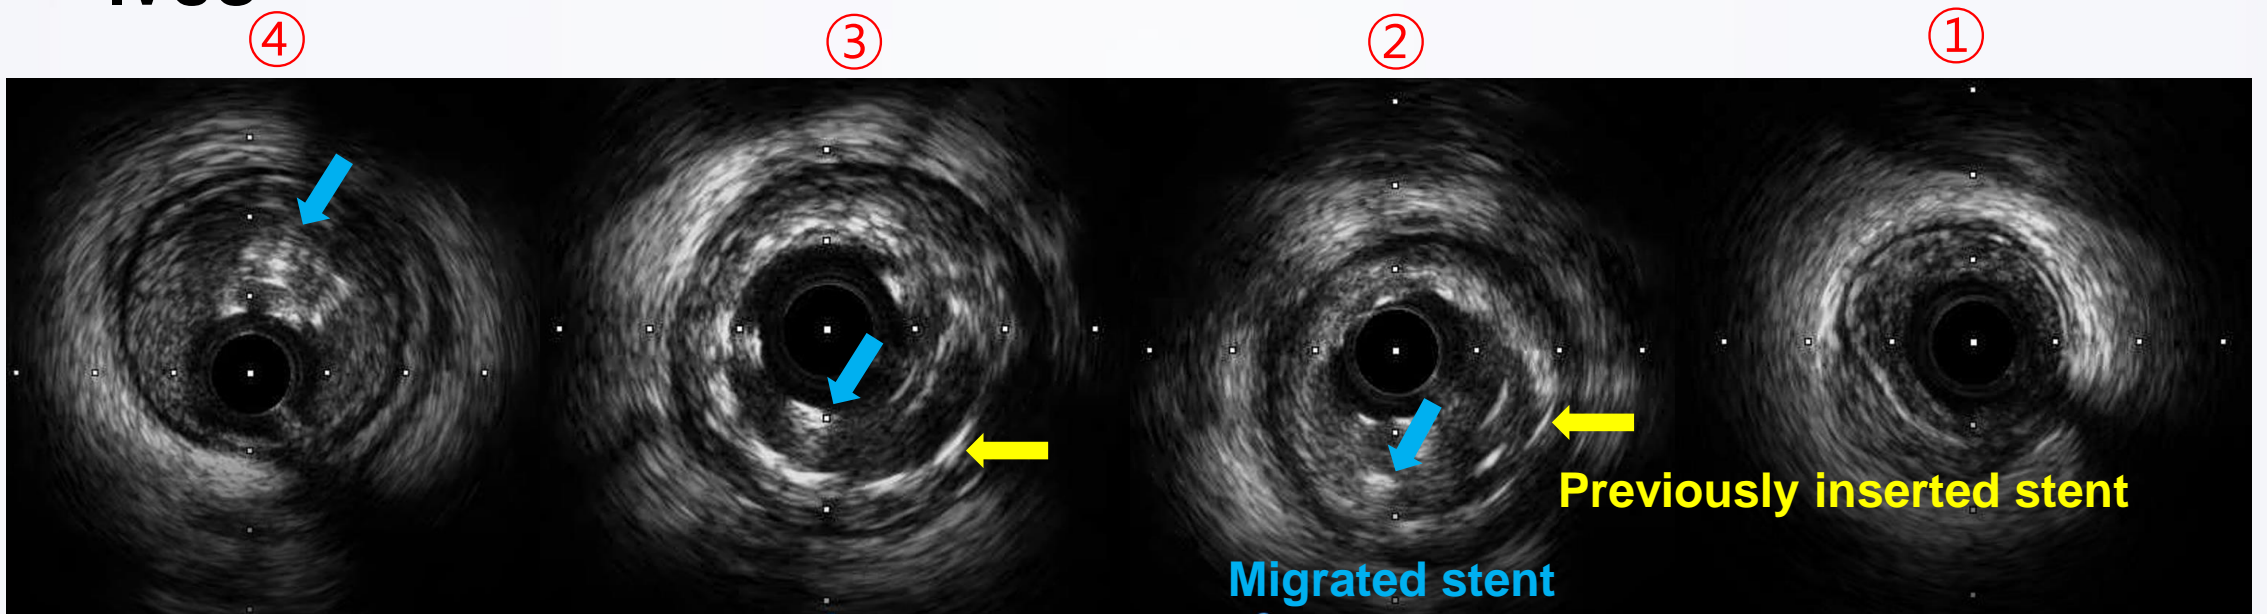
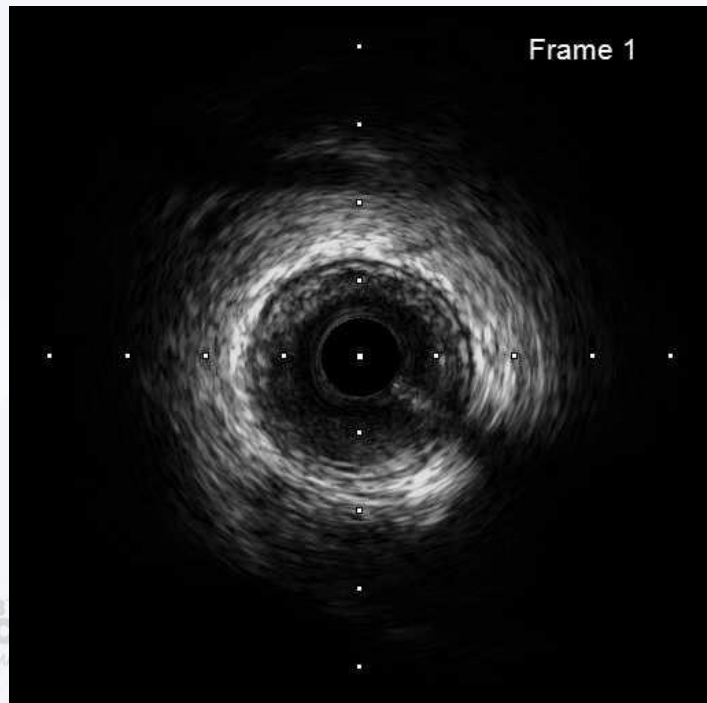
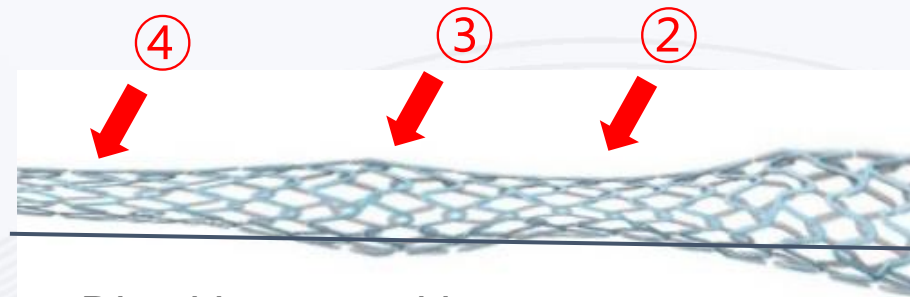
• IVUS

- Distal intramural hematoma
- Broken stent inside the previously inserted stent
- Wire placed in and out of the stent throughout the LCx

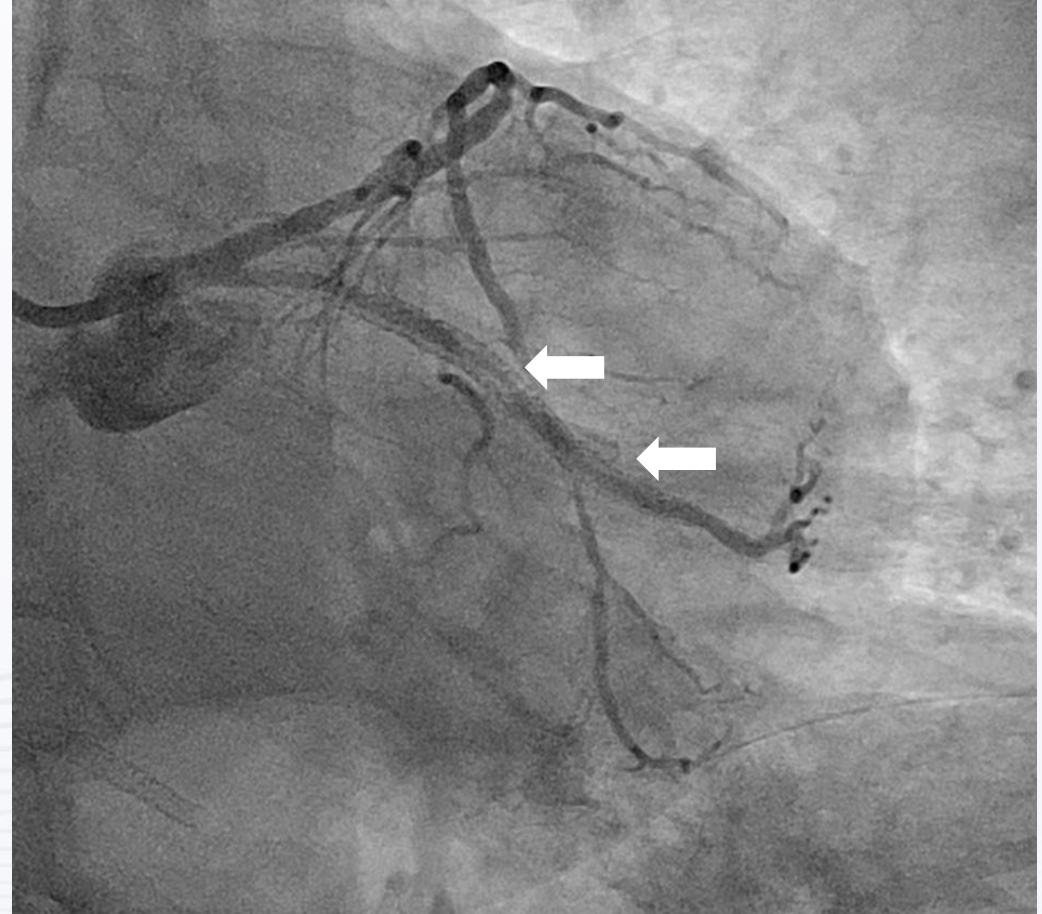
ISR at proximal to OM br. of LCx

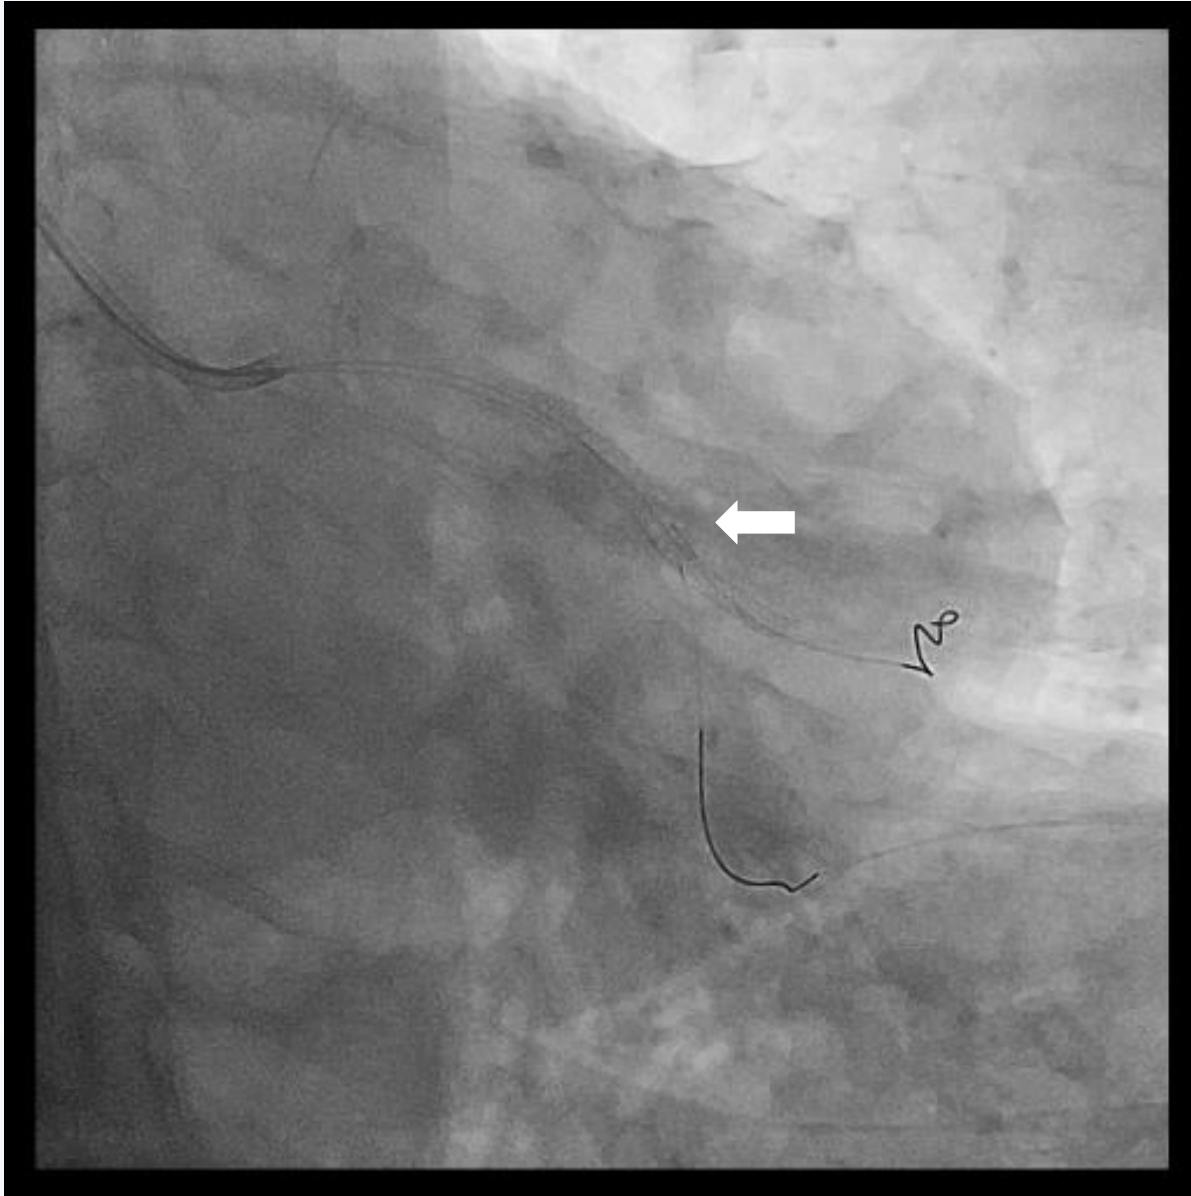
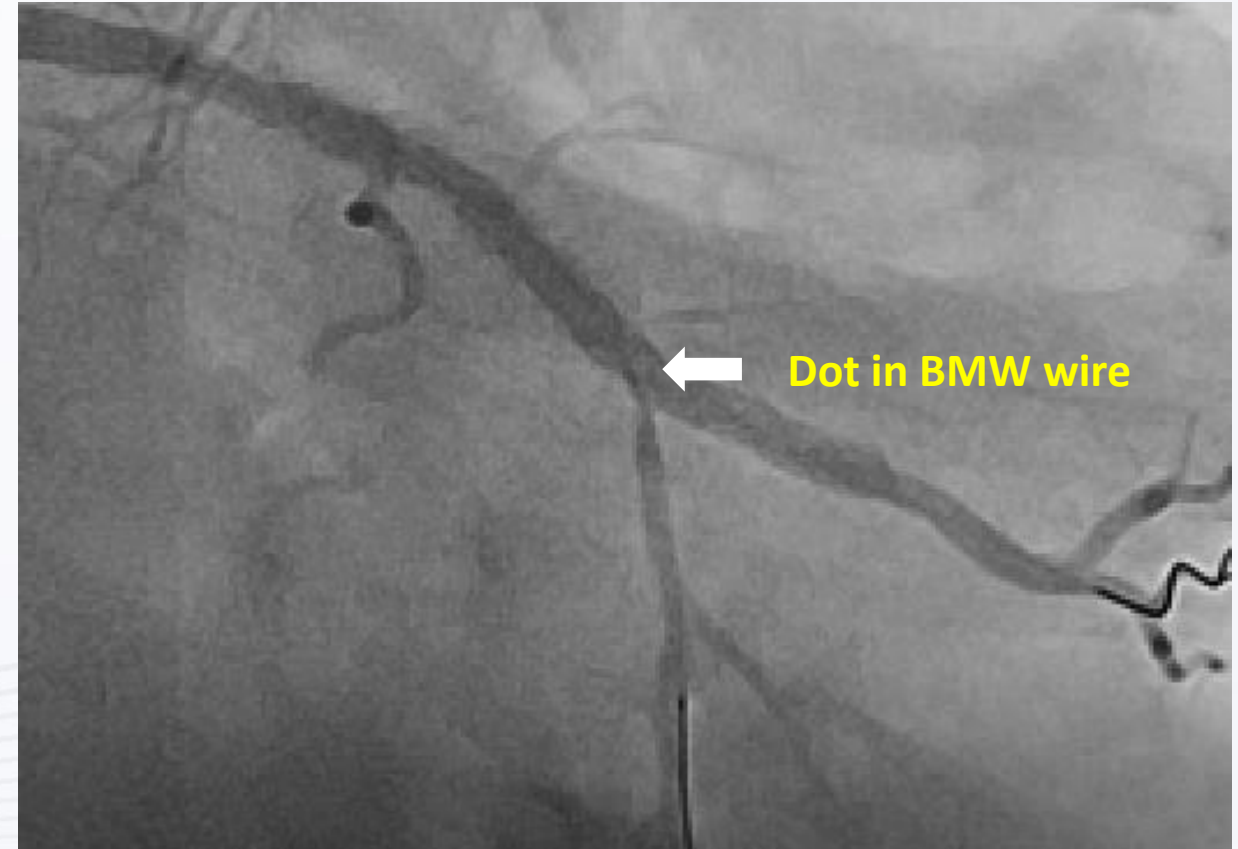
1. The wire might have been damaged during RCA intervention
2. Dot (connection between the core and the shaft) in BMW wire might have anchored the stent

The dot was positioned right at the overlapping area of the two stents which could cause resistance

1. **Carefully choose the type of the side branch wire and carefully manipulate the coiled wire**
2. **If your stent migrated, extract the damaged stent if possible**
