*Optical Coherence
Tomographic Analysis of
Sirolimus-Eluting Stent*

Mitsuyasu Terashima, MD

Toyohashi Heart Center

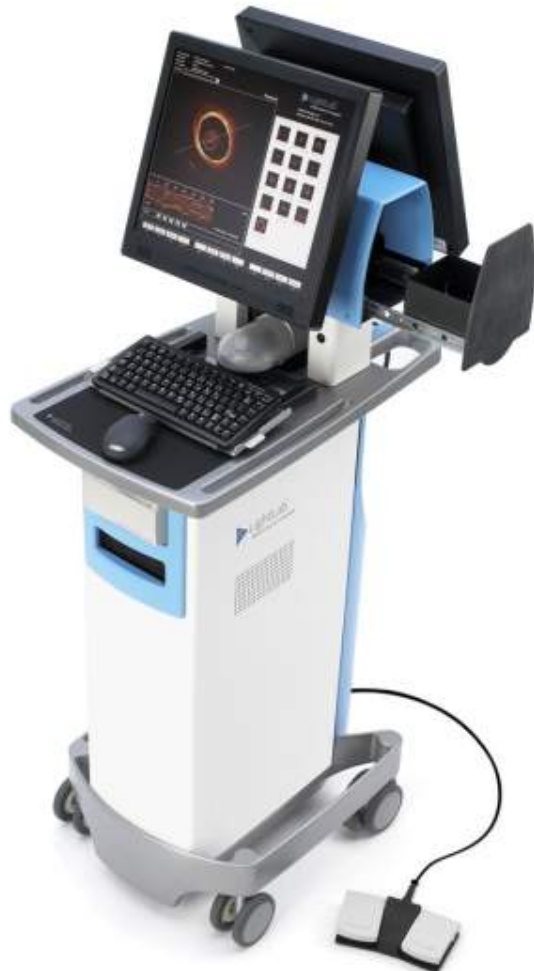
Console

Lightlab OCT Imaging System

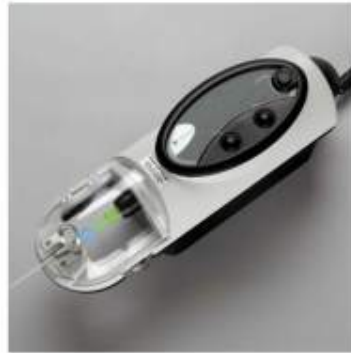
Probe interface unit
motor drive unit
&
motorized pullback unit
(1.0mm/sec)

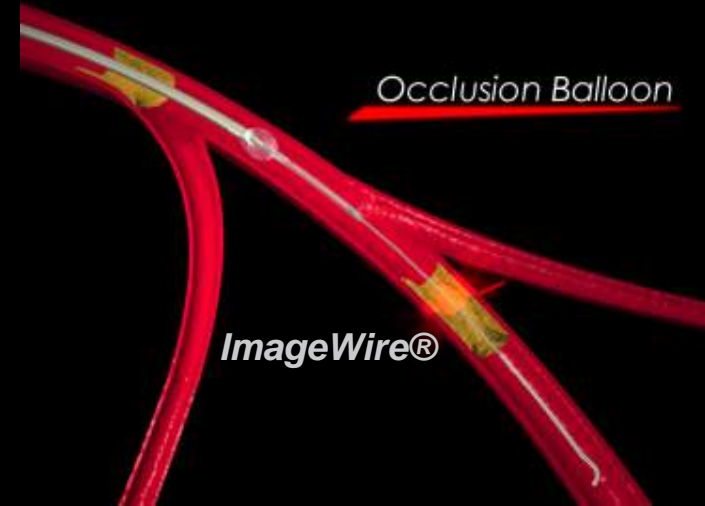
OCT image wire (ImageWire®)

- ✓ 1310 nm broadband light source
- ✓ 0.014 inch at the tip, 0.016 inch at the lens
- ✓ resolution: 10 ~ 15 μ m
- ✓ frame rate: 15fps

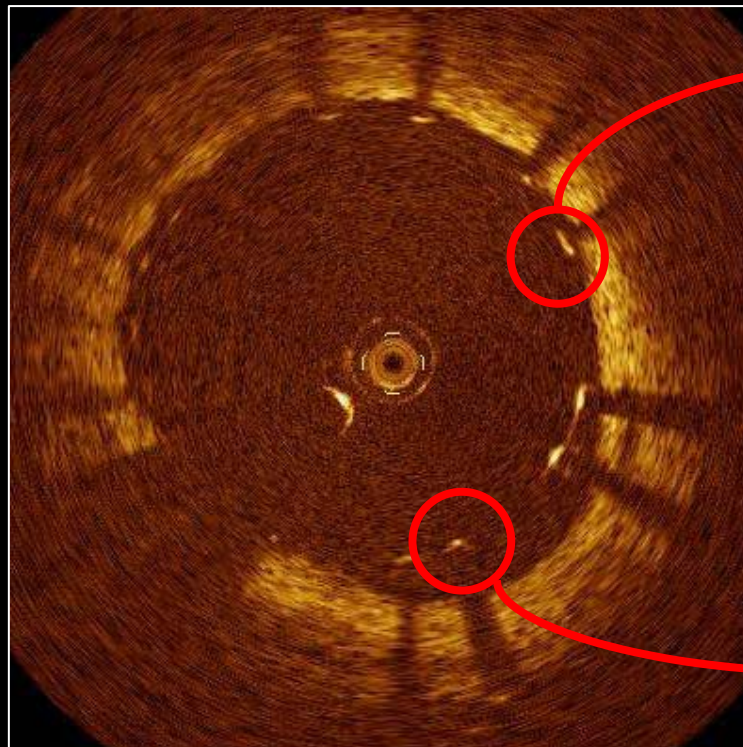
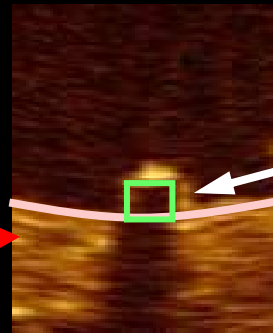
Complete stent apposition (CSA)

Stent Strut

\leq thickness of struts

Near infrared light used in OCT

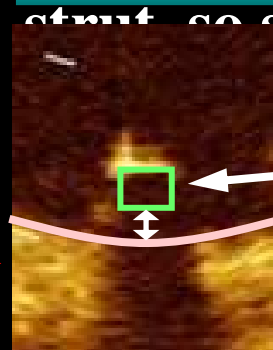
Incomplete stent apposition (ISA)

Stent Strut

thickness of struts

stent is visualized as highly reflective structures of the stent due to the typical dorsal shadowing in OCT.

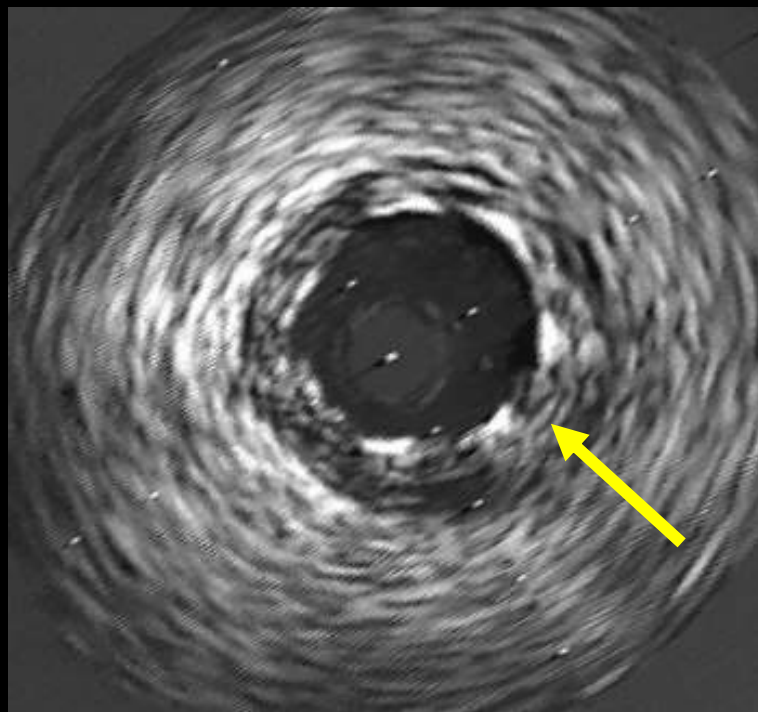
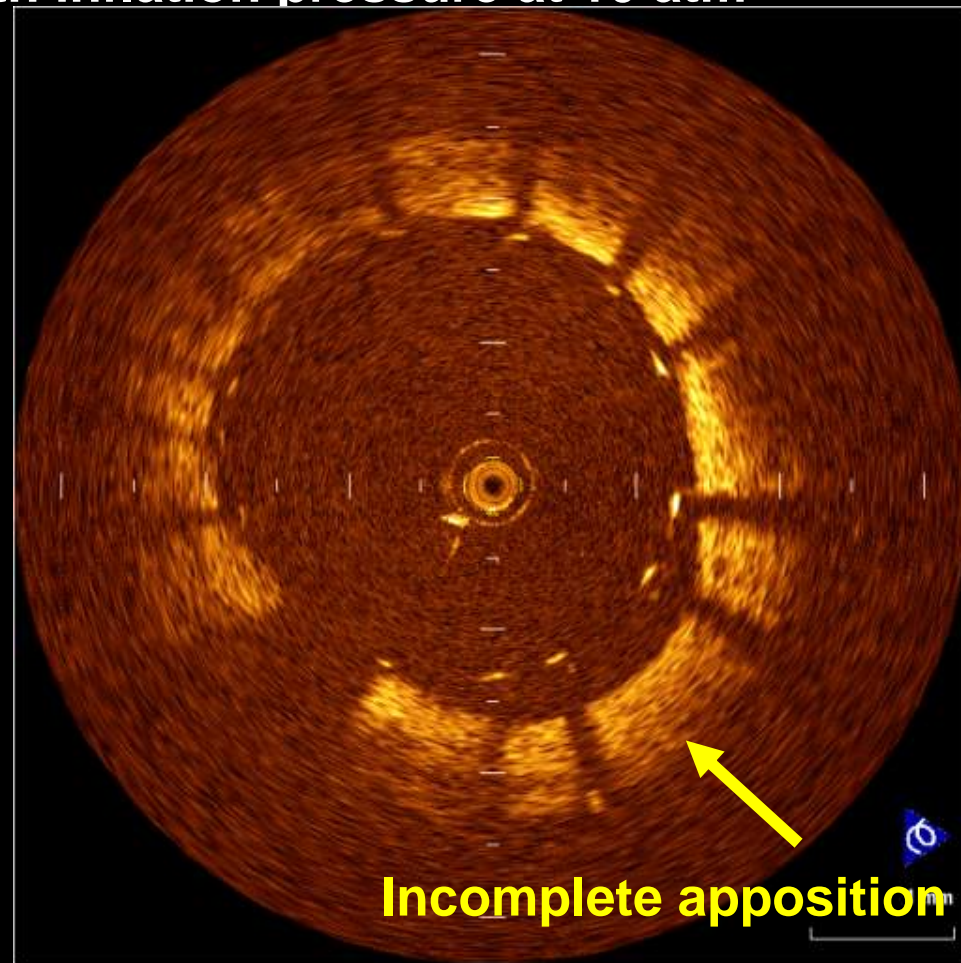
Incomplete apposition

After stenting of the mid-LAD
with inflation pressure at 10 atm

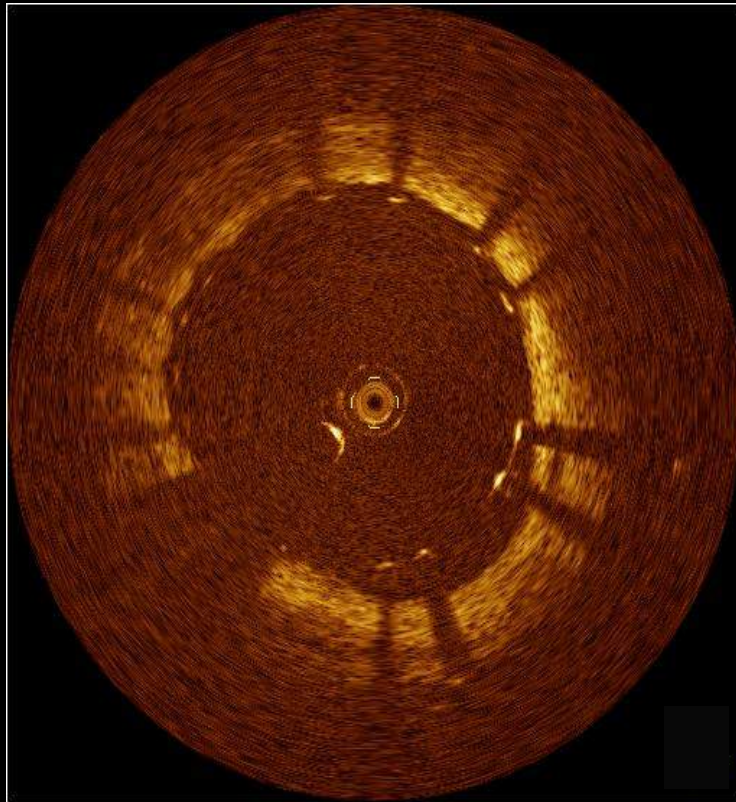
Post Dilatation of Incompletely Apposed Stent

10 atmosphere

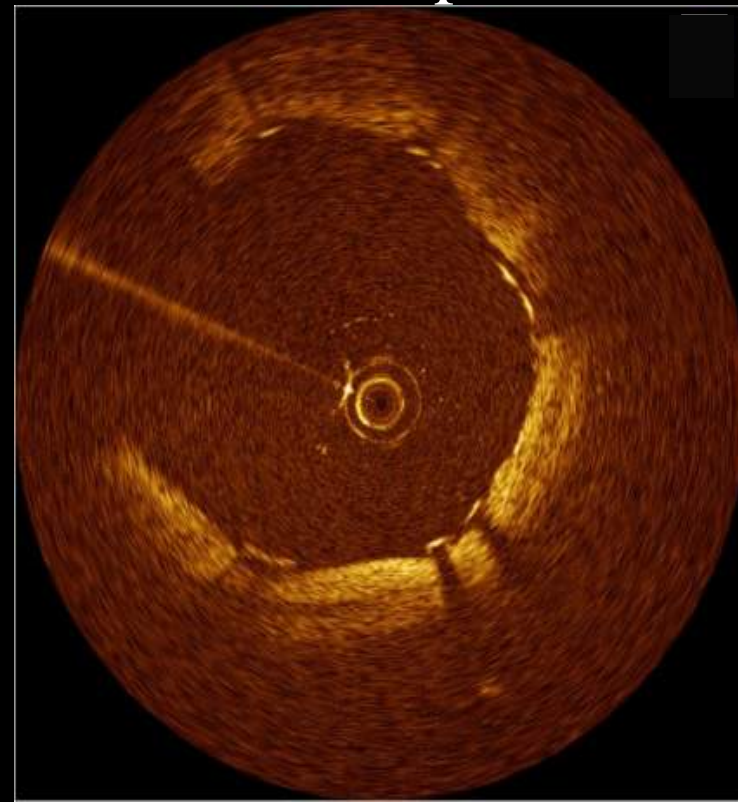
Adjunctive ballooning at
20 atmosphere

Incomplete apposition

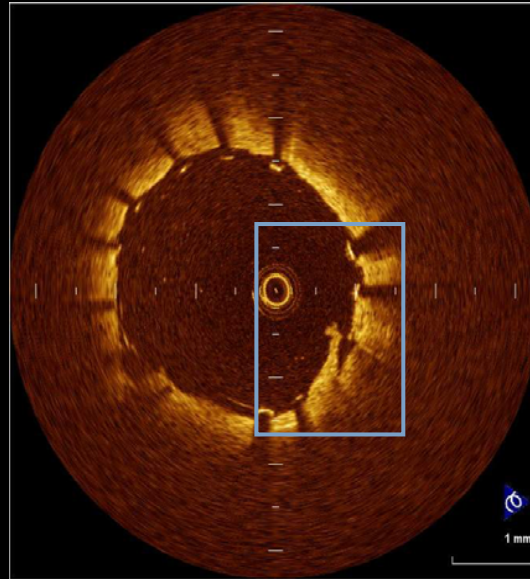
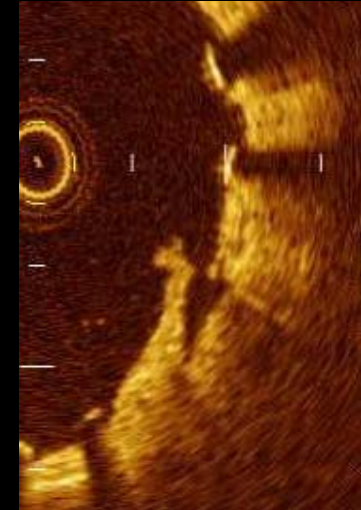
Dissection

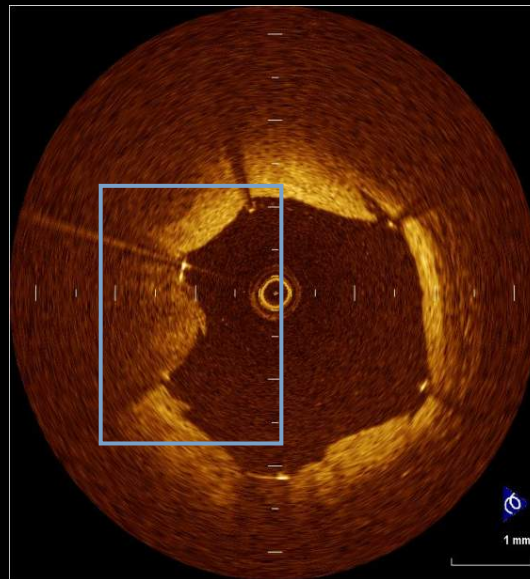
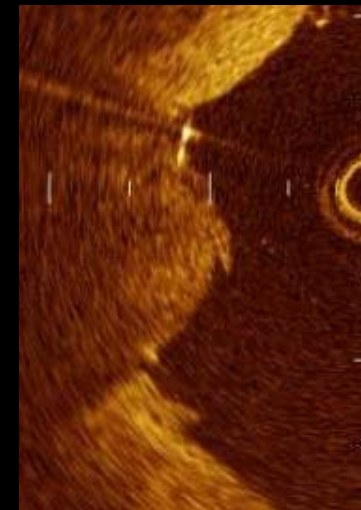
Tissue prolapse

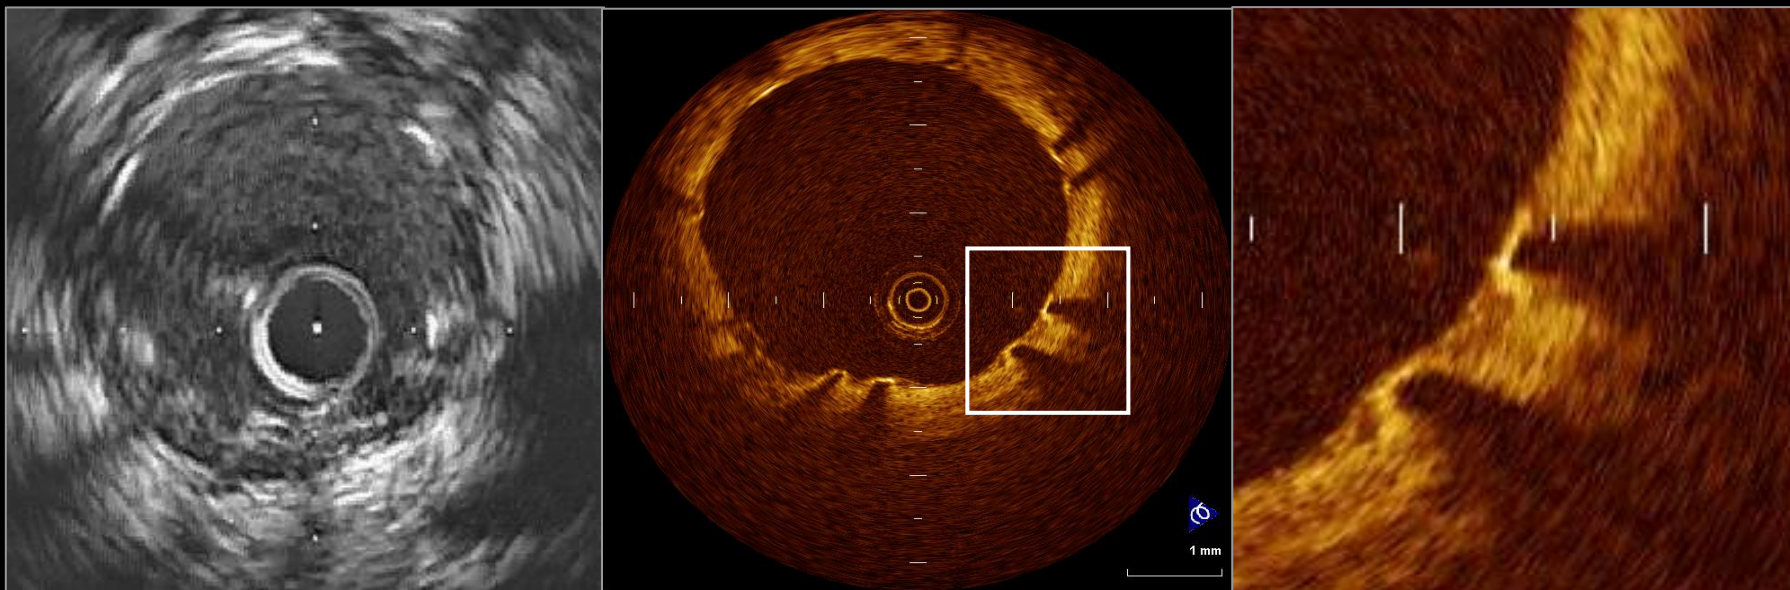
IVUS and OCT image of SES at 3-month follow-up

✓ OCT provides detailed visualization of the individual stent struts and a thin neointimal layer over DES struts that IVUS can not detect.

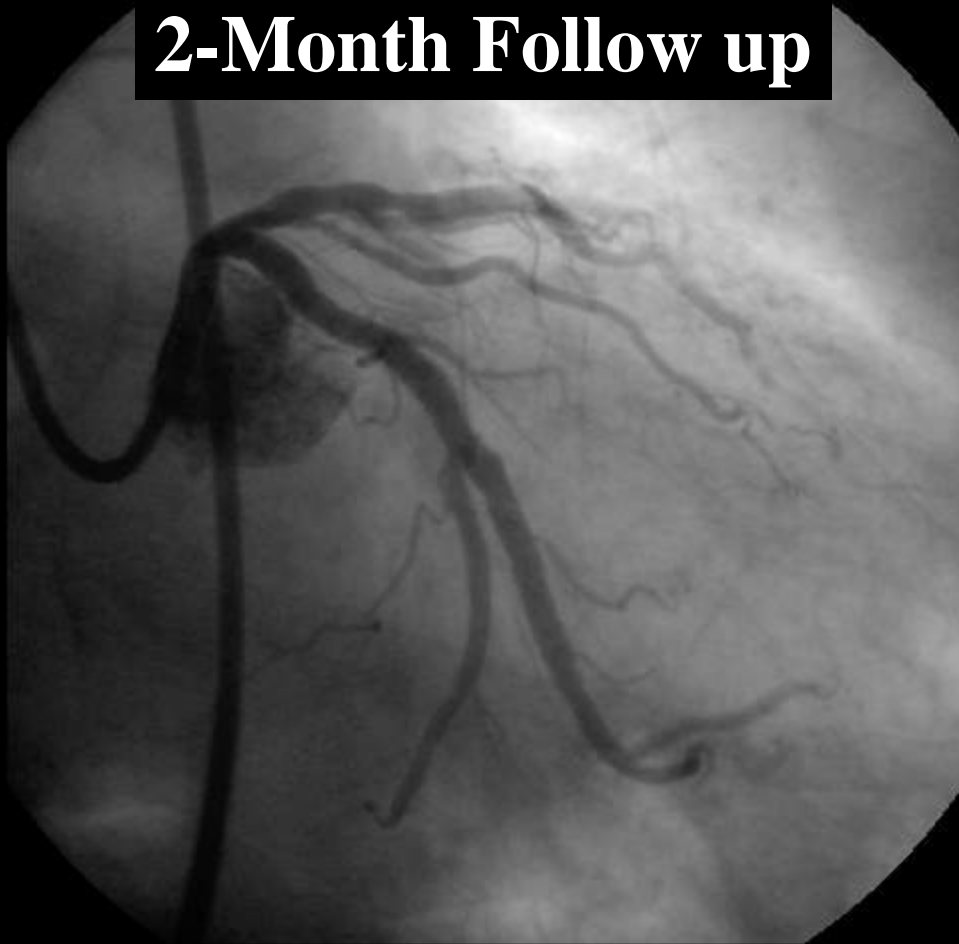
2-Month Follow up

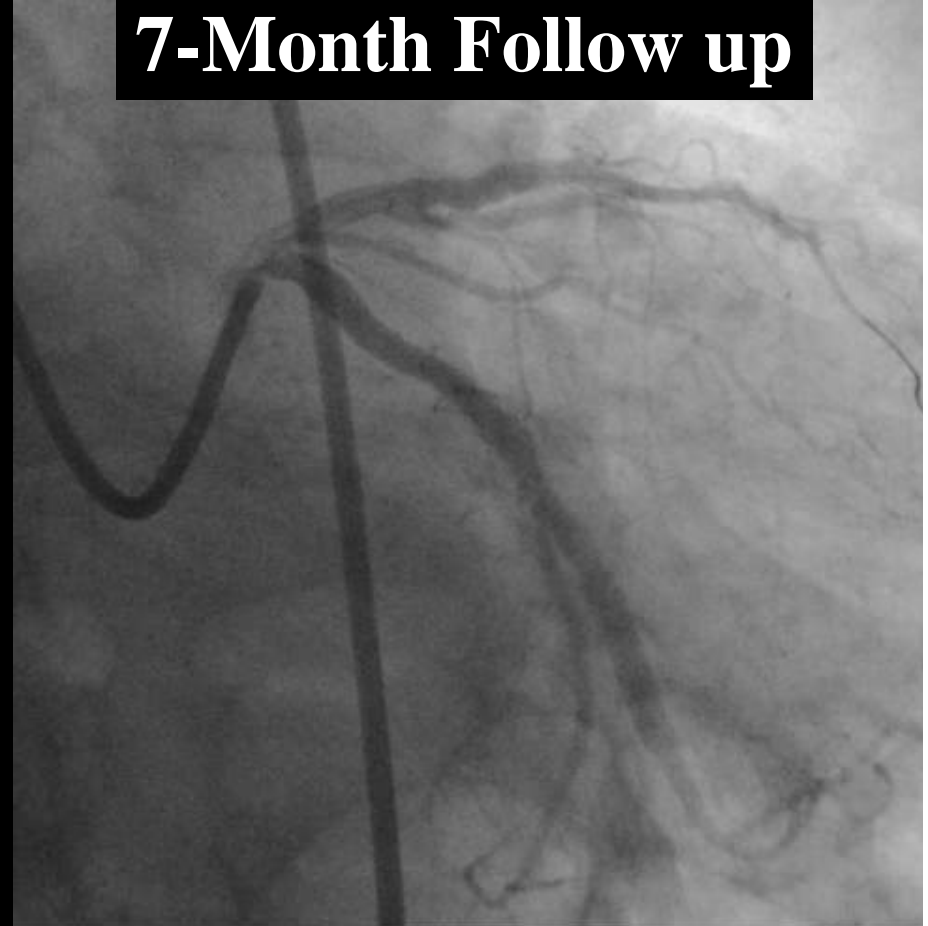
7-Month Follow up

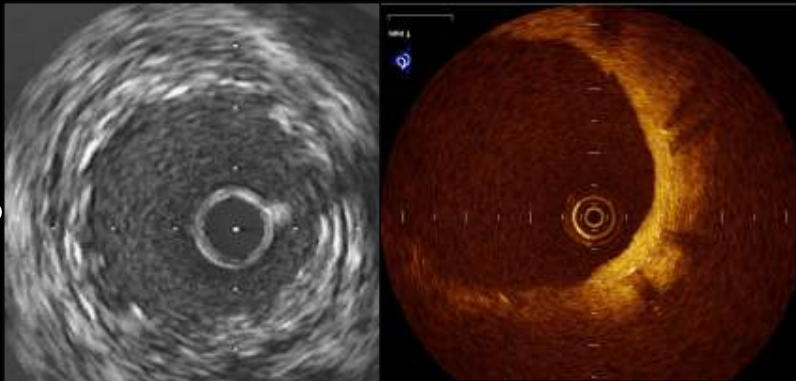
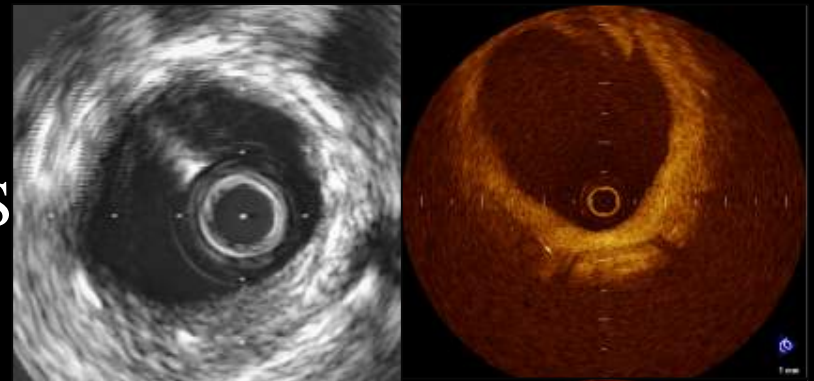
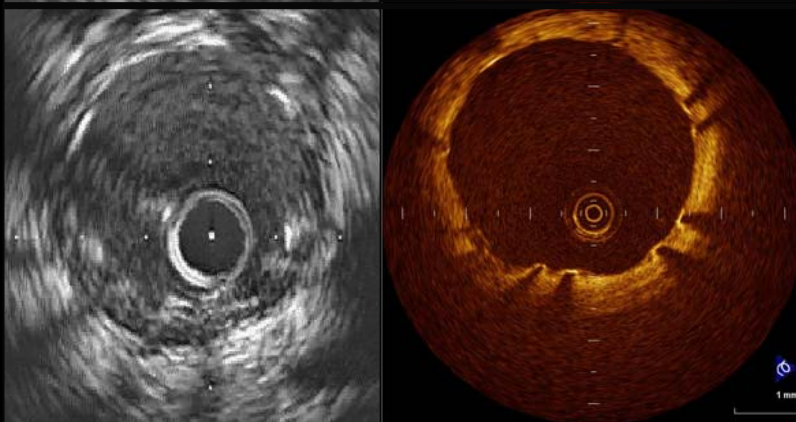
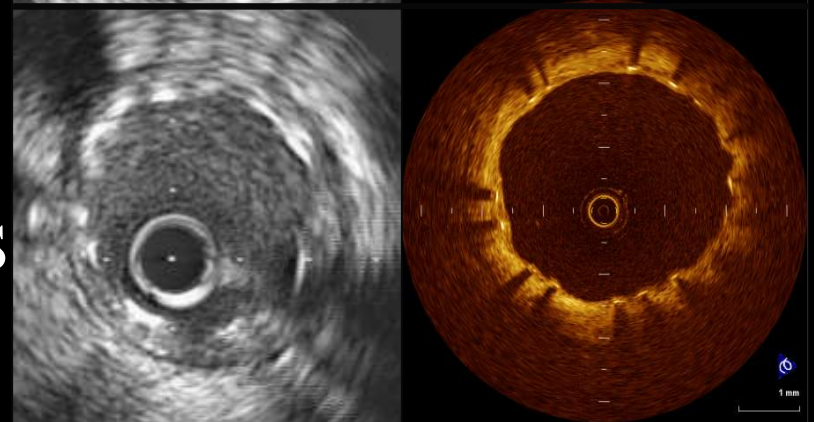
Comparison of IVUS and OCT images between BMS and SES

2-month follow up

7-month follow up

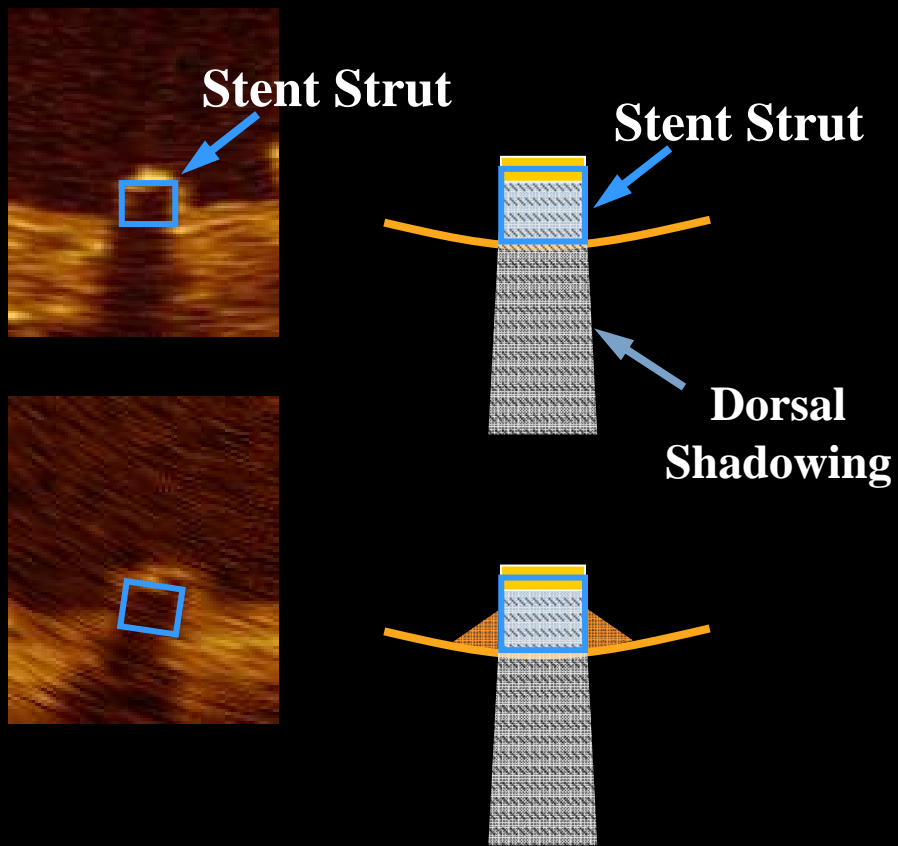
Uncovered Struts

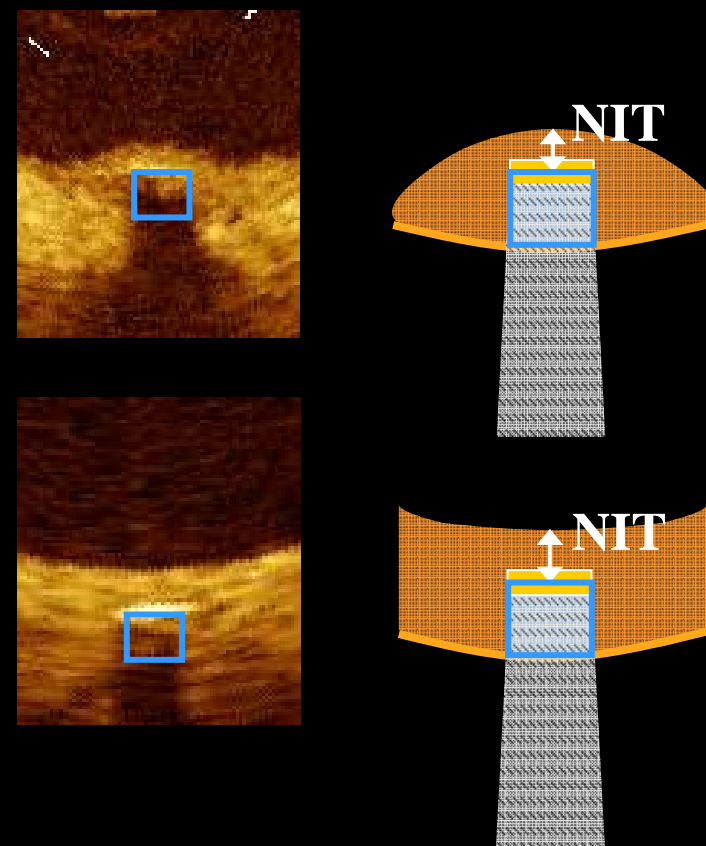
Covered Struts

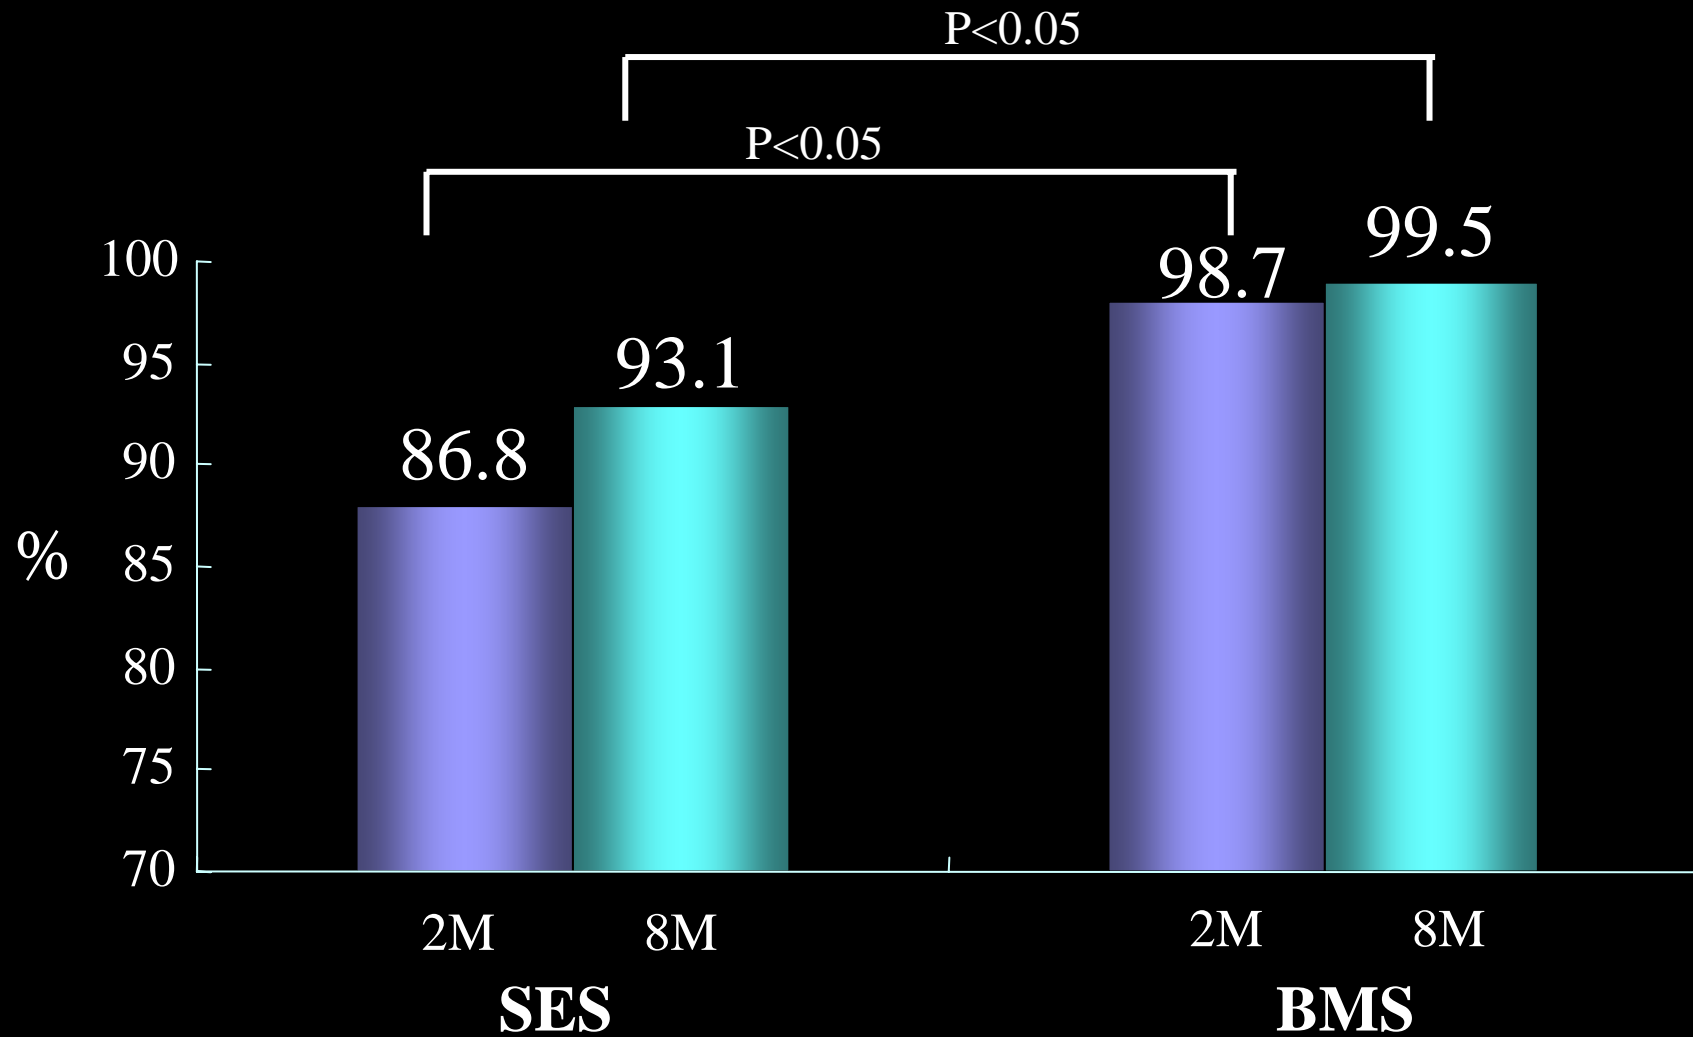
Neointimal Stent Coverage (%)

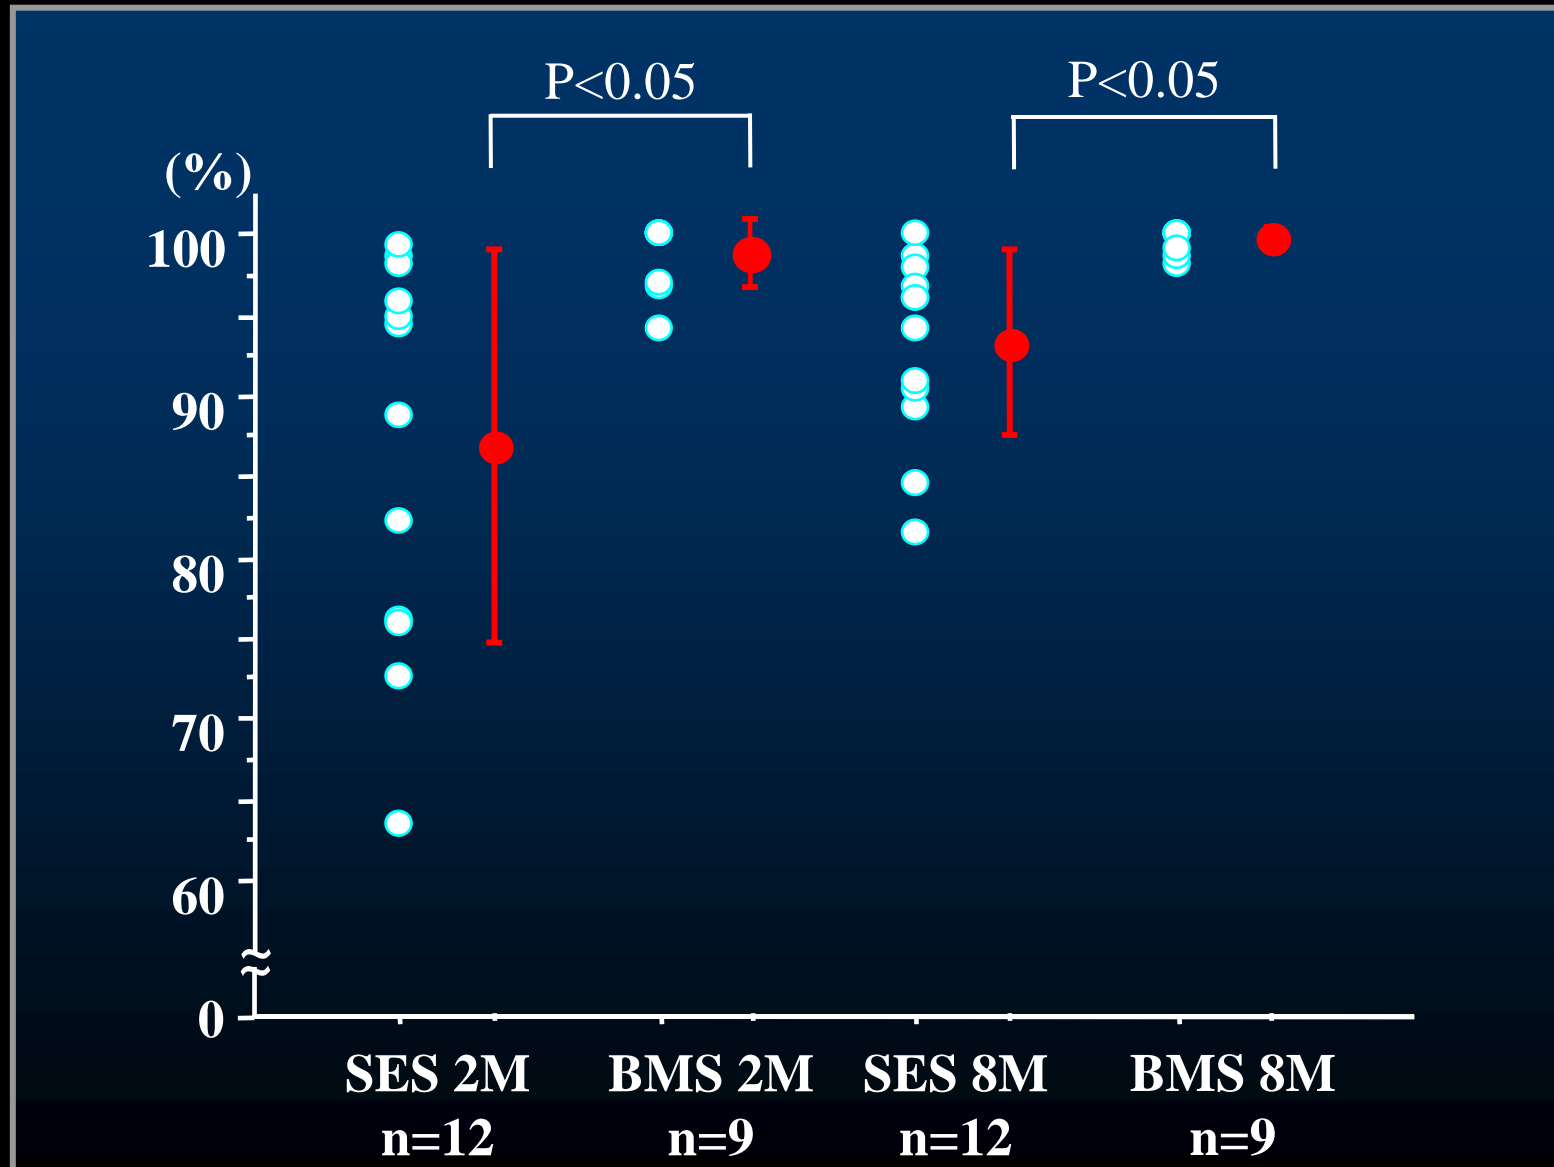
Neointimal Stent Coverage (%)

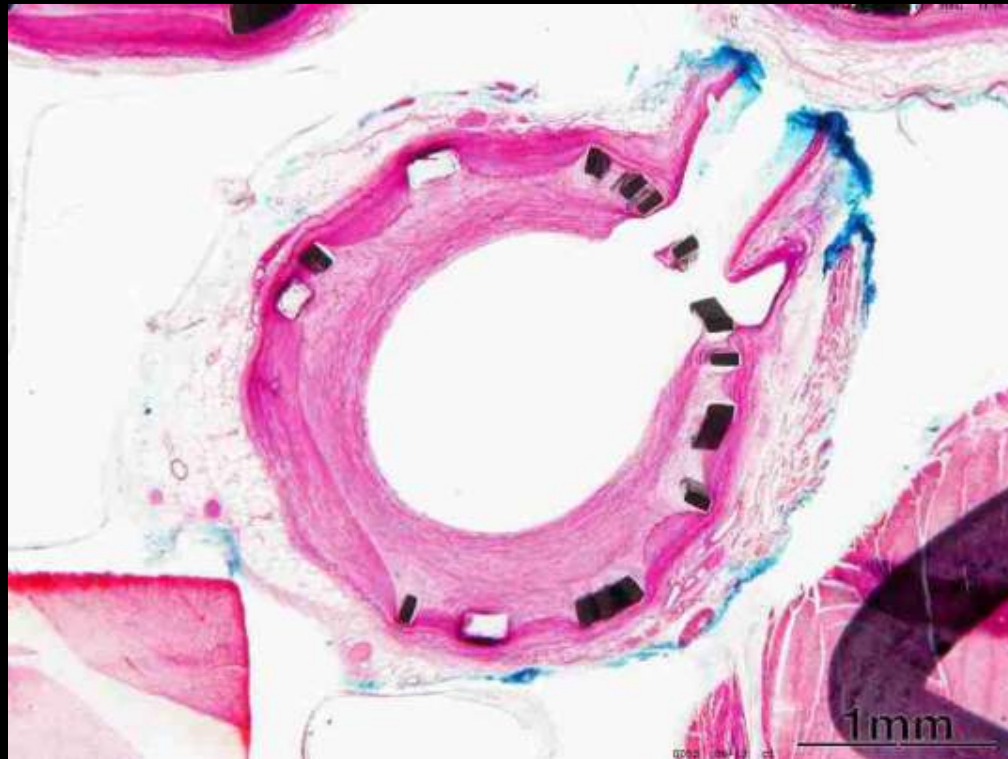
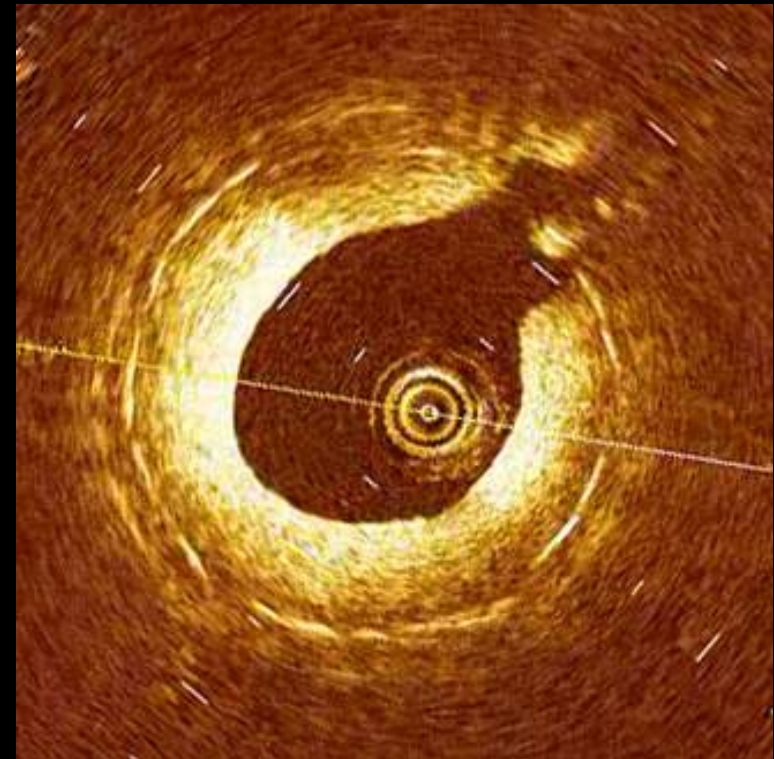
Neointimal Growth on SES Struts Crossing a Side Branch on Porcine Model

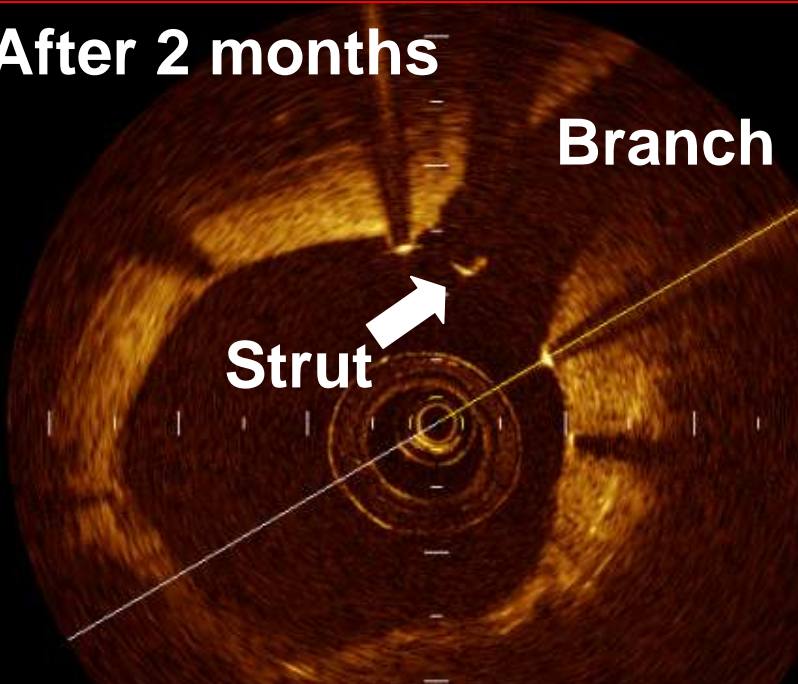
After 2 months

Branch

Strut

Incomplete neointimal coverage of a strut

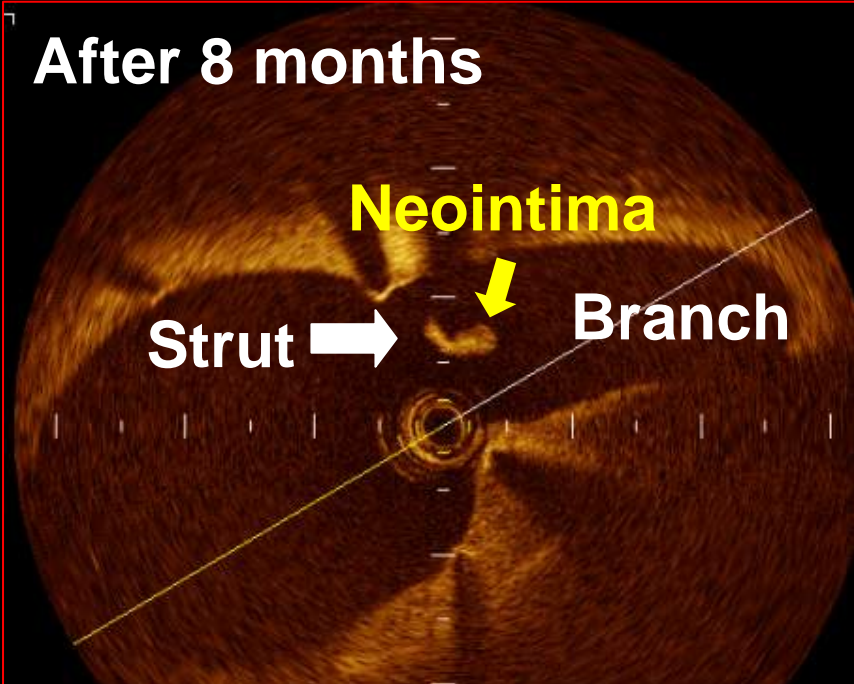
After 8 months

Neointima

Strut

Branch

Complete neointimal coverage of a strut

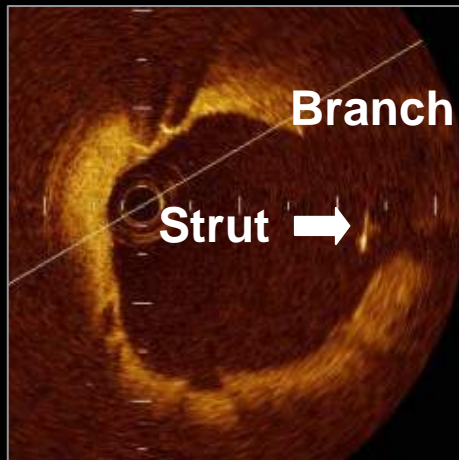
Uncovered

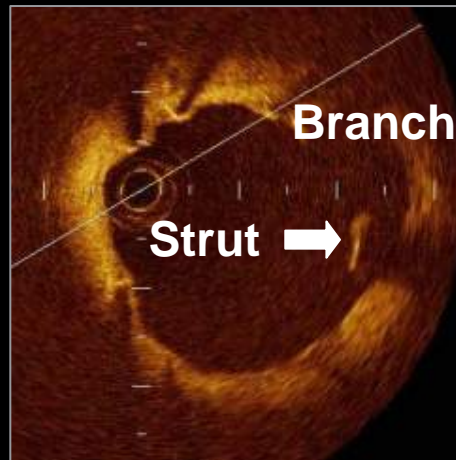
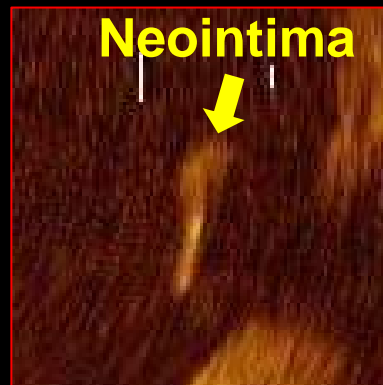
Partially covered

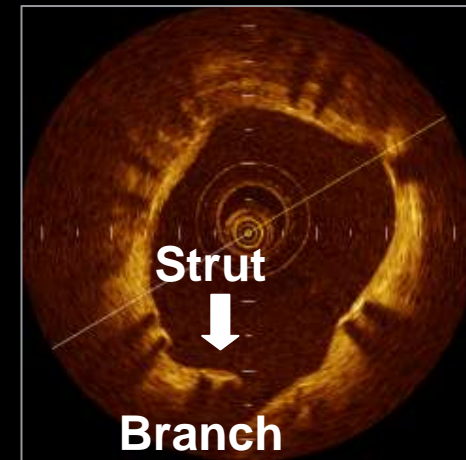
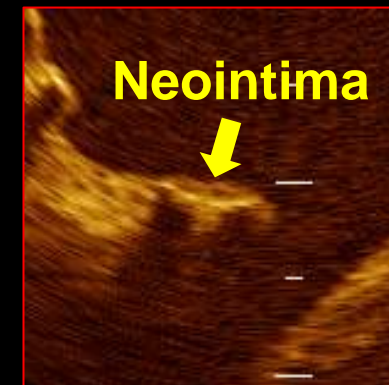
Completely covered

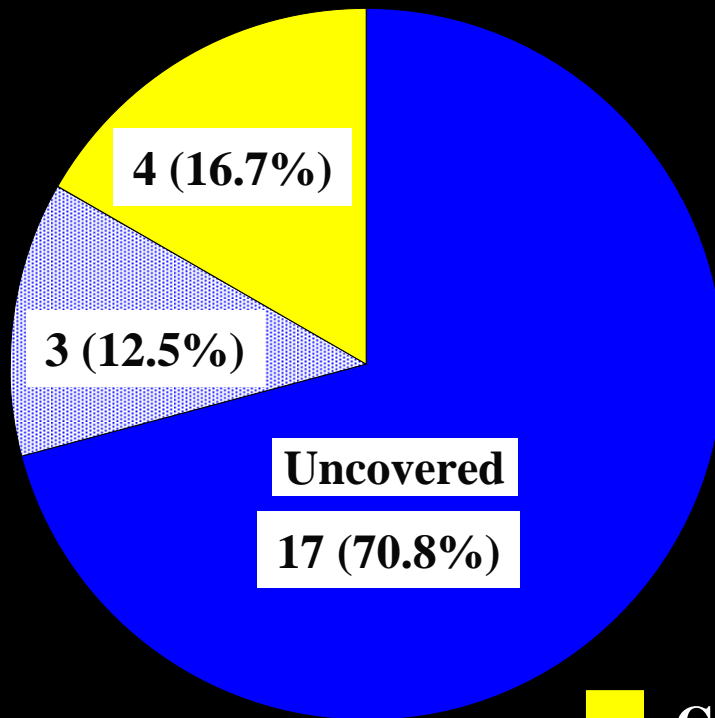
Neointimal Coverage of Struts Crossing a Side Branch at 2 and 8 months After SES Implantation

2-month

- Completely covered
- Partially covered
- Uncovered

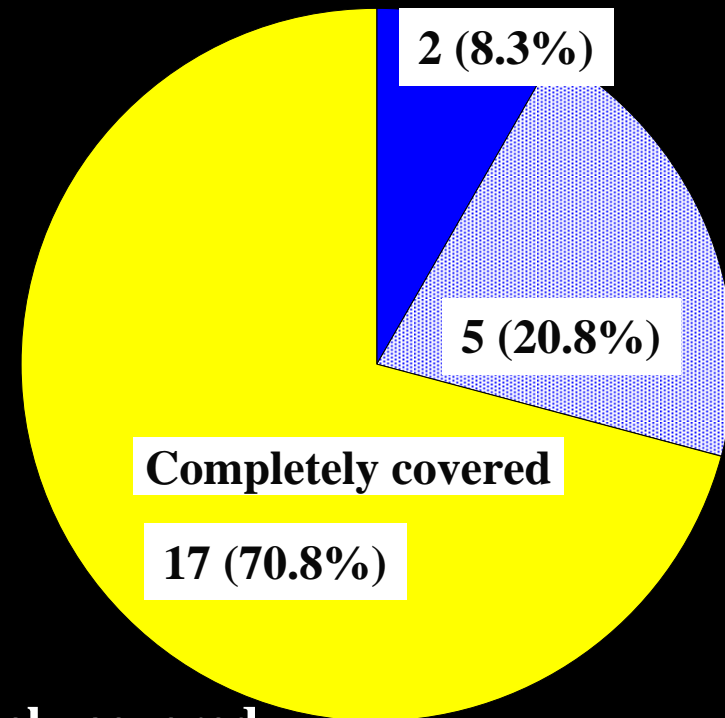
8-month

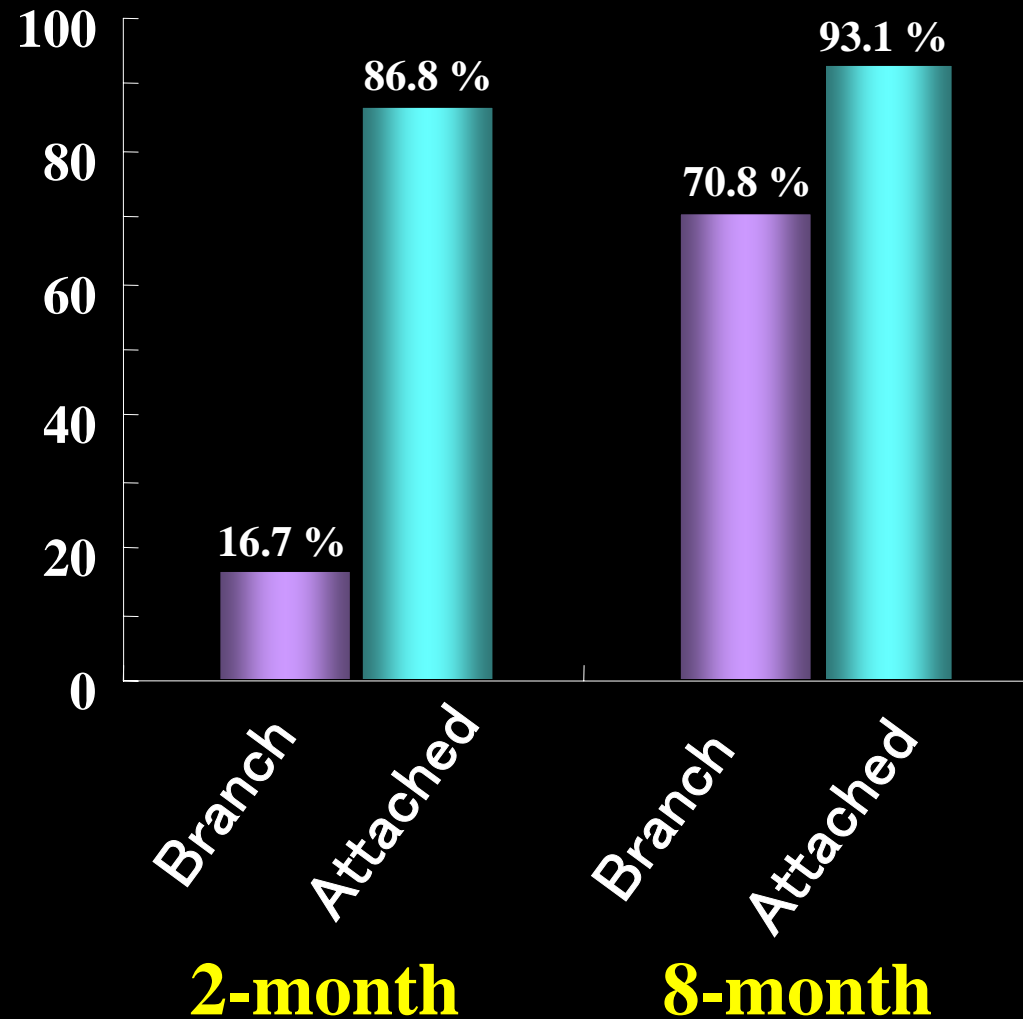
Comparison of Frequencies of Complete Neointimal Coverage between Side-branch and Attached struts

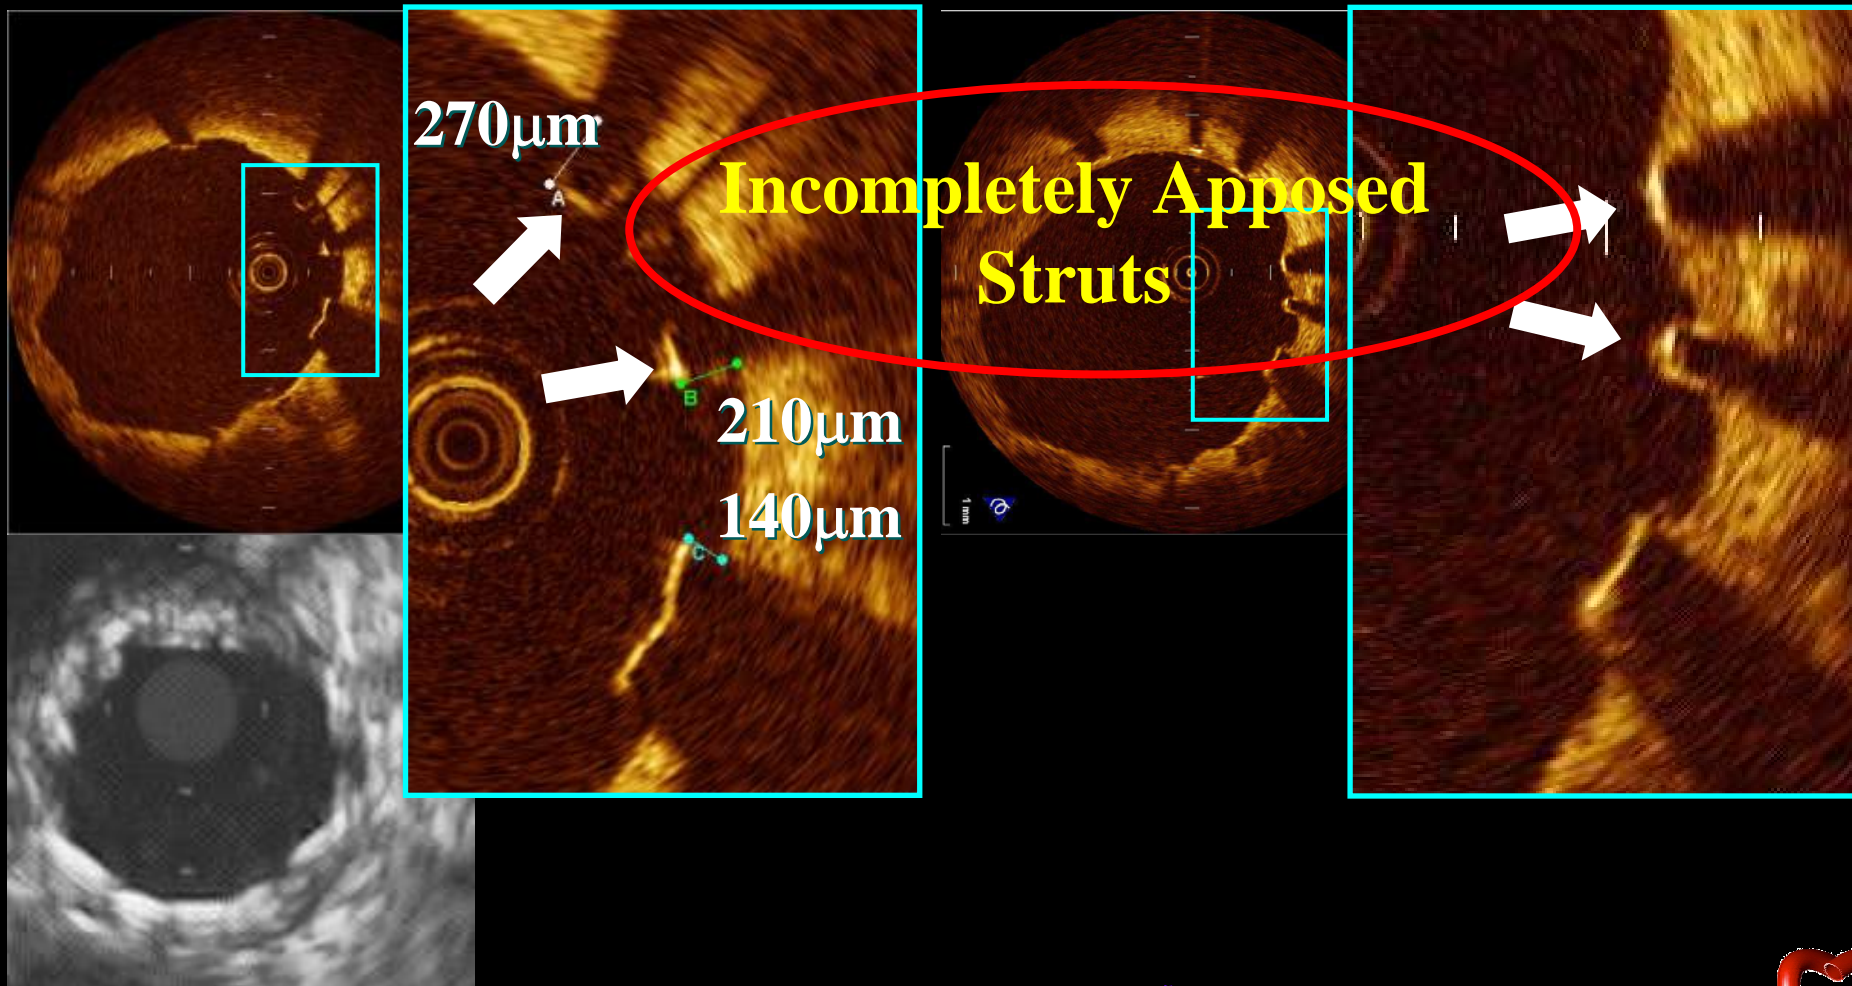
Follow-up of Struts with Incomplete apposition

Post PCI

2Mo. FU
