An In-Stent Restenosis Case of an Under Expanded Stent due to Heavy Calcification Treated by Rotational Atherectomy and Wire Cracking

Department of Cardiology, Shiga General Hospital

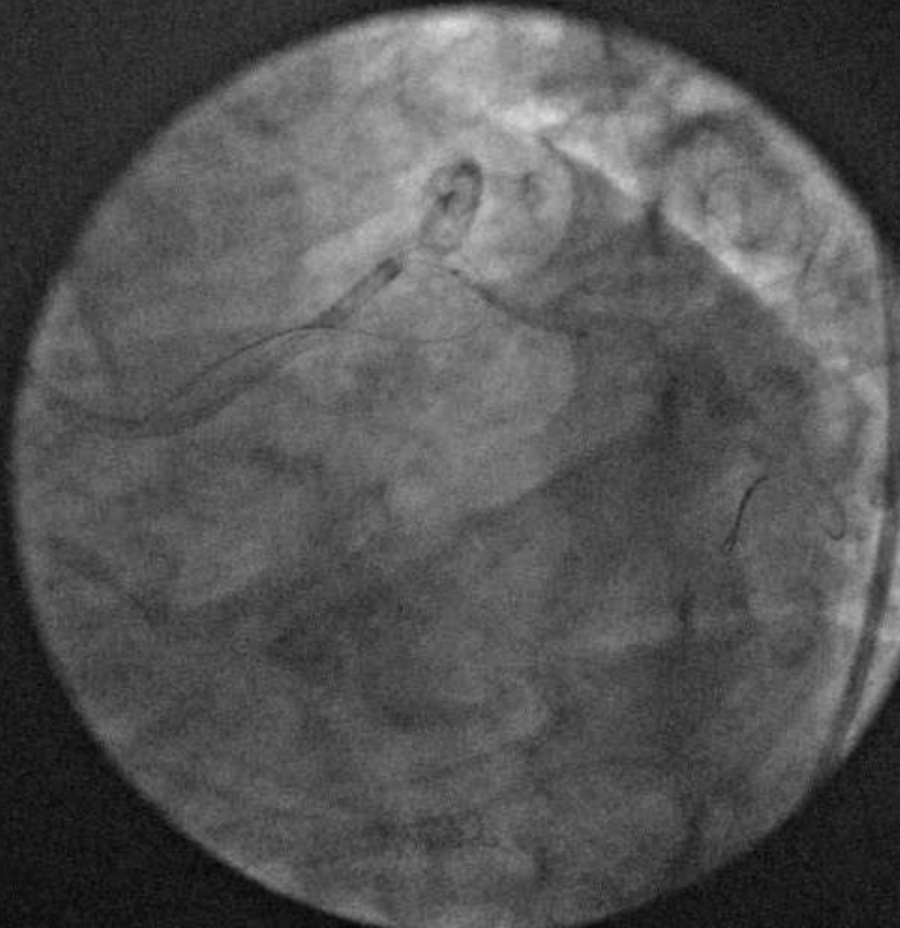
Previous PCI

#11os→Xience PRIME 3.5x18mm

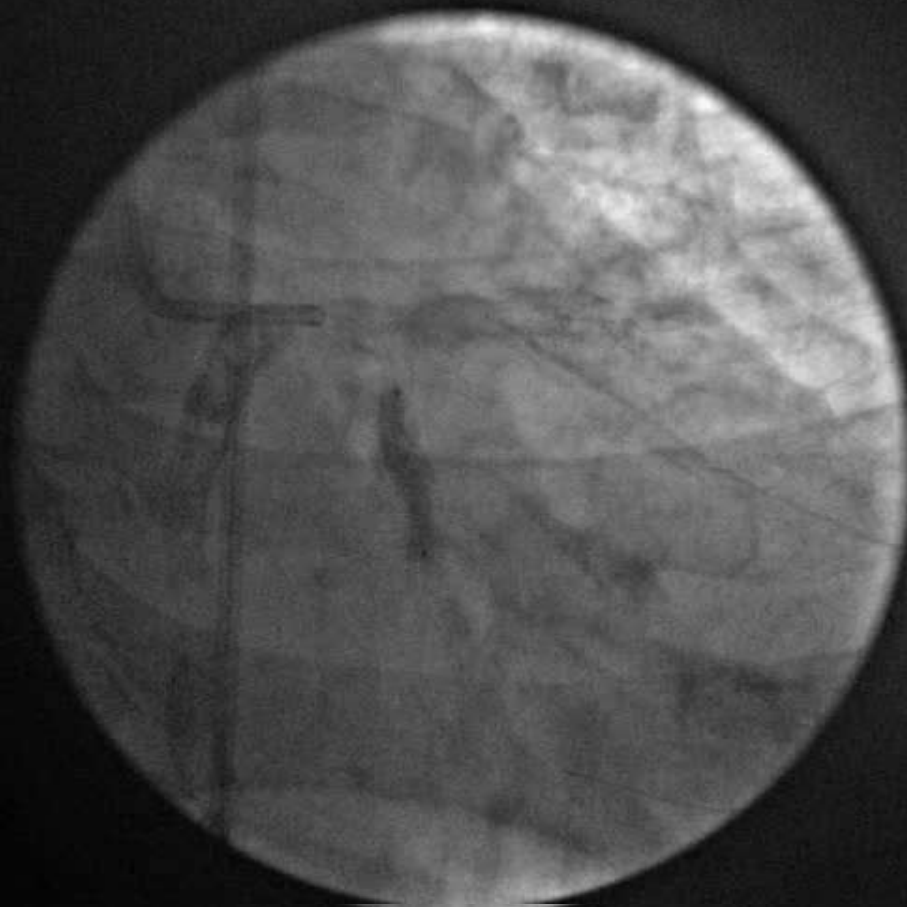
COMPLEX PCI 2018

#13→Xience PRIME 3.0x28mm

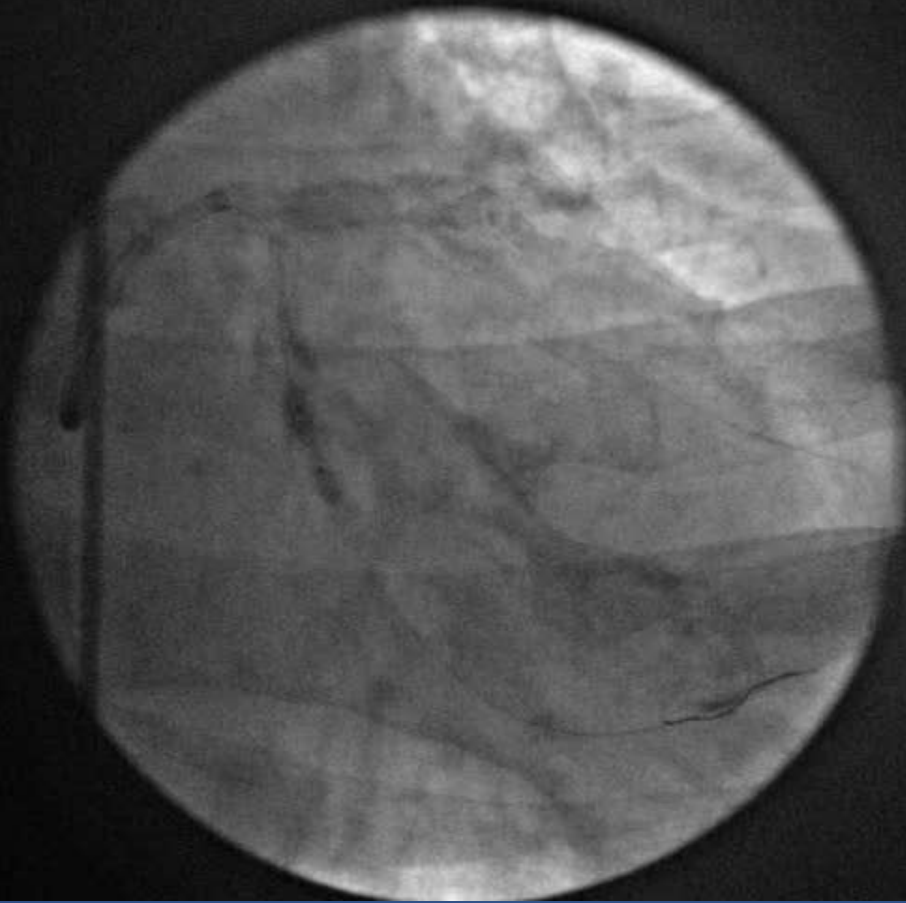
Previous PCI

NC Sprinter 2.75x12mm, 28atm

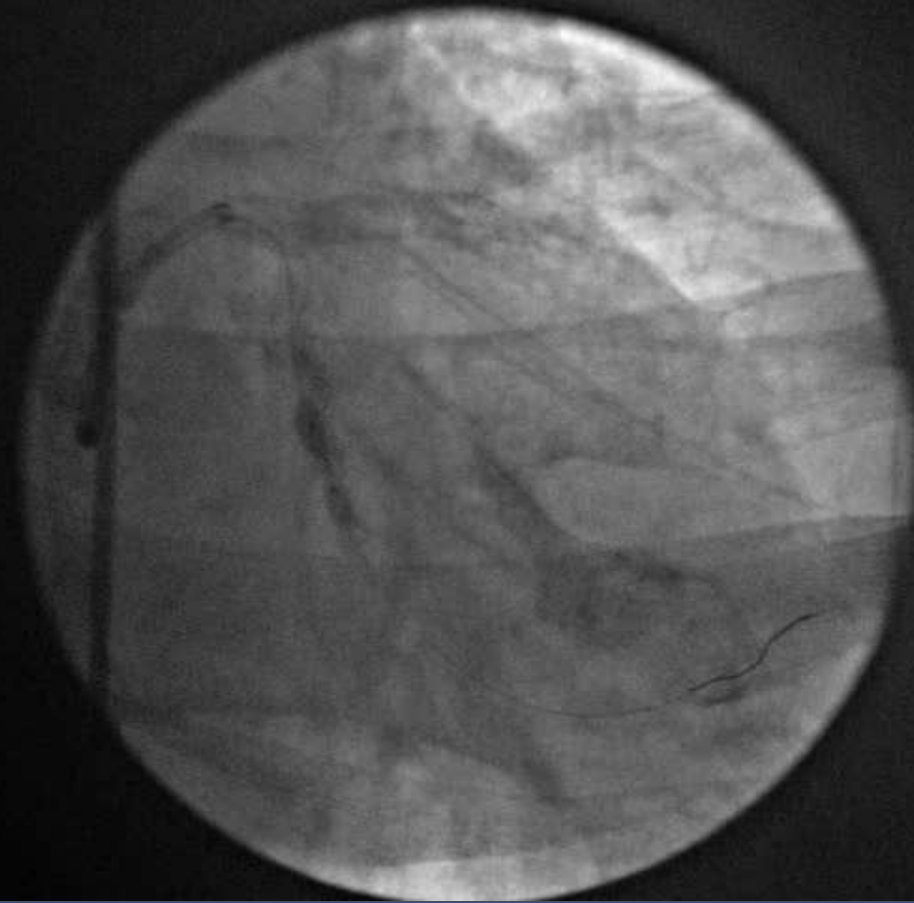
COMPLEX PCI 2018

Cyclone HP 3.25x10mm, 30atm

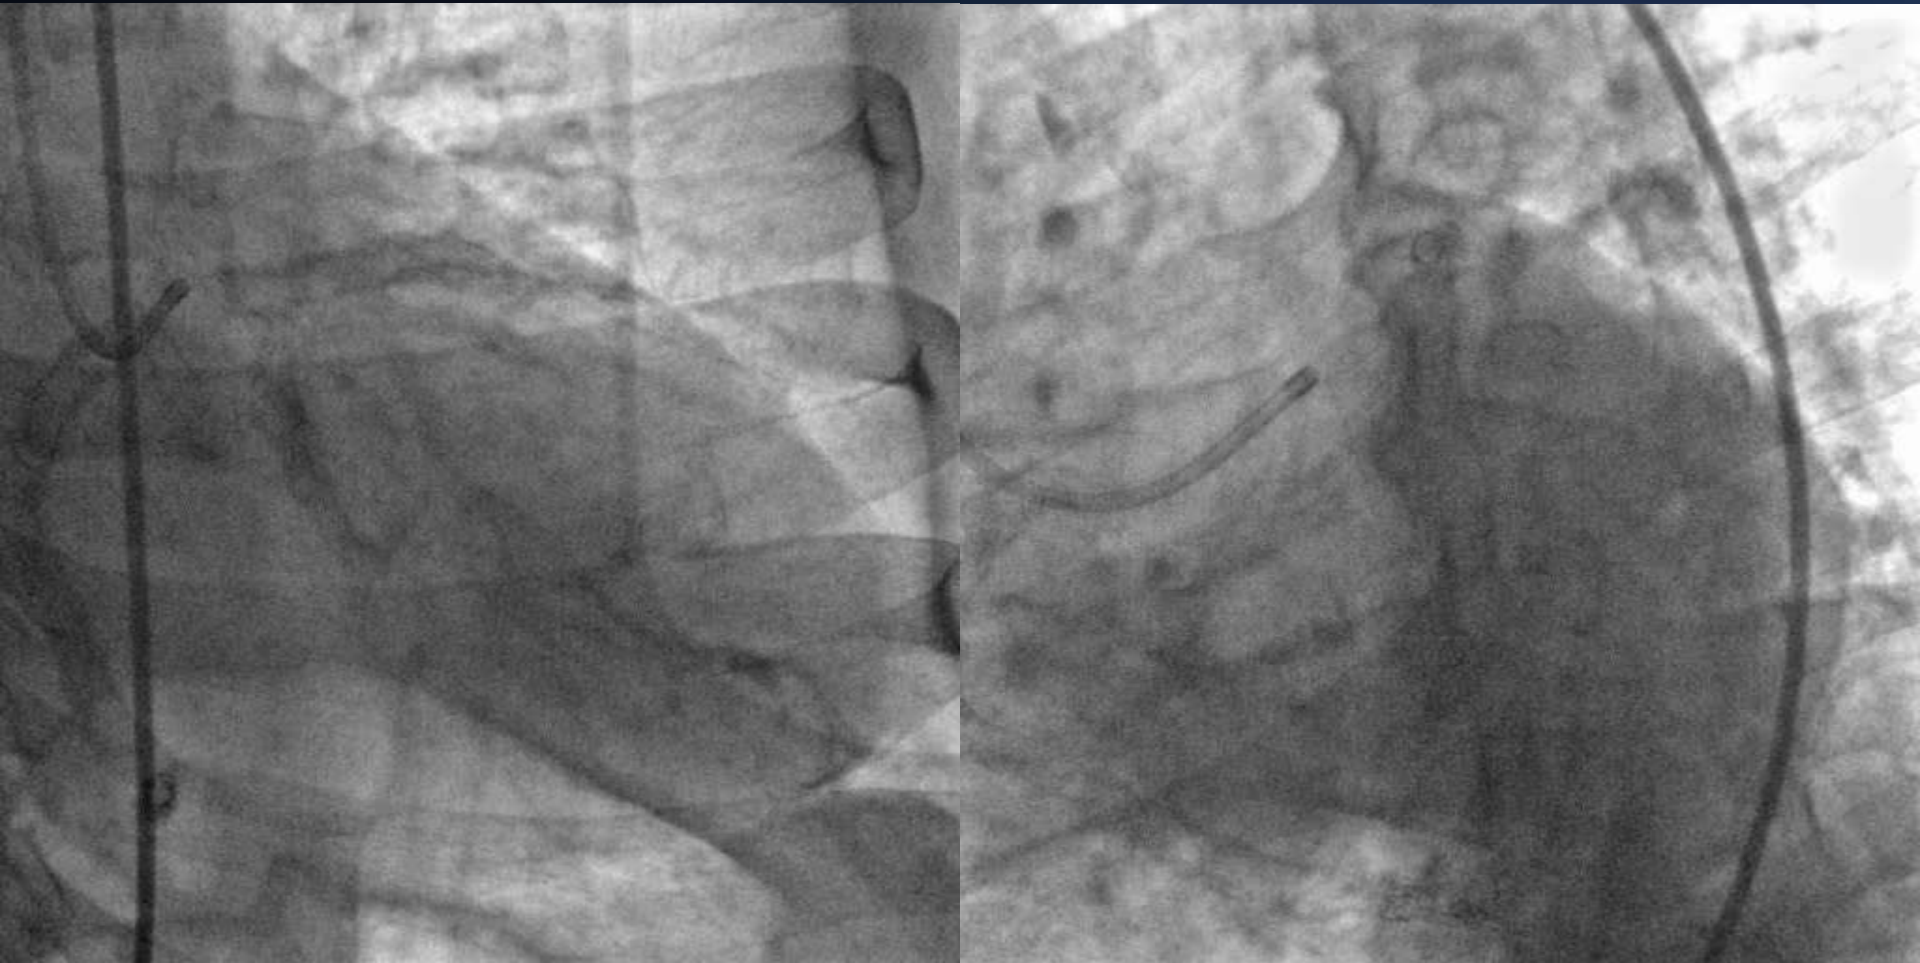
Control CAG

Lt.Femoral 7Fr approach
G.C; Hyperion SPB375SH 7Fr

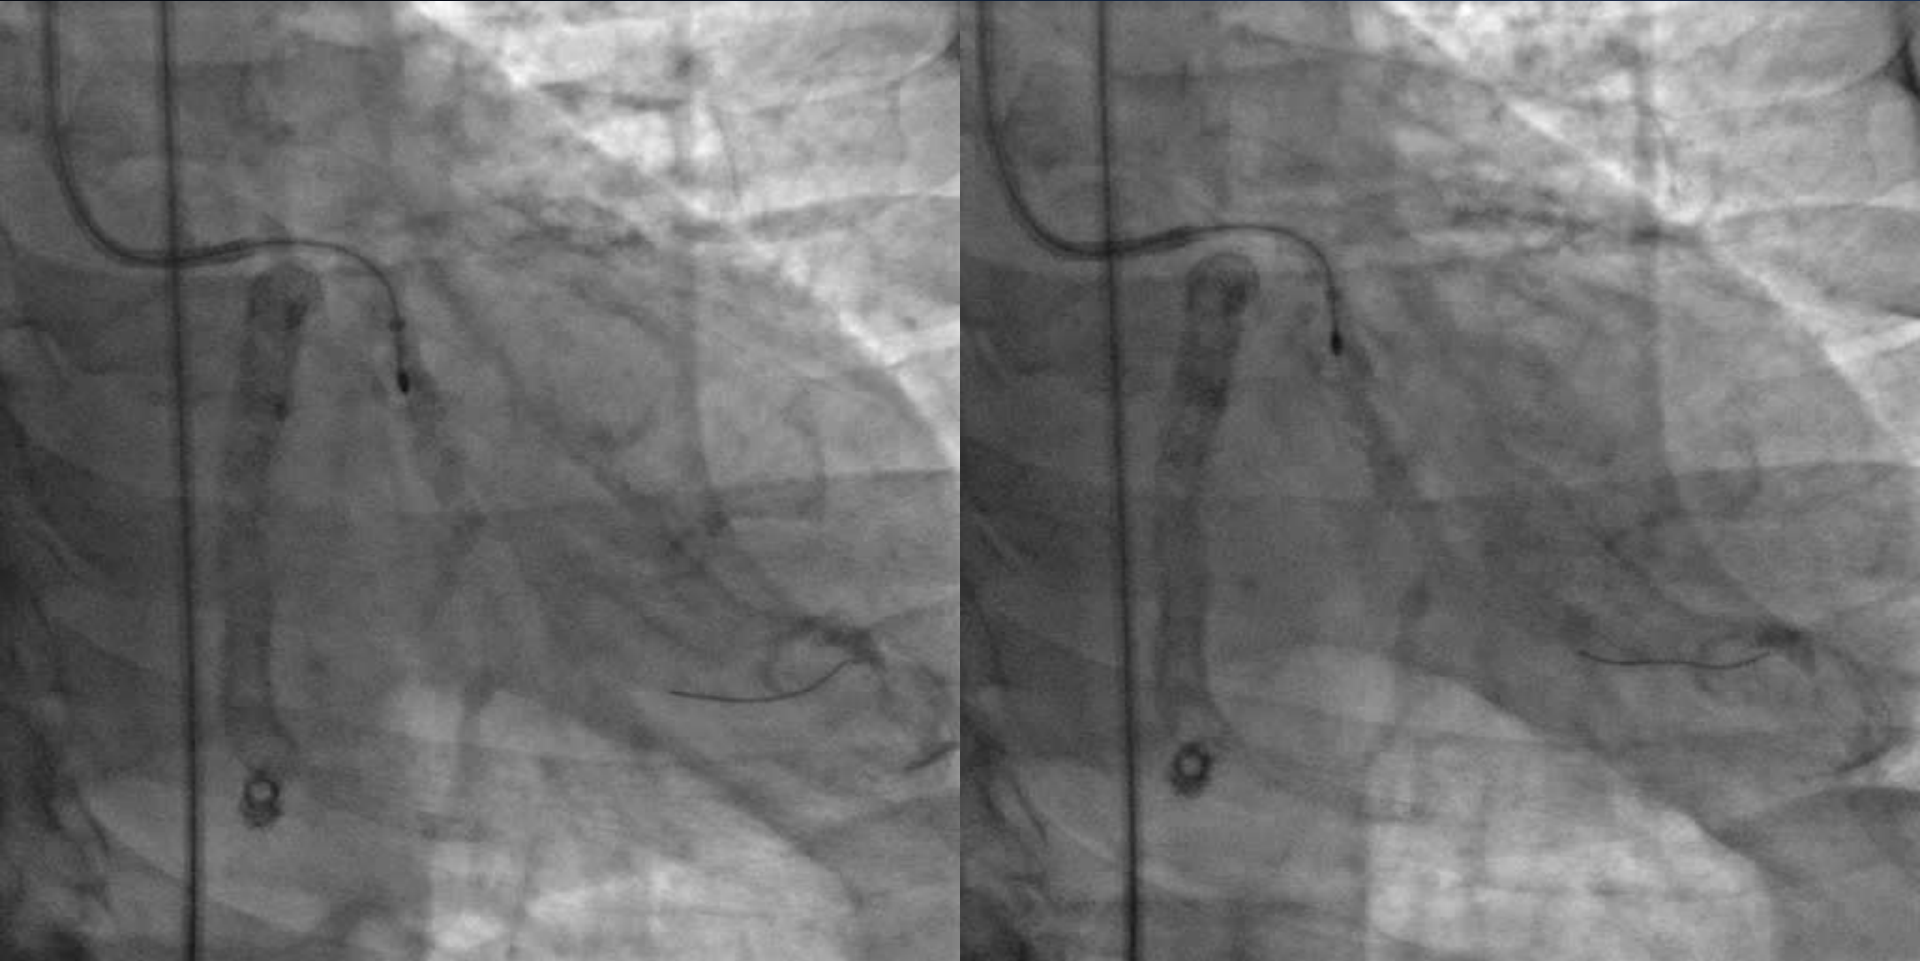
Rotational Atherectomy

**Rotawire Extrasupport
1.5mm burr, 200,000rpm**

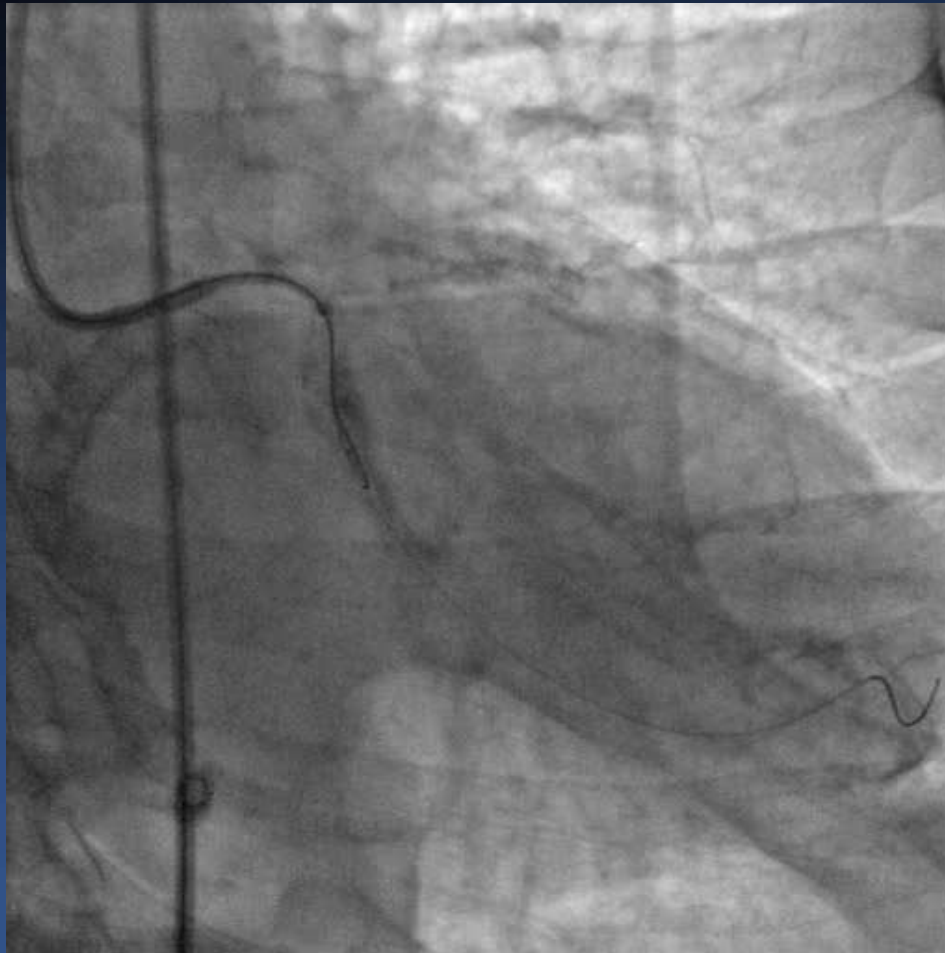
Wire Cracking

Crusade K support

In this case, in addition to thick calcification, the under expanded stent was the obstacle, and we needed to make mandatory cracks with stiff wire.

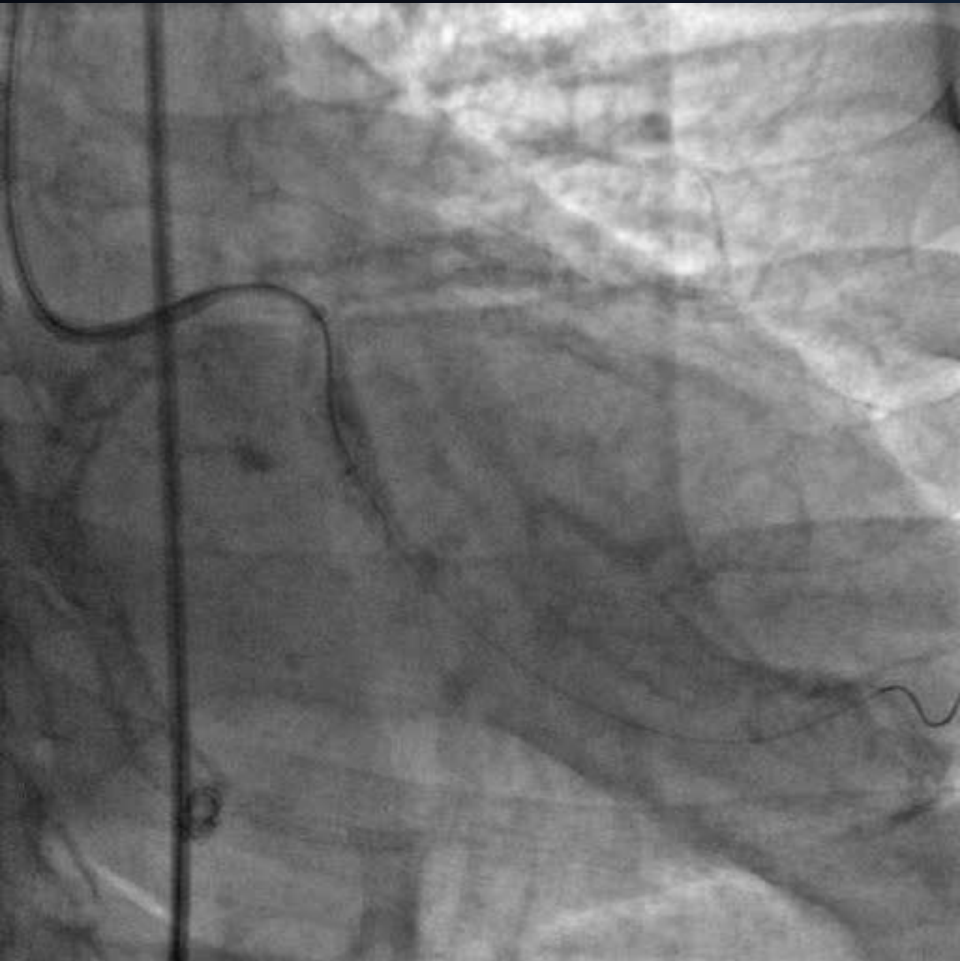
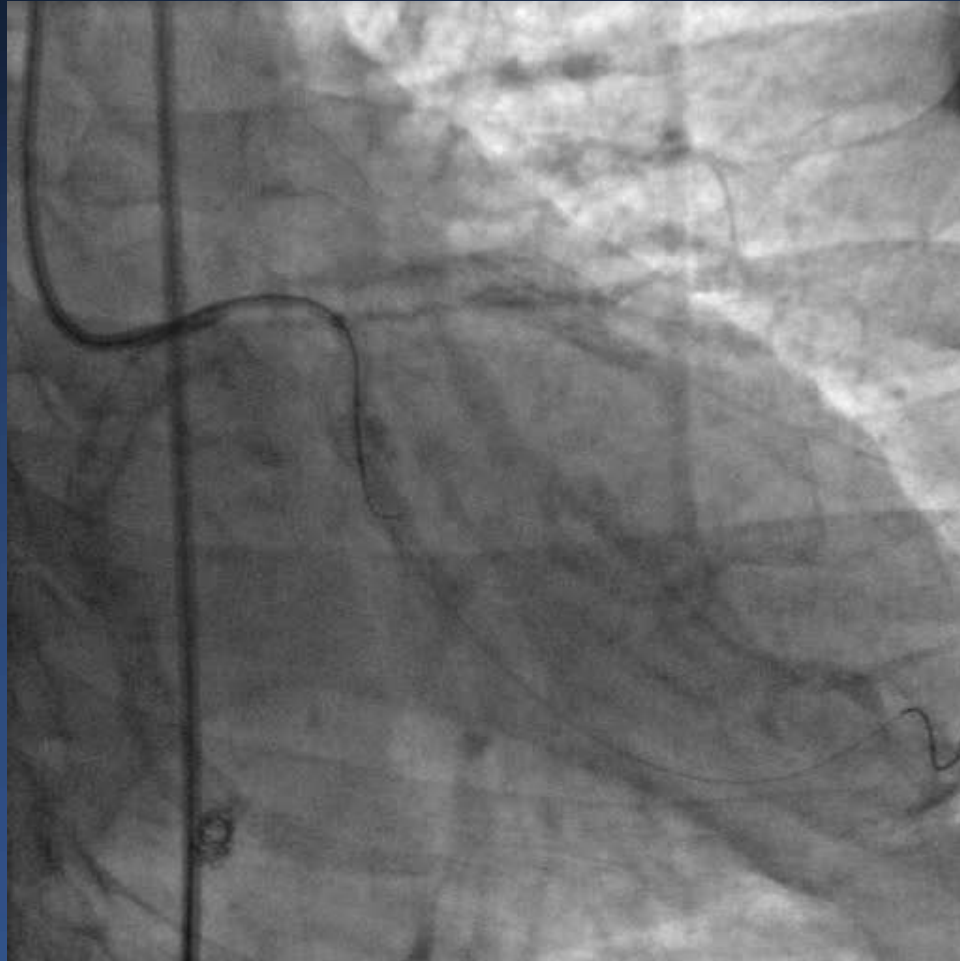
Wire Cracking

Crusade K support

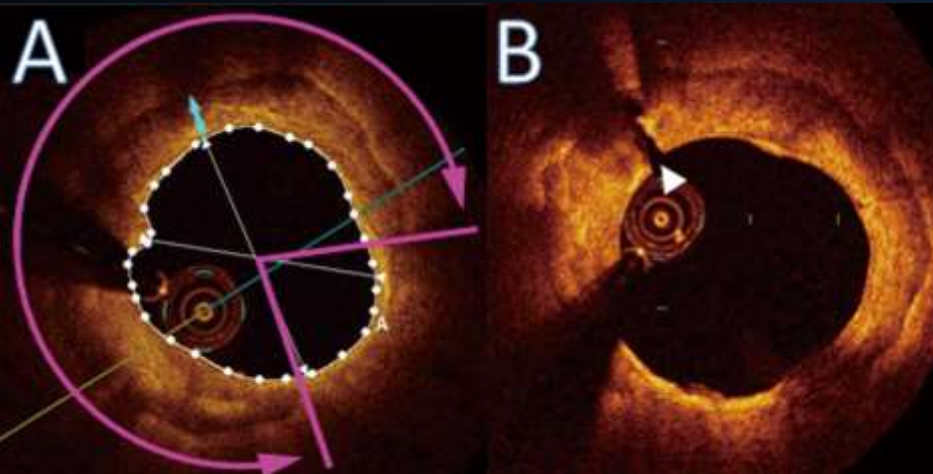
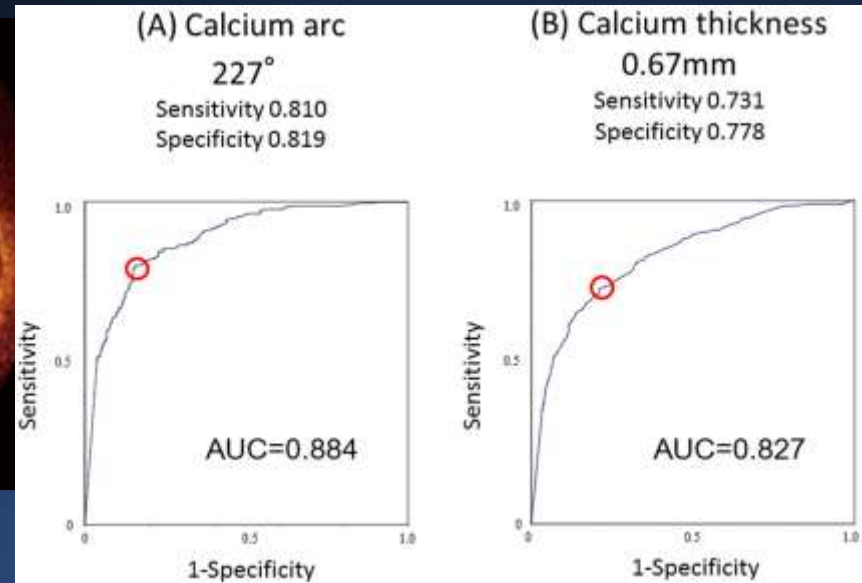
Discussion

Presence of calcium crack was the important determinant of optimal stent expansion in the calcified coronary lesions.

Larger calcium arc ($>227^\circ$) and thinner calcium thickness ($<0.67\text{mm}$ ($670\mu\text{m}$)) were associated with formation of calcium crack. (*Circ J* 2016; 80: 1413-1419)
