Going Beyond Angiography;

VH-IVUS defined plaque rupture

Sang-Wook Kim, MD
Director of Heart Center
Director of Core Lab
Professor of Medicine
Chung-Ang University Hospital

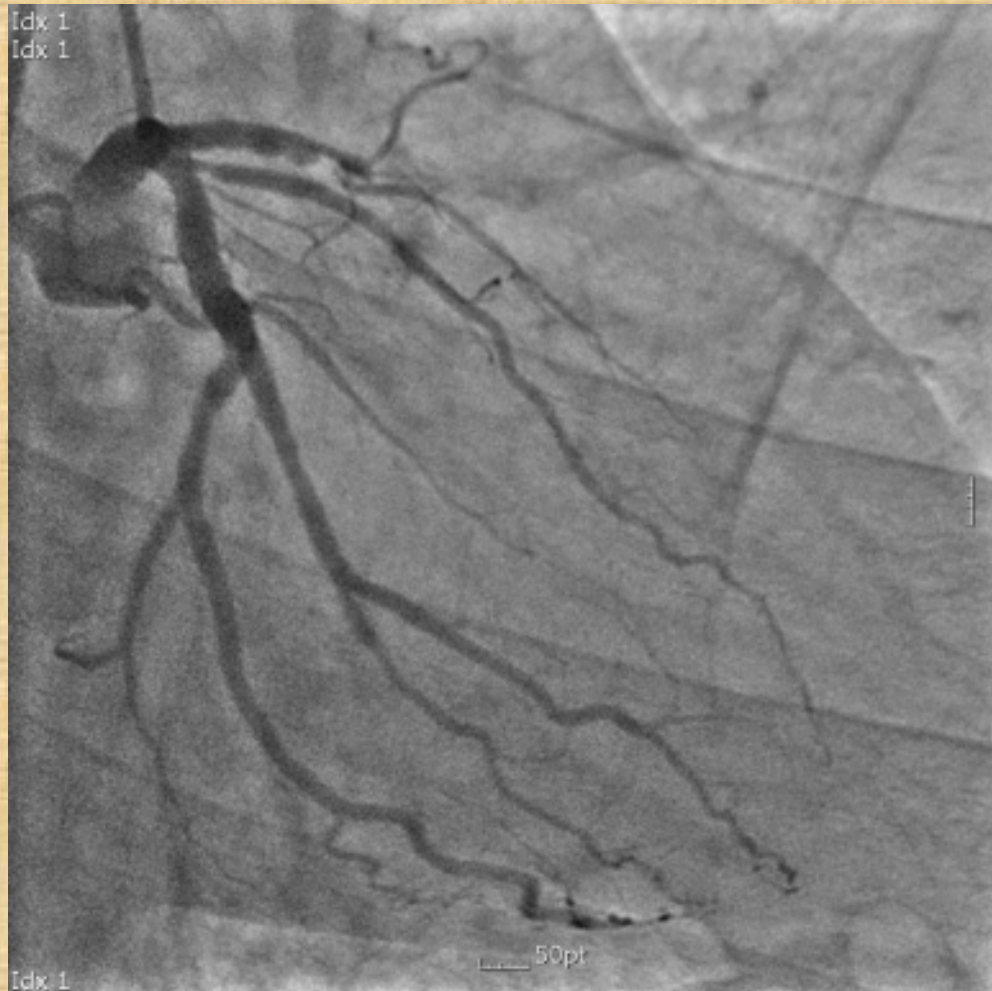
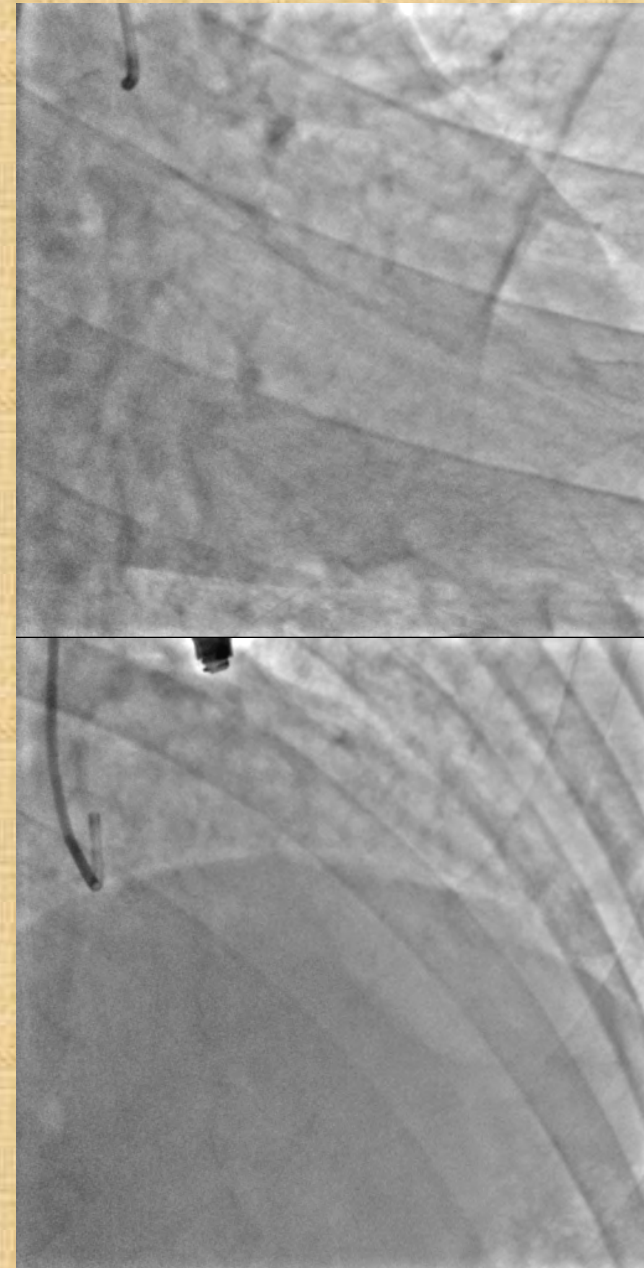
Case 1.

M/64, Acute ST elevation MI

Primary PCI and VH-IVUS

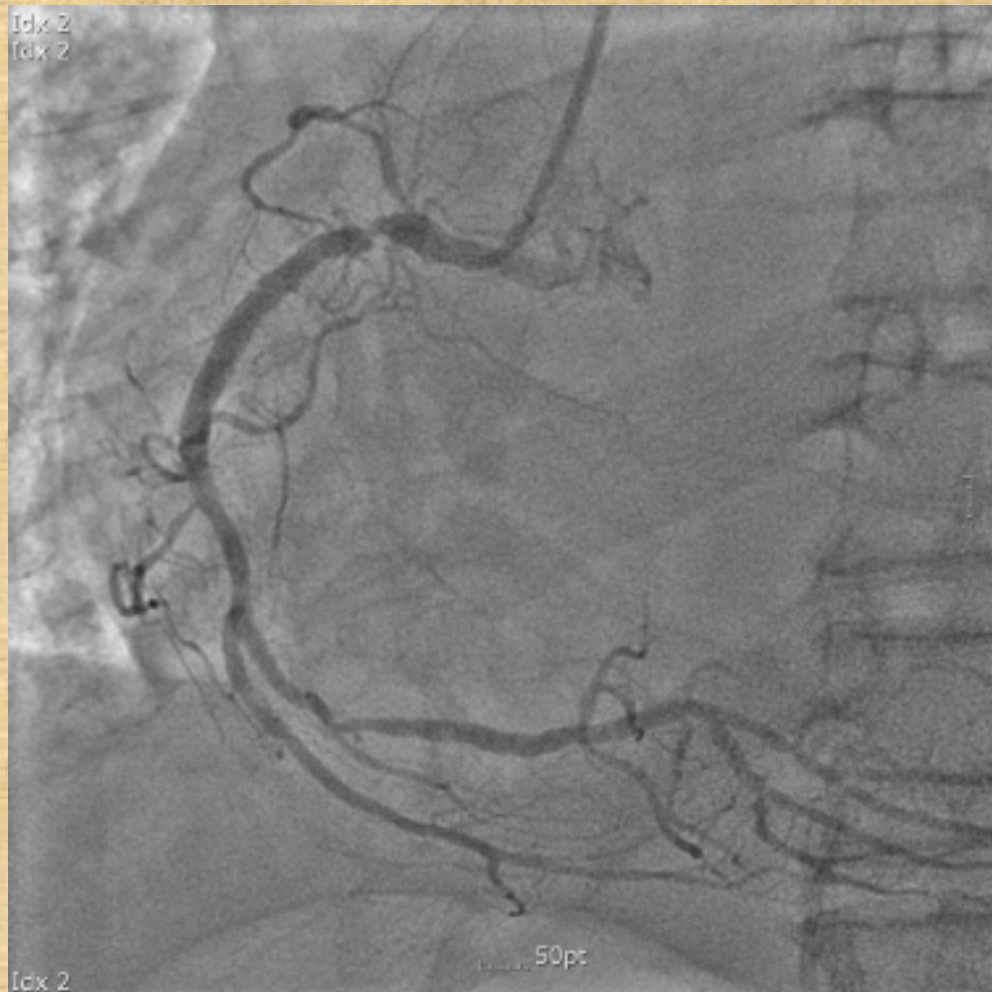
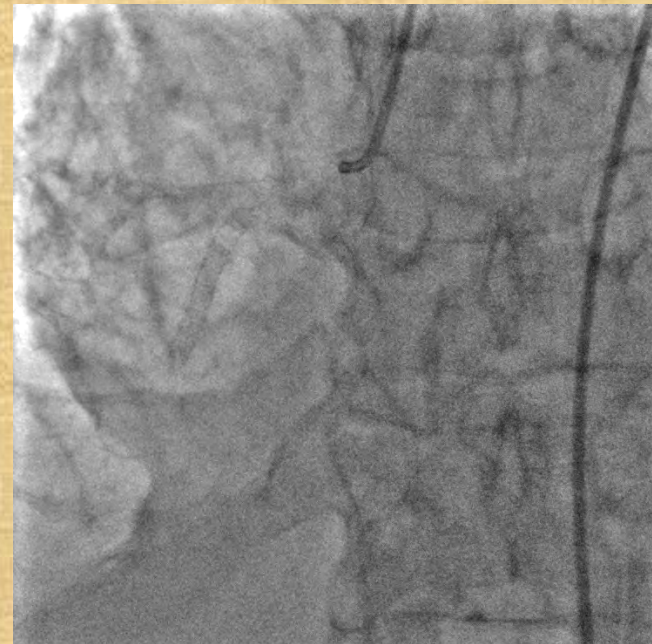
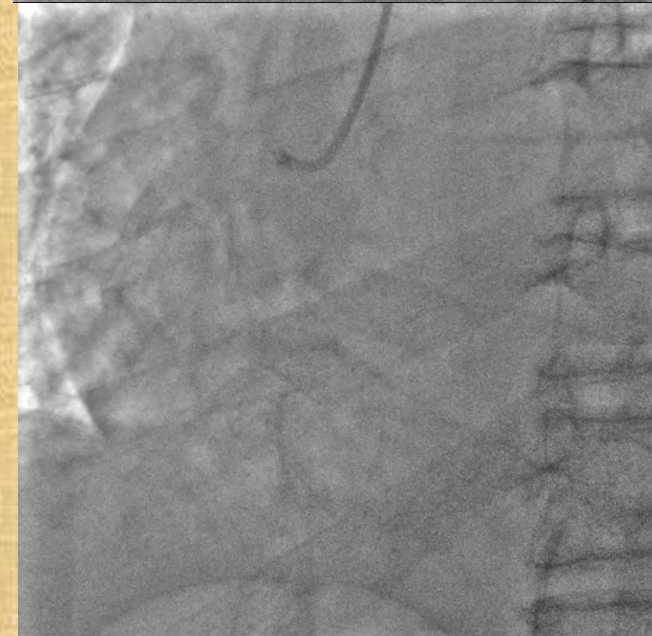
Case 2. M/72, Acute ST elevation MI

Past medical history; PCI mRCA, 2009.12.

Primary PCI with VH-IVUS
