OCT Findings in Very Late Stent Thrombosis

Jung-Sun Kim, MD, PhD

Division of Cardiology, Severance Cardiovascular Hospital,
Yonsei University College of Medicine

**Could incomplete stent strut
coverage in OCT be a
possible cause of VLST ?**

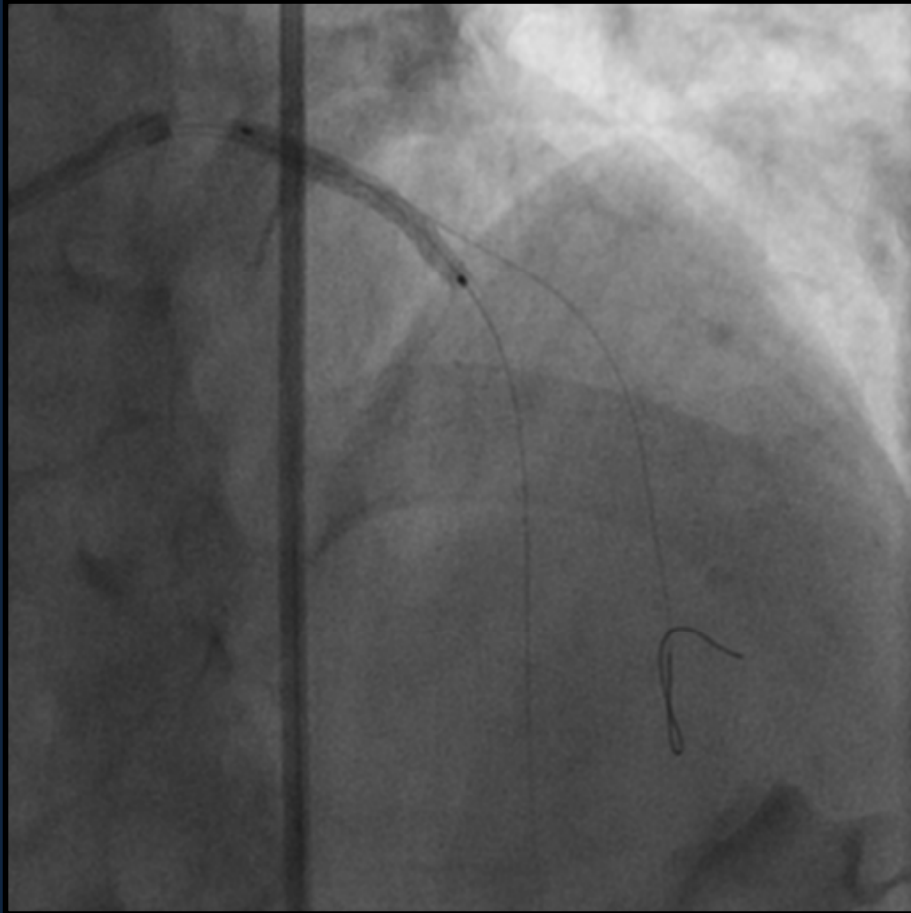
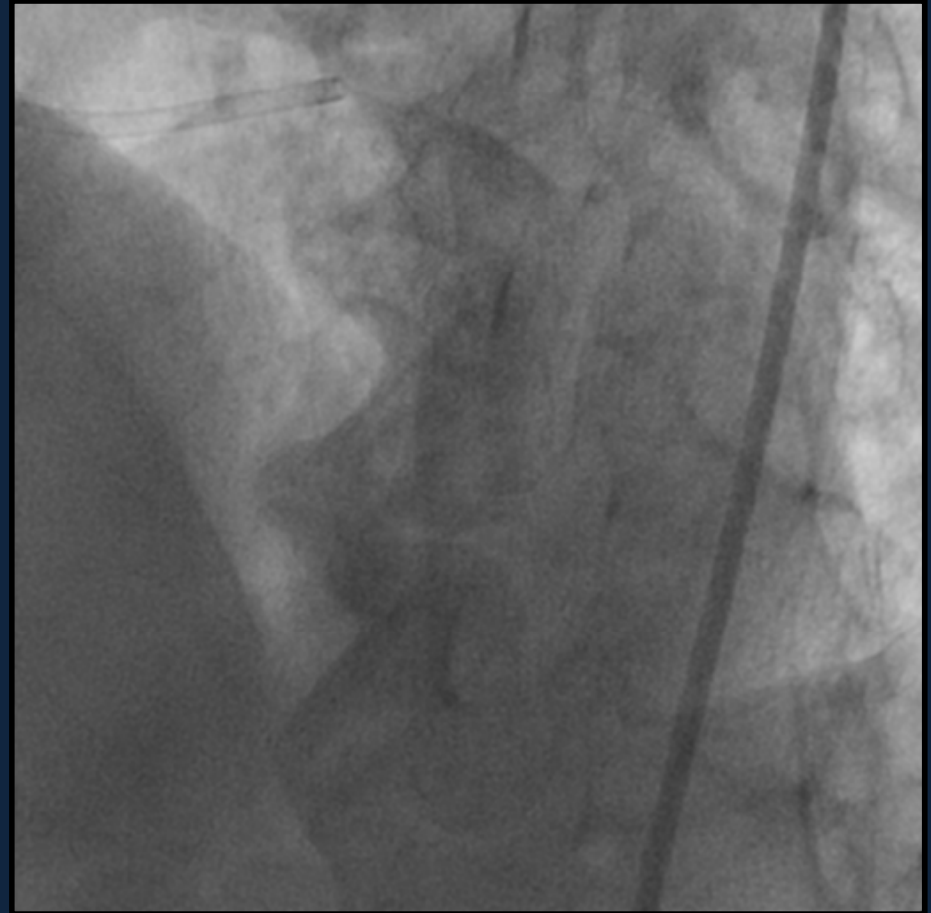
PTCA c stent

**Endeavor Resolute
(2.75 x 24 mm)**

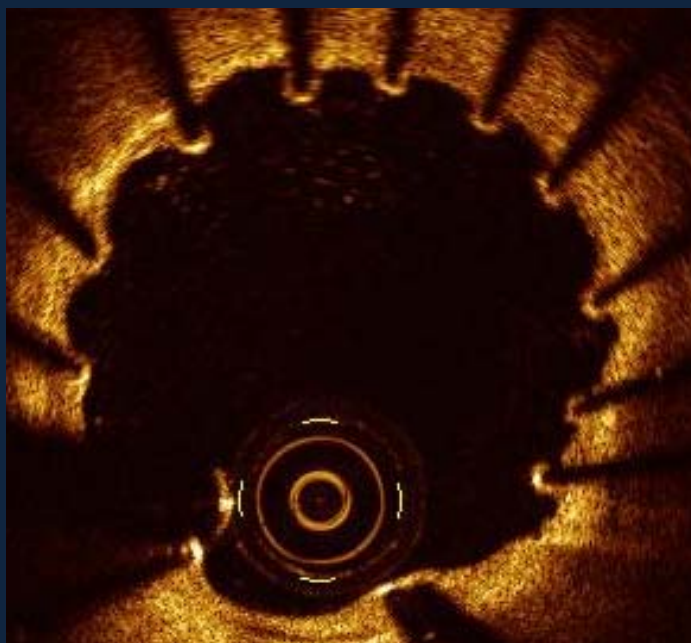
Cross-section with the most uncovered and malapposed struts

- No. of total analyzable struts: 200
- No. of malapposed struts: 11 → % malapposed struts = 5.5%
- No. of uncovered struts: 43 → % uncovered struts = 21.5%

A Length: 0.00mm
B Length: 0.00mm
C Length: 0.00mm
D Length: 0.00mm
E Length: 0.00mm
F Length: 0.00mm
G Length: 0.00mm
H Length: 0.00mm
I Length: 0.00mm
J Length: 0.03mm
K Length: 0.00mm
L Extra Lumen Area: 7.31mm²
M stent area: 6.42mm²
N Length: 0.00mm
O UN Malapposition: 0.15mm
P UN Malapposition: 0.17mm
Q UN Malapposition: 0.12mm
R UN Malapposition: 0.11mm
S UN Malapposition: 0.15mm
T UN Malapposition: 0.12mm
