### OCT Detectable Stent Malapposition and Plaque Erosion

The story and strategy which IVUS can not tell us.

Chao-Feng Lin, MD Shuang Ho Hospital Taipei Medical University Taiwan

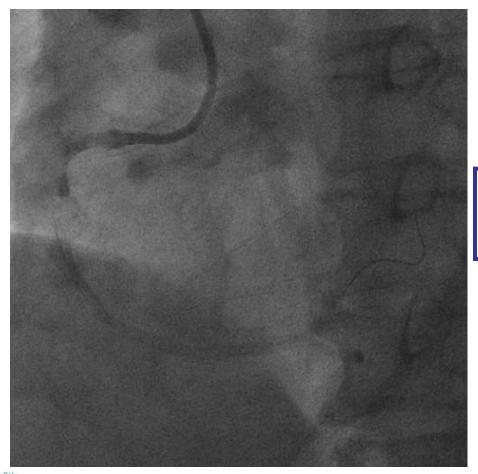
Angiography showed total occlusion of RCA.

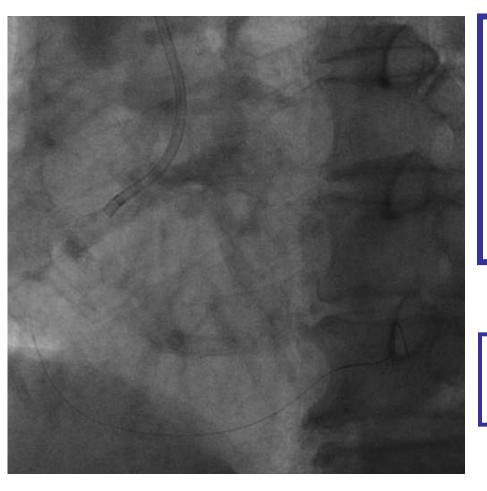
After multiple attempts of thrombus aspiration:

→ There was still thrombus sticky to the vessel wall with TIMI 2 flow.

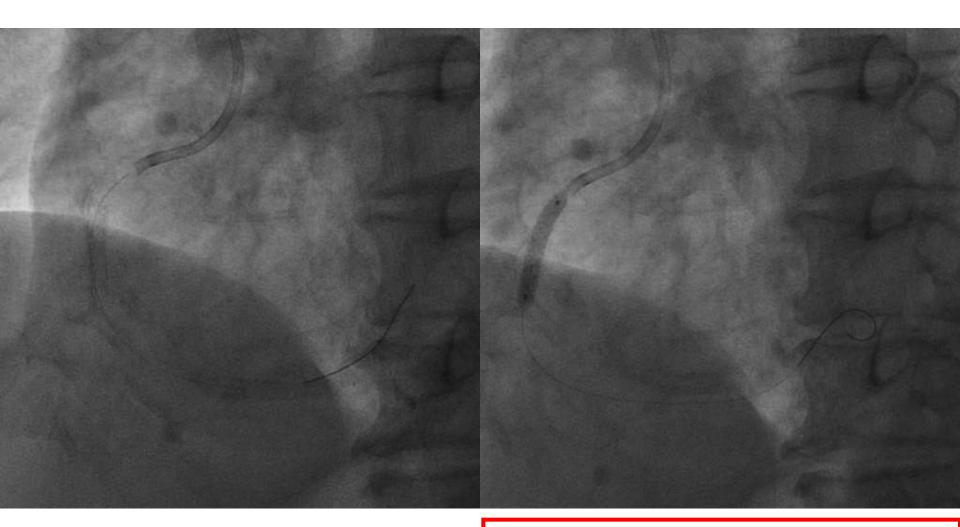
## A DES of 3.5 mm was placed.

Post-dilate with NC balloon 3.5 x 20, mm

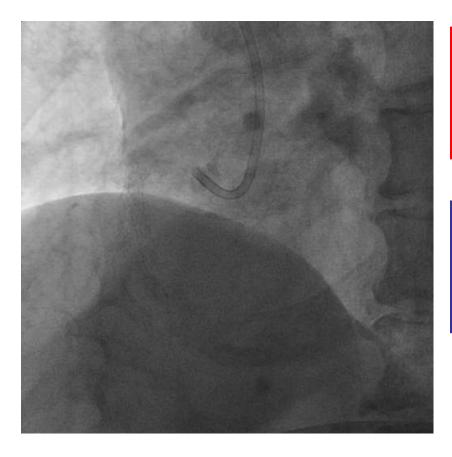
Followed angiography showed patent lumen with TIMI 3 flow.

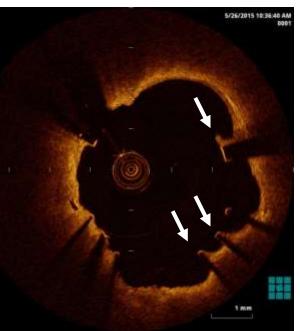
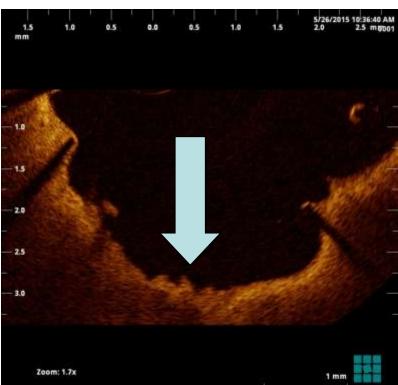
#### At the level $A \rightarrow$

OCT showed malapposition of strut and plaque erosion with tiny thrombus which IVUS failed to detect.

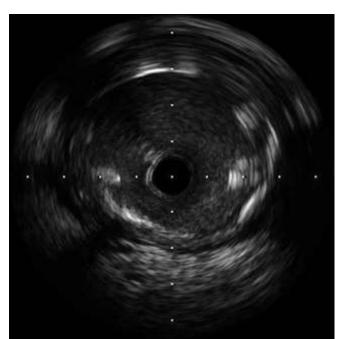
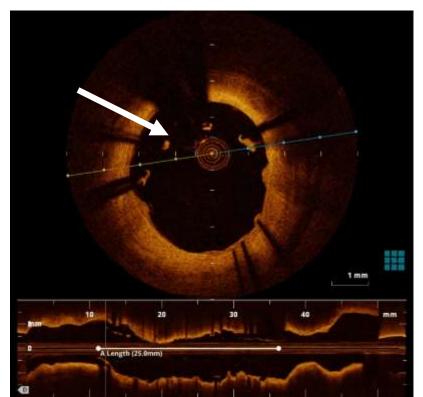
#### At the level $B \rightarrow$

OCT showed malapposition of strut which IVUS could not show clearly.

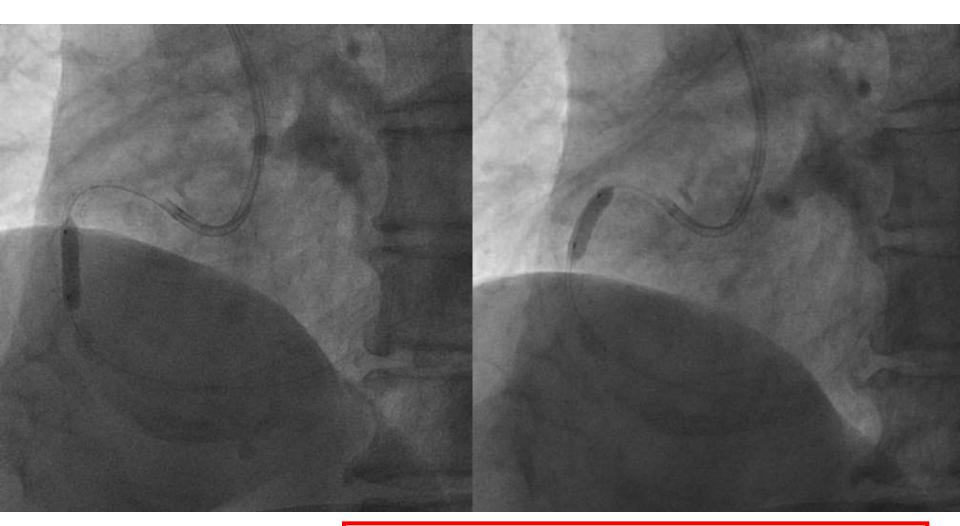
In-stent dilation by using NC balloon 4.0 x 15 mm

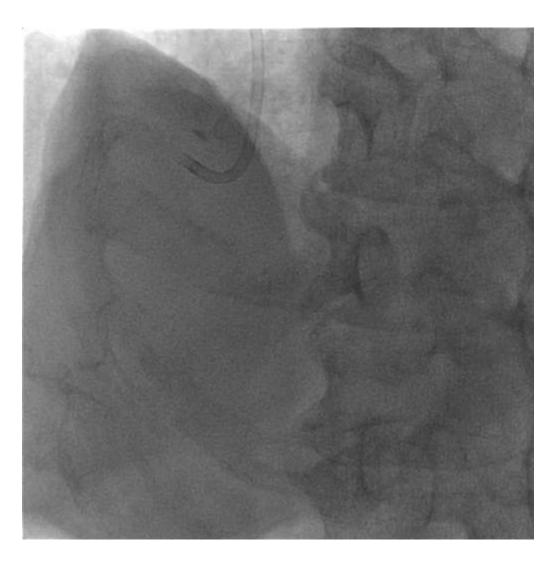
### Final angiography showed optimal results.

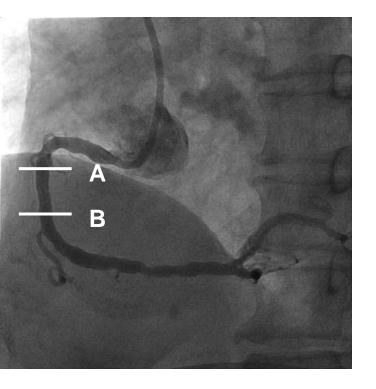
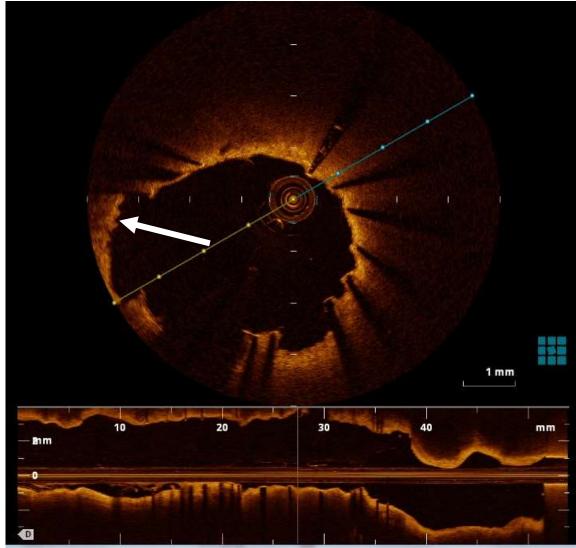
#### Level A $\rightarrow$

Improved apposition of strut.

However, plaque erosion still existed.

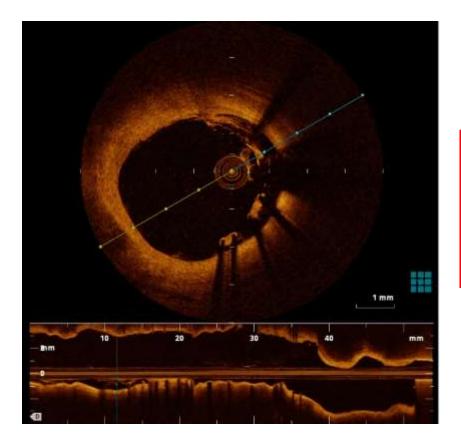
### Level $B \rightarrow$

OCT showed improved apposition of strut.
