Melody transcatheter pulmonary valve implantation: Tips and tricks

Frank F. Ing, MD
Professor of Pediatrics
Children's Hospital Los Angeles
University of Southern California

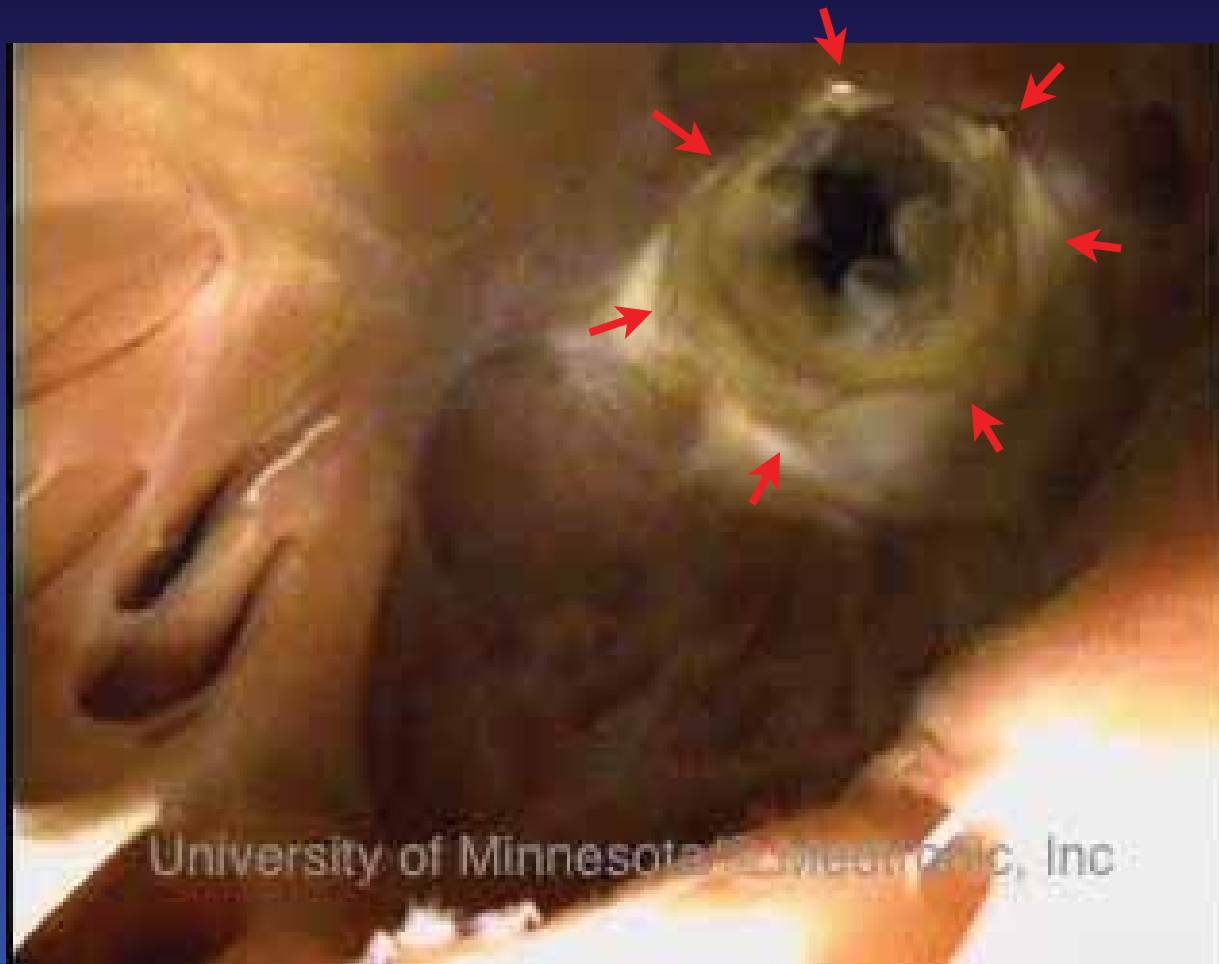
Melody valve function in a dog model

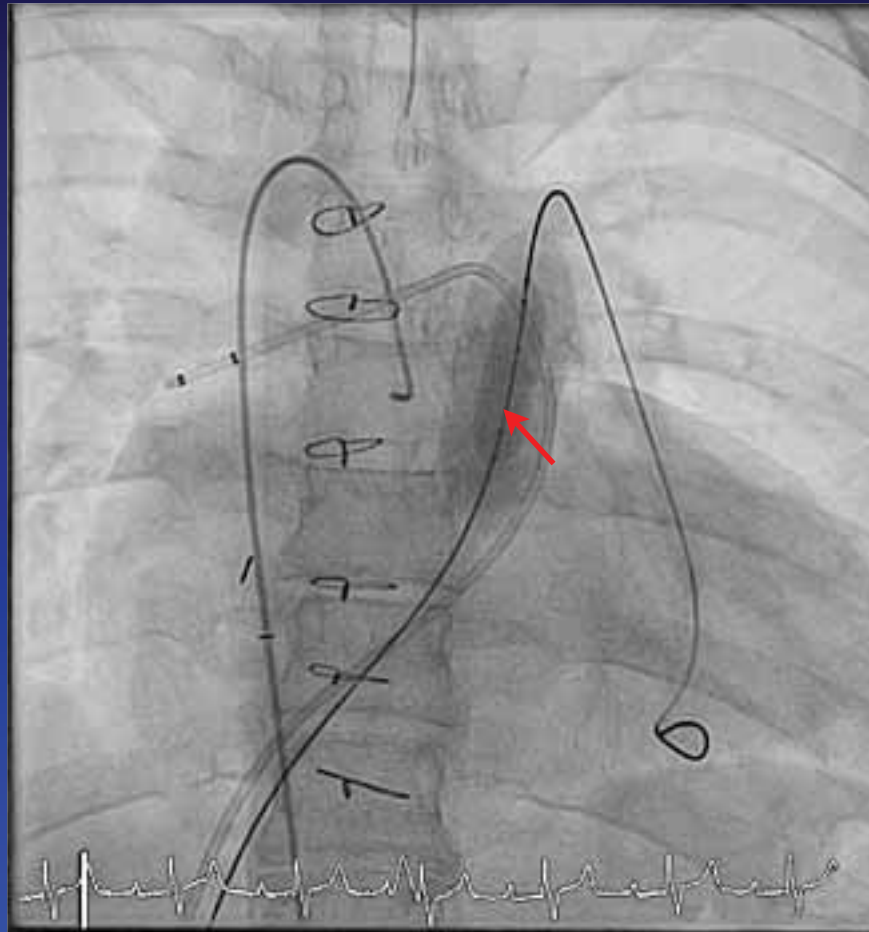
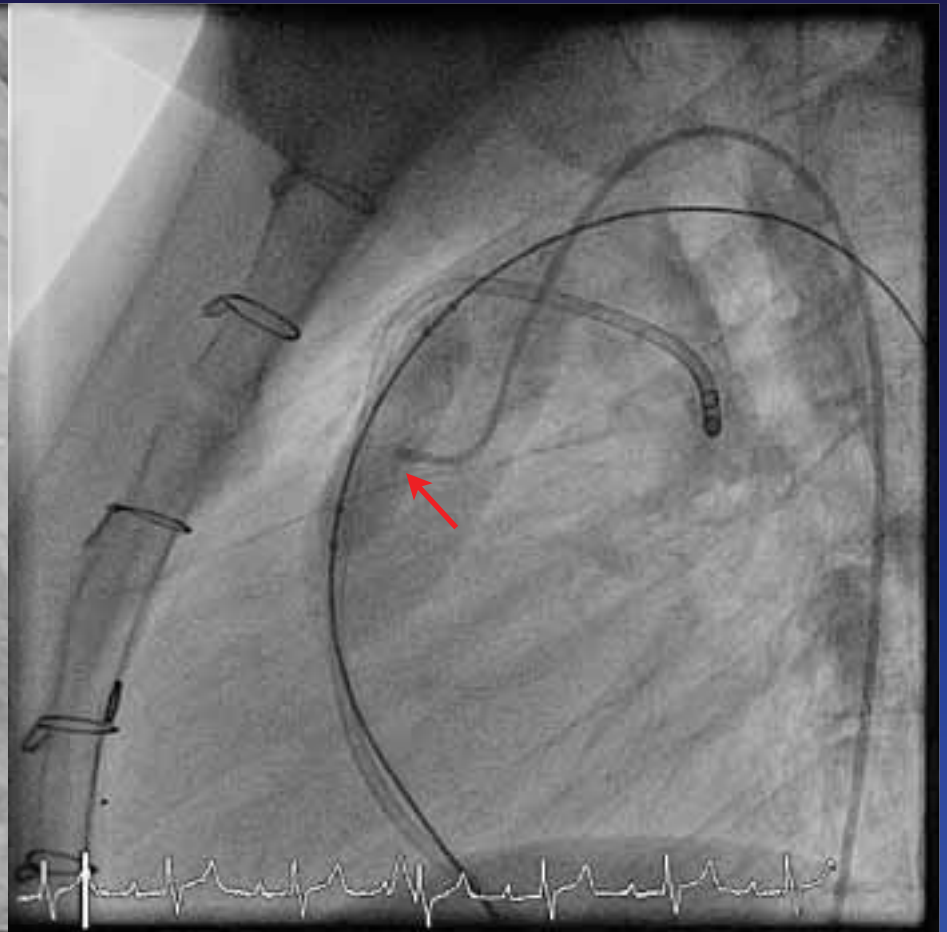
Use 1:5 or 6 dilution of contrast for balloon testing

- Tip:
 - Keep contrast in balloon dilute (1:5 or 1:6 dilution)- to see coronary compression superimposed over balloon
 - If in doubt, repeat angiogram using different angulations; rotational angiography

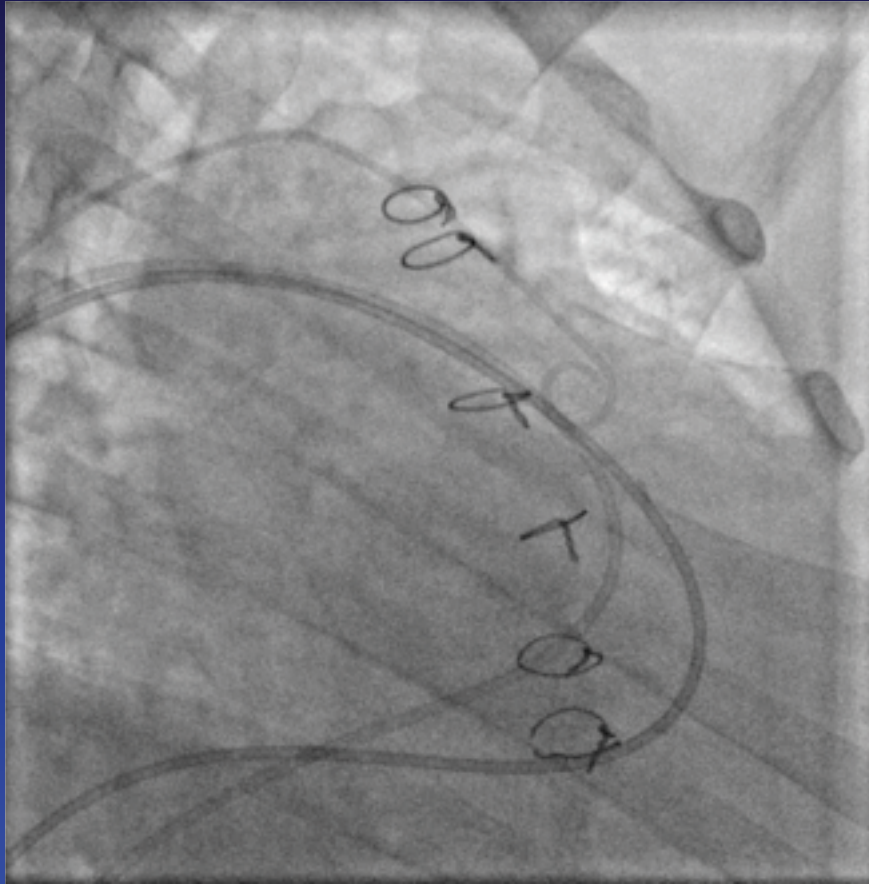
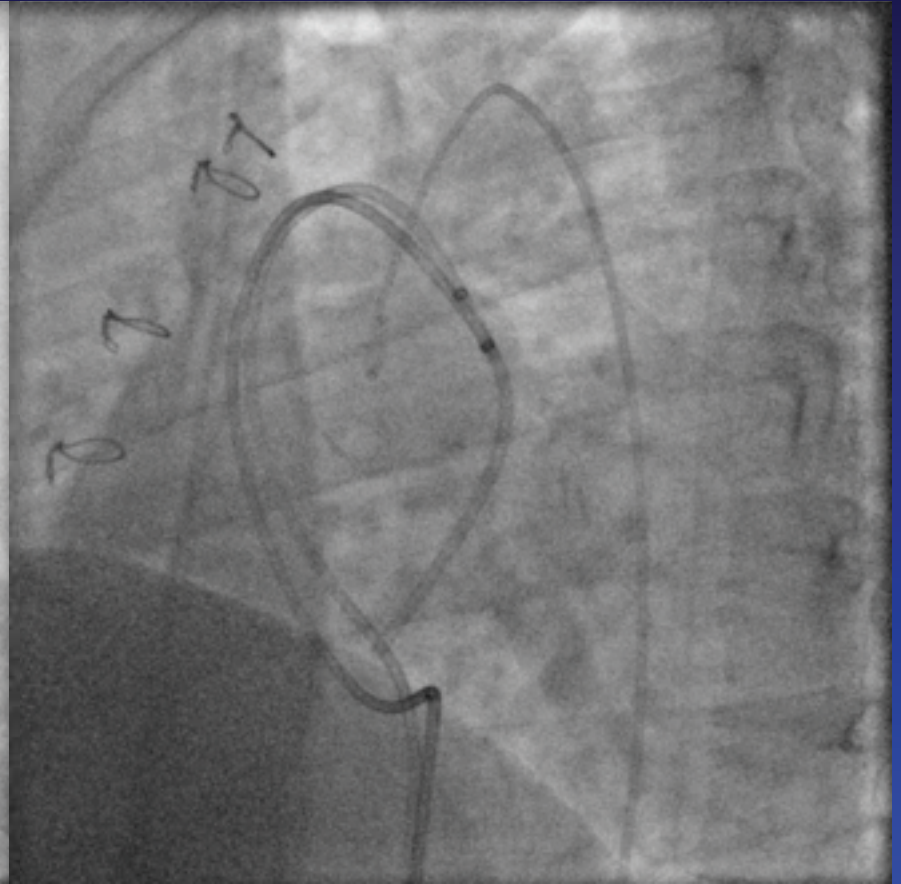
Aortogram- CA course not clear

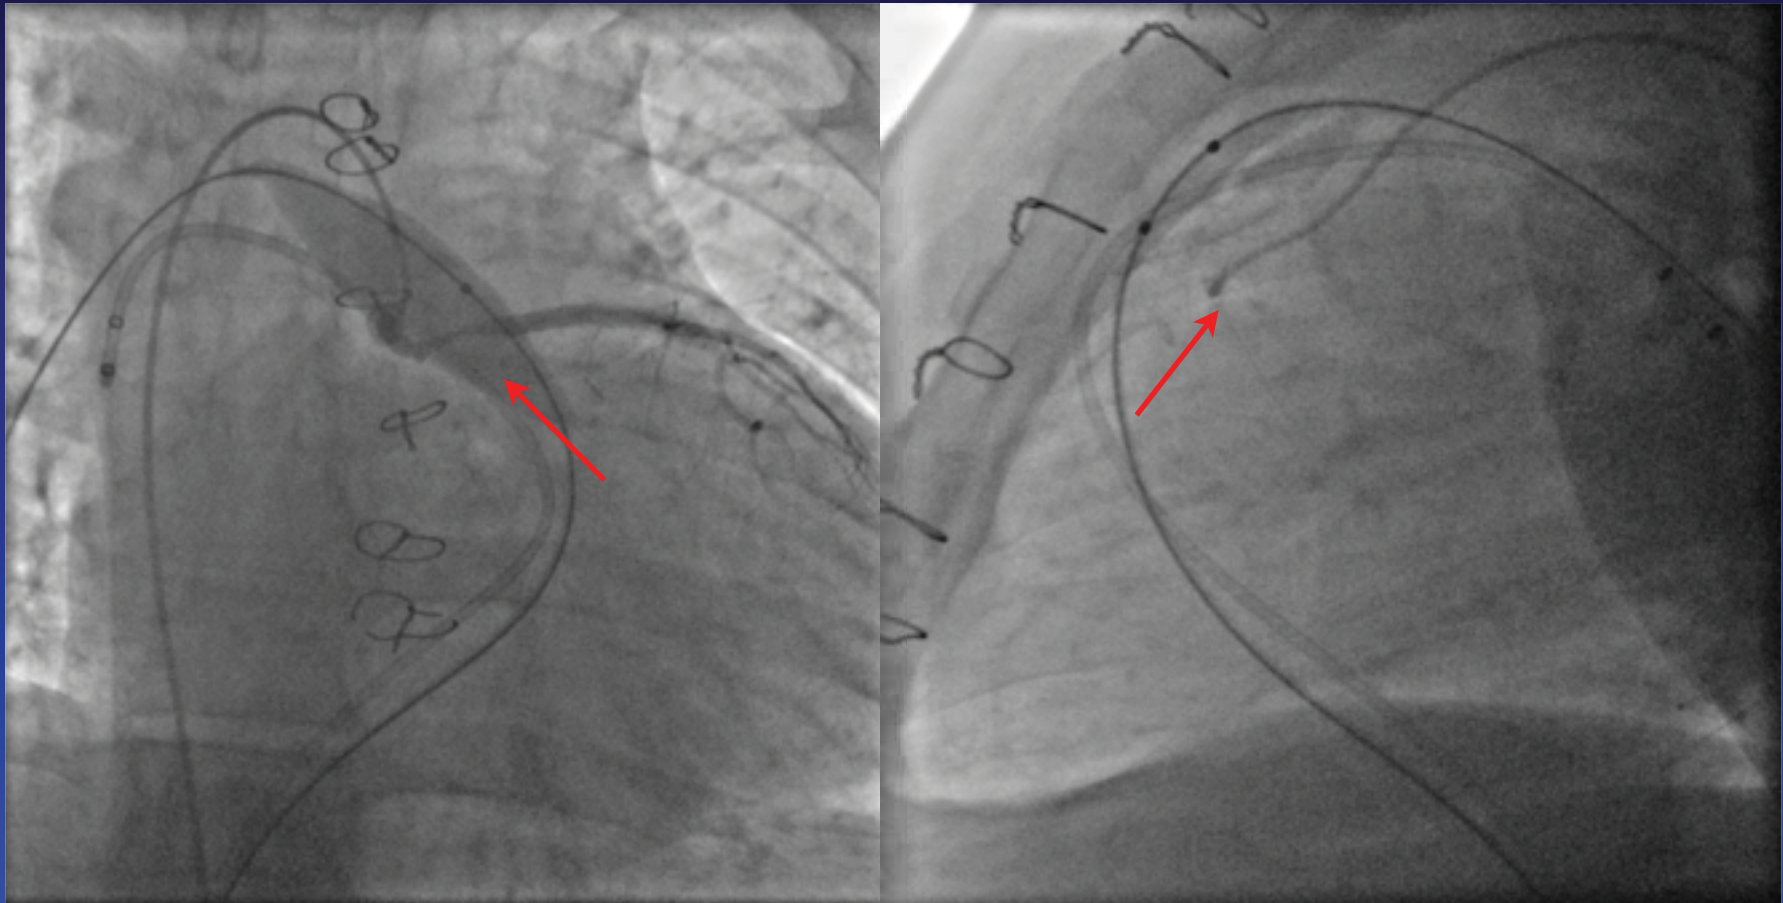
Balloon test inflation: LAD off right coronary sinus

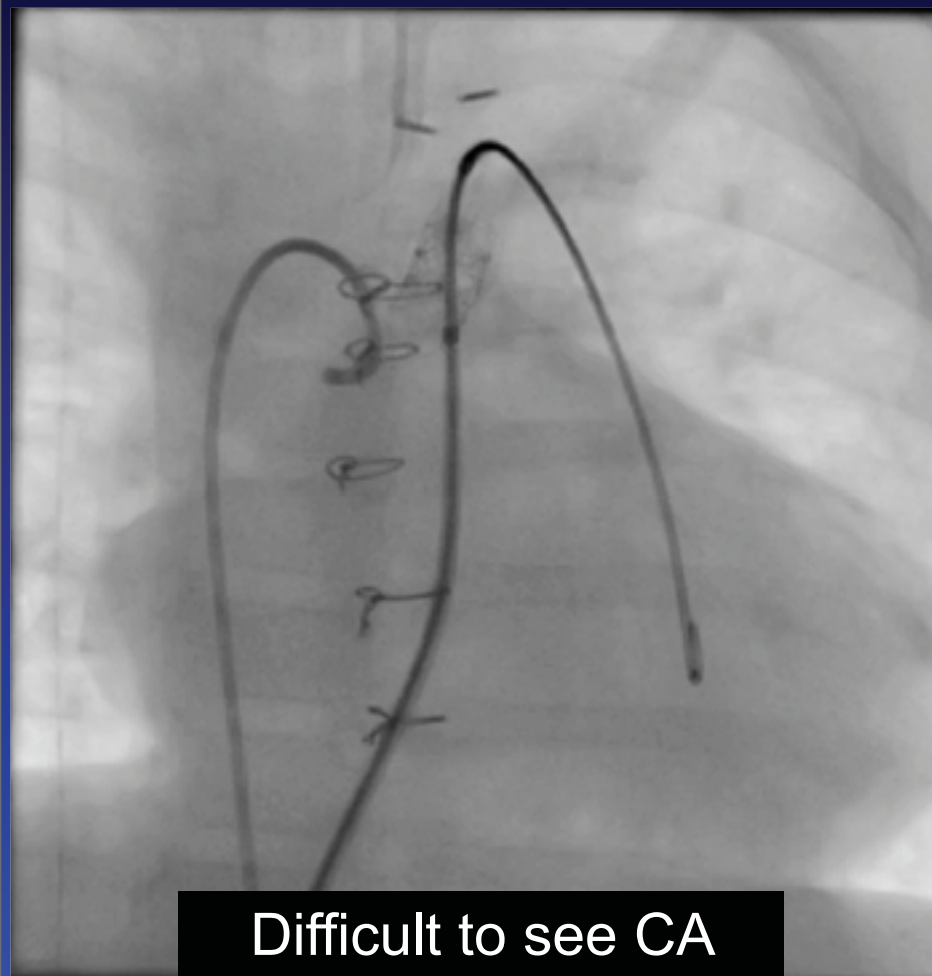
Cononary artery compression

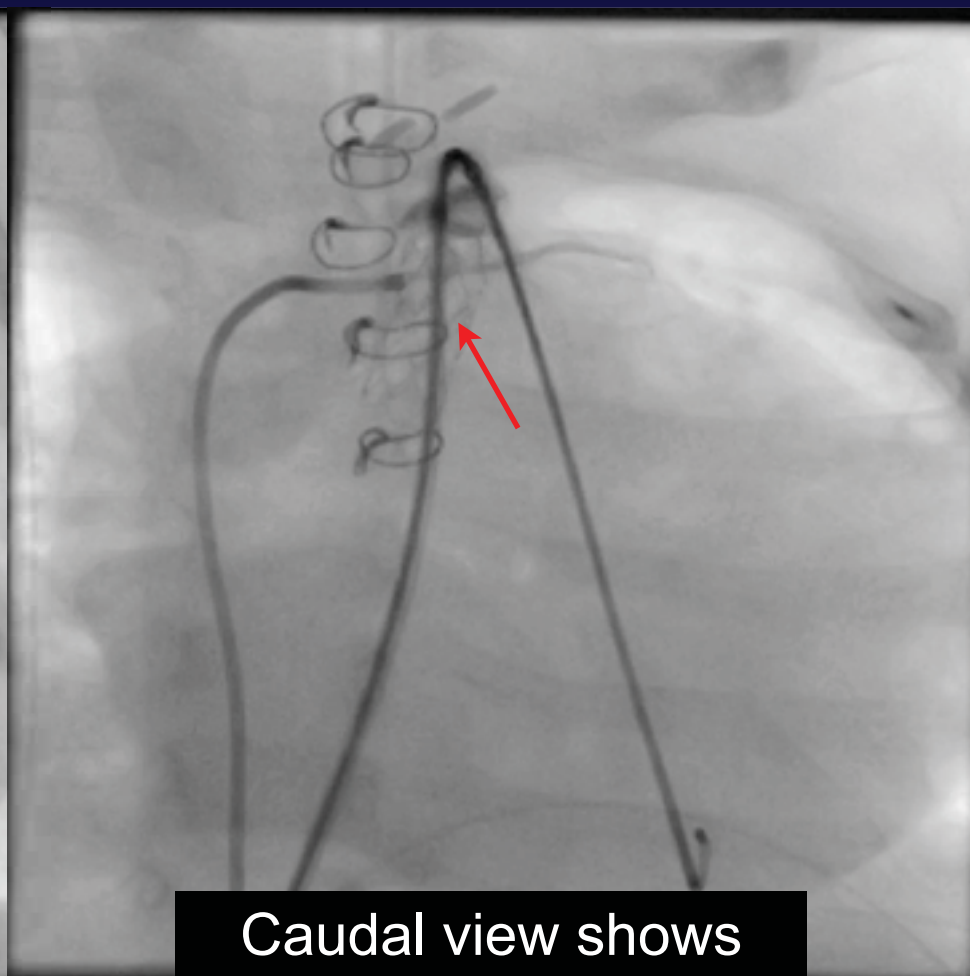
Difficult to see CA
with dark balloon

Caudal view shows
CA under Balloon

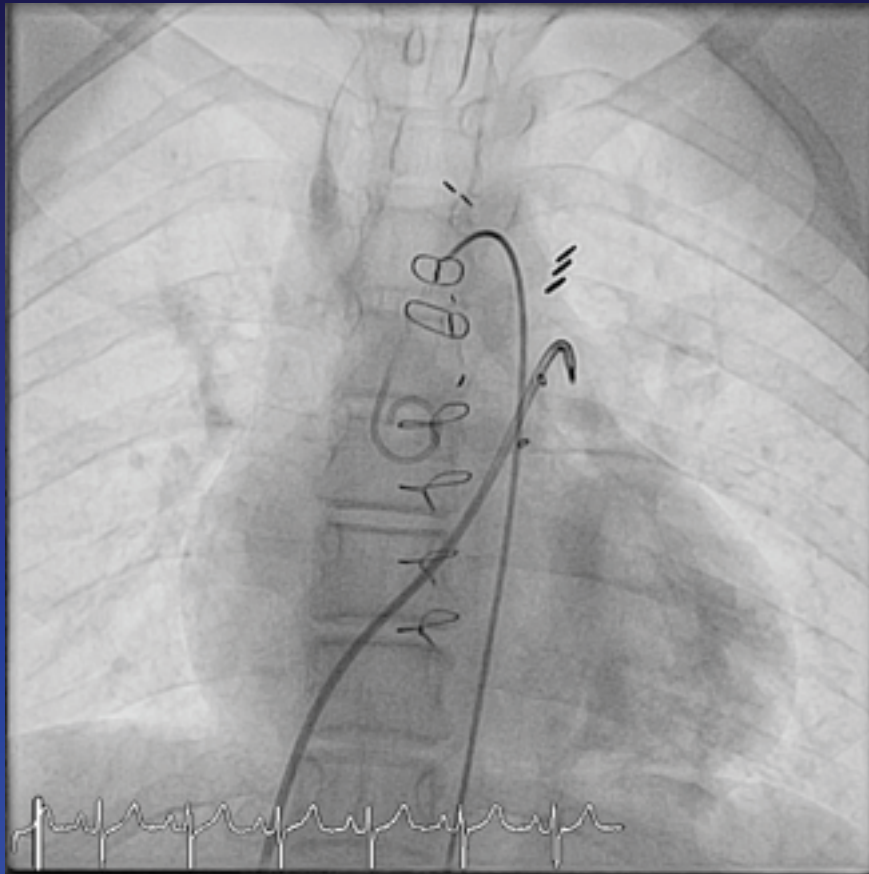
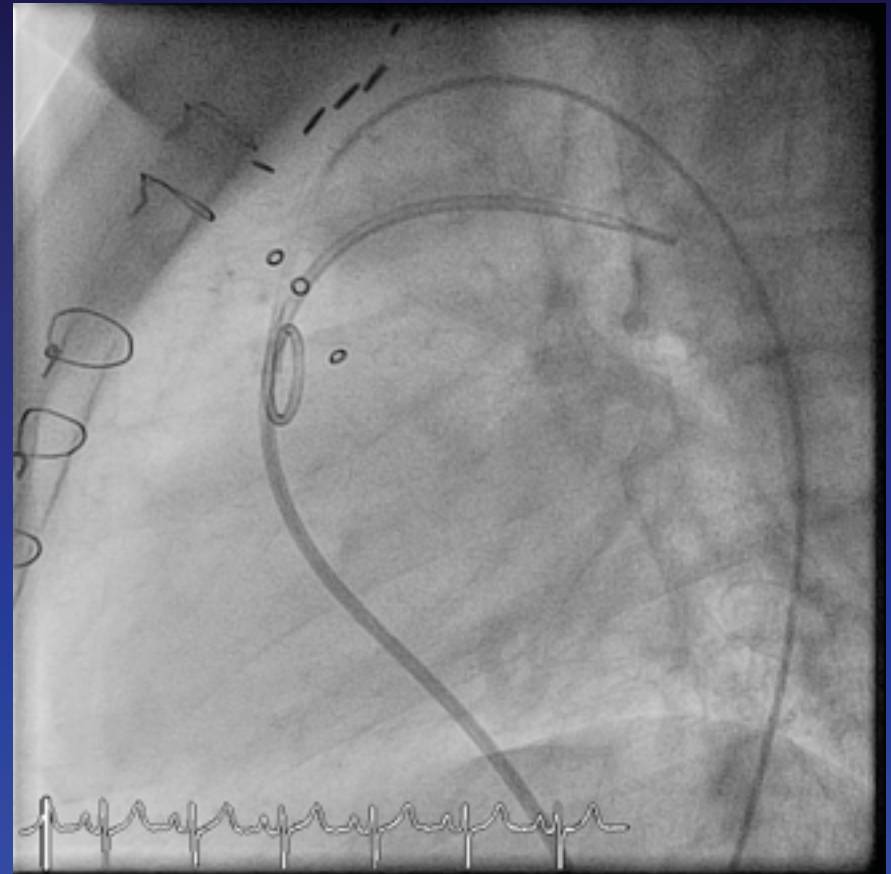
Aortogram: Coronary artery unclear

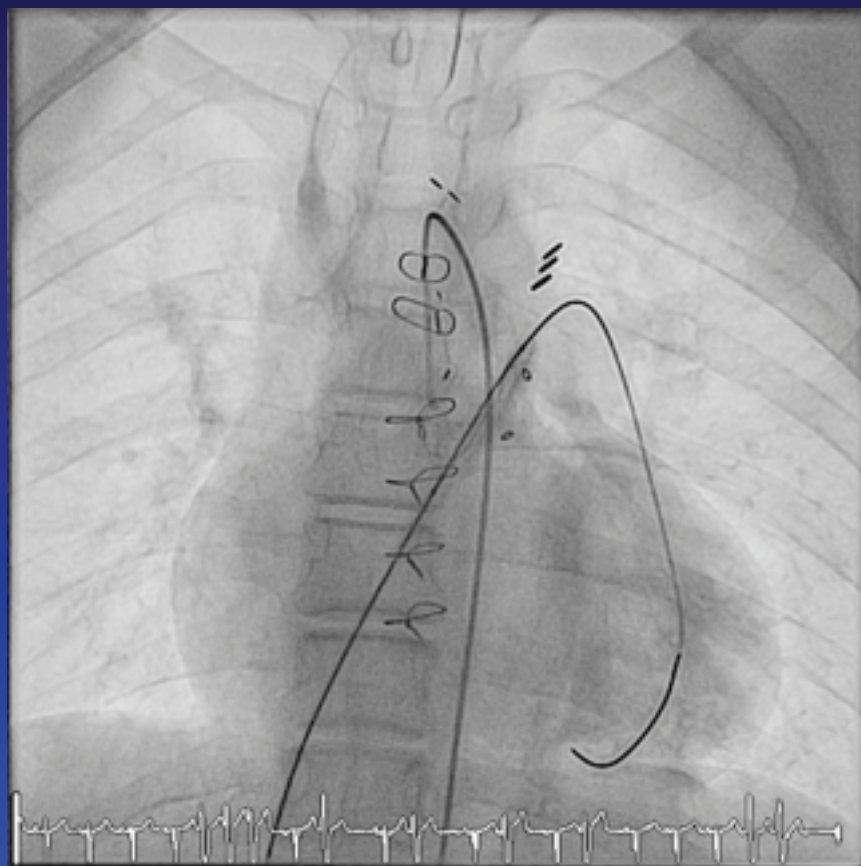
AP

Balloon testing: CA compression not always obvious even with selective angiogram

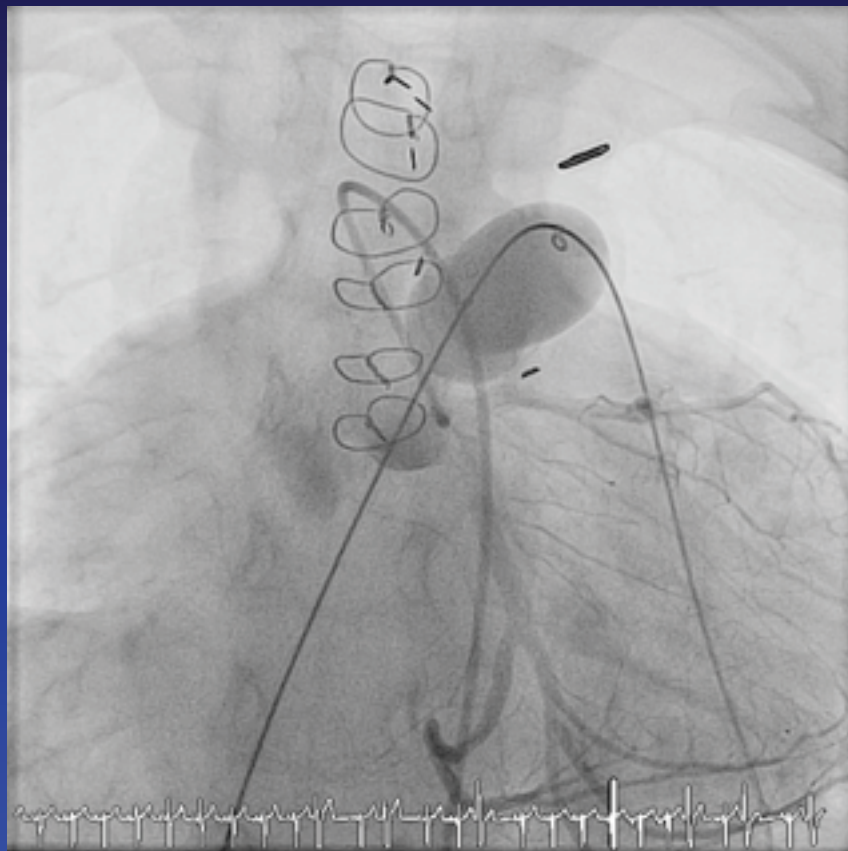
AP-Cau 32

Repeat balloon testing and angiography with new angulation

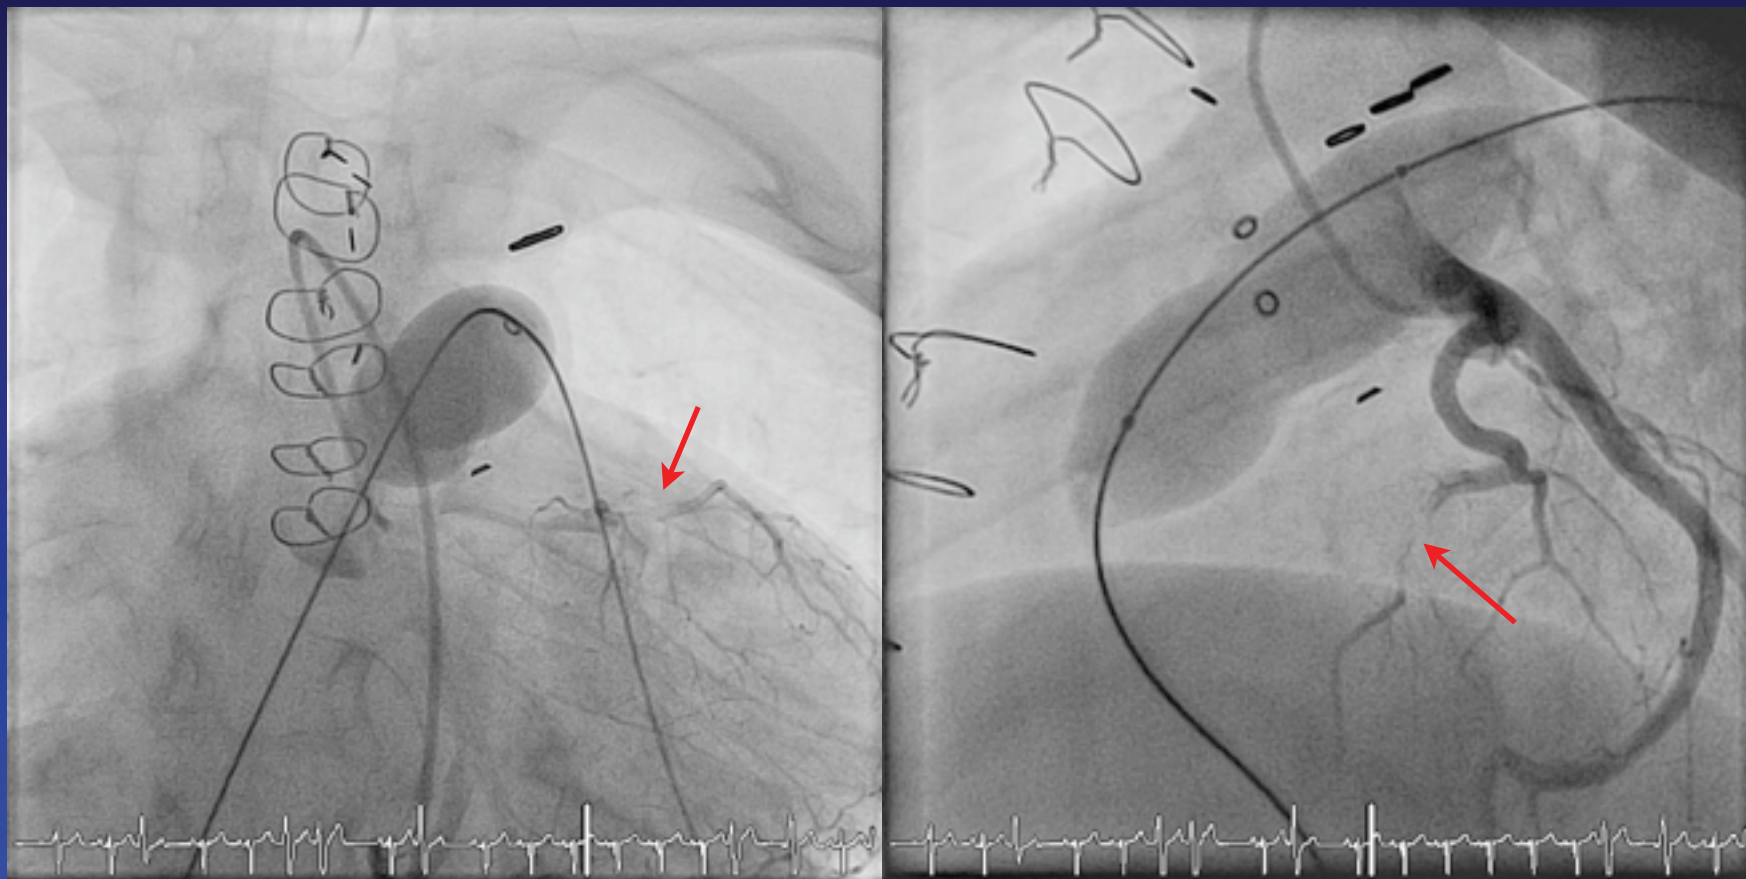
Repeat balloon testing with new angulation

AP-Cau 32

Lat-Lao 66, Cra 18

Coronary compression far from balloon

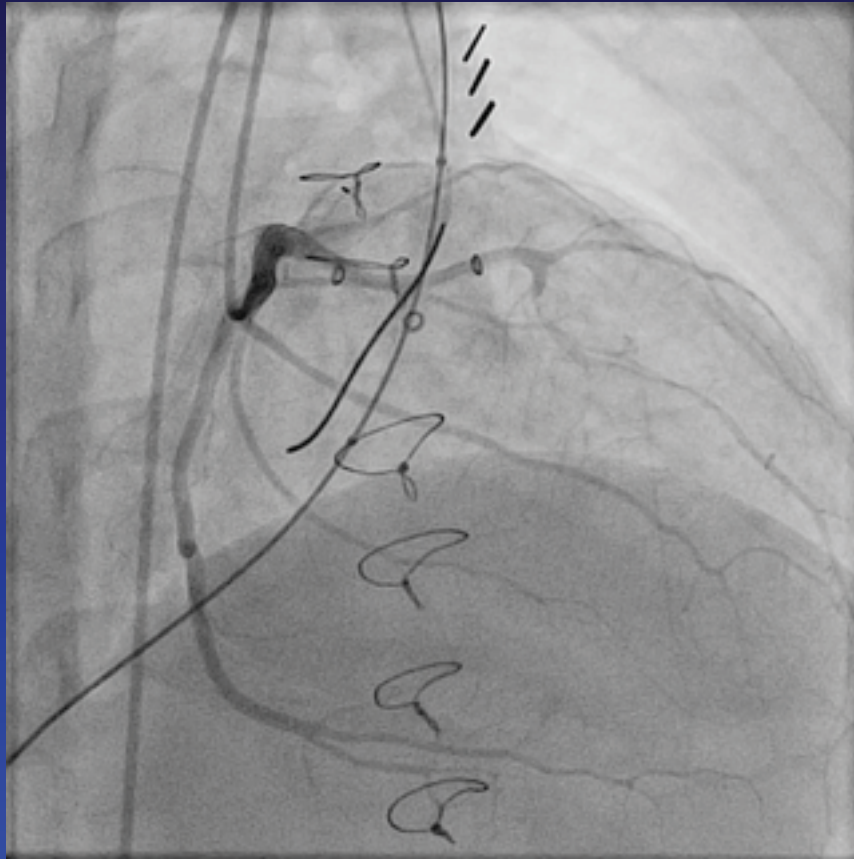
Rotational angiography

Balloon down

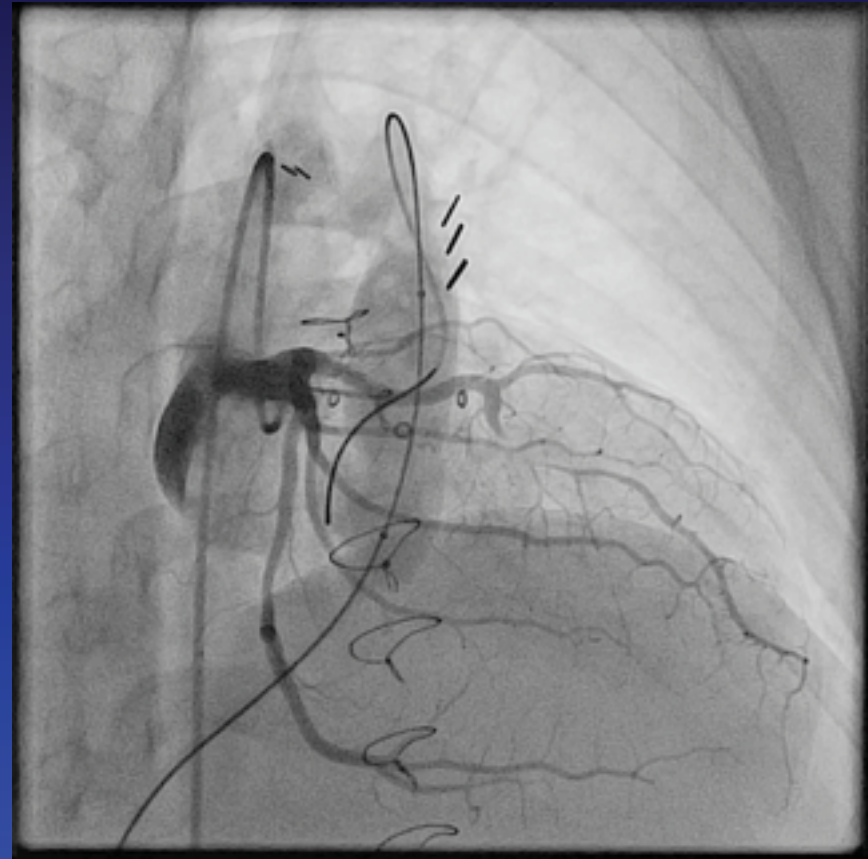
Balloon up: mid-LAD compression

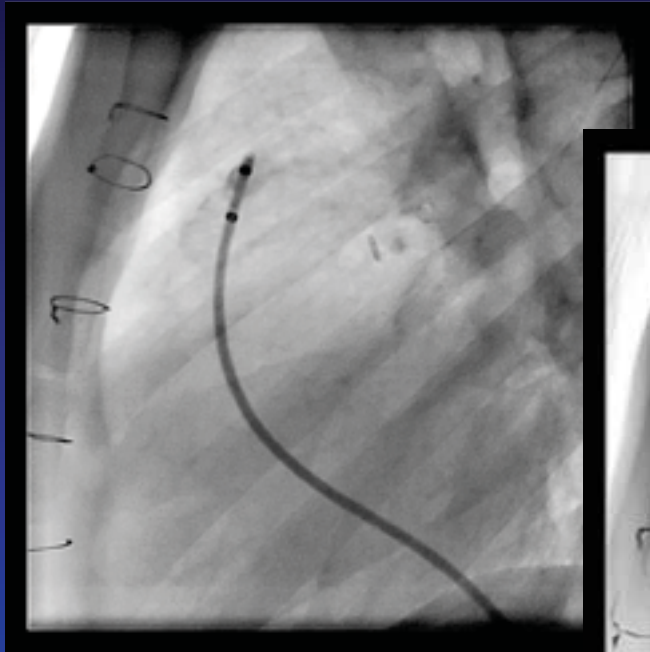
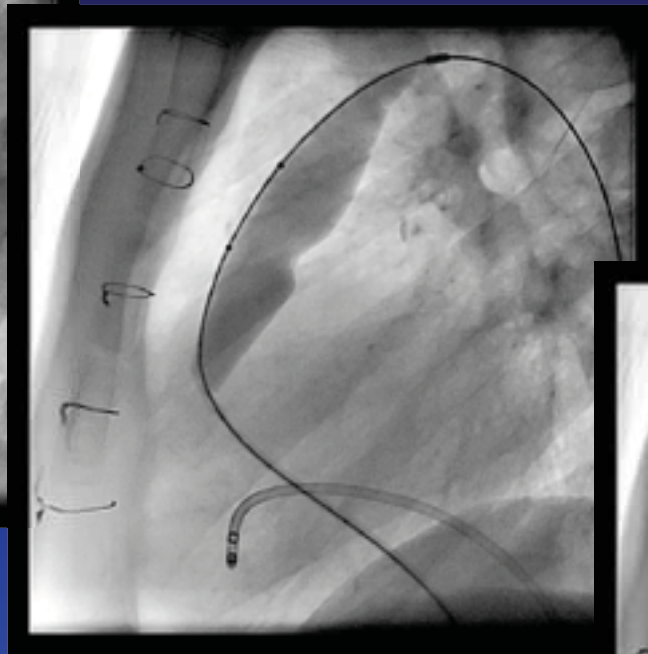
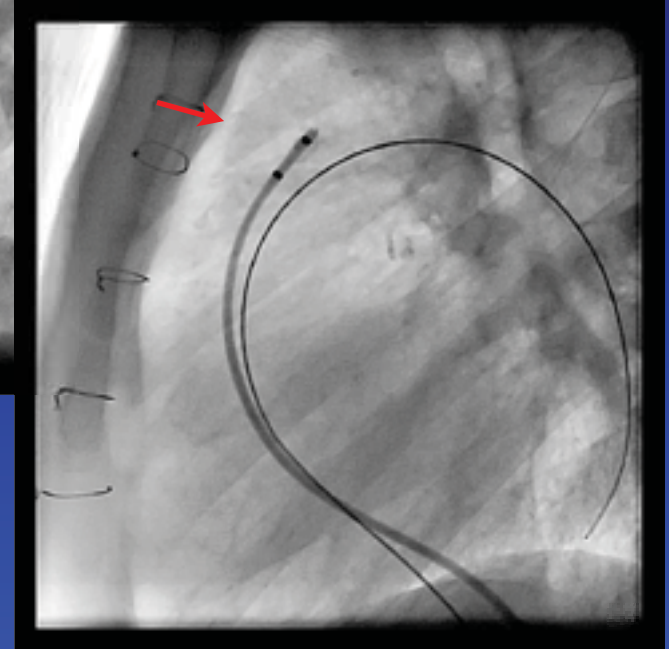
Conduit stenosis

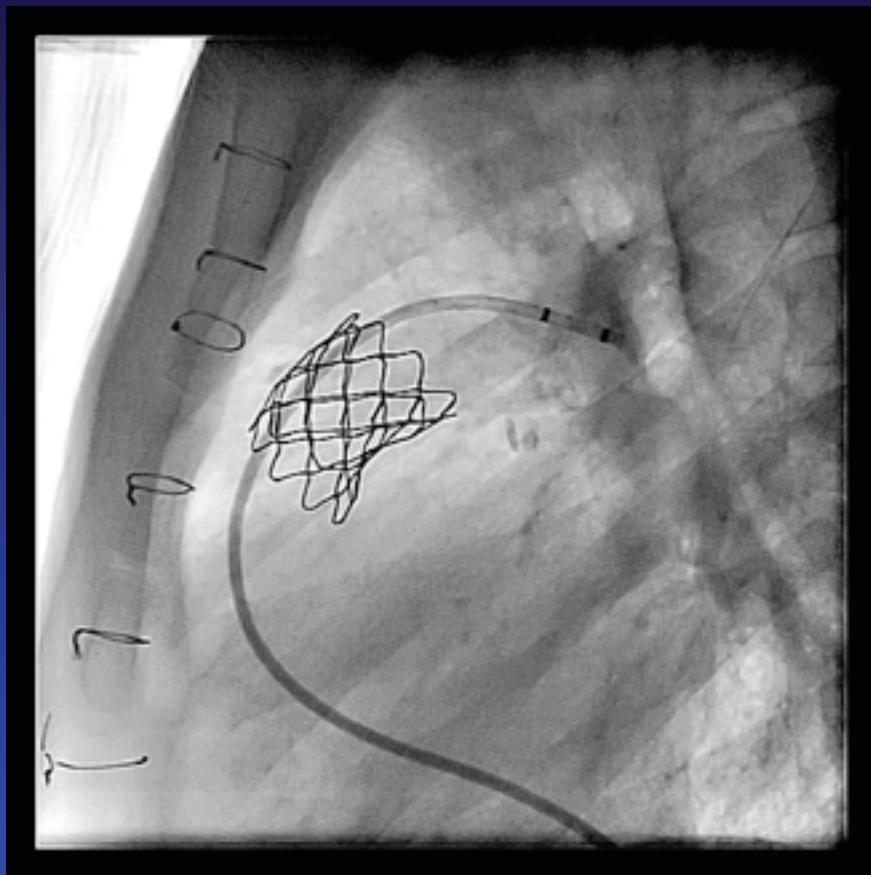
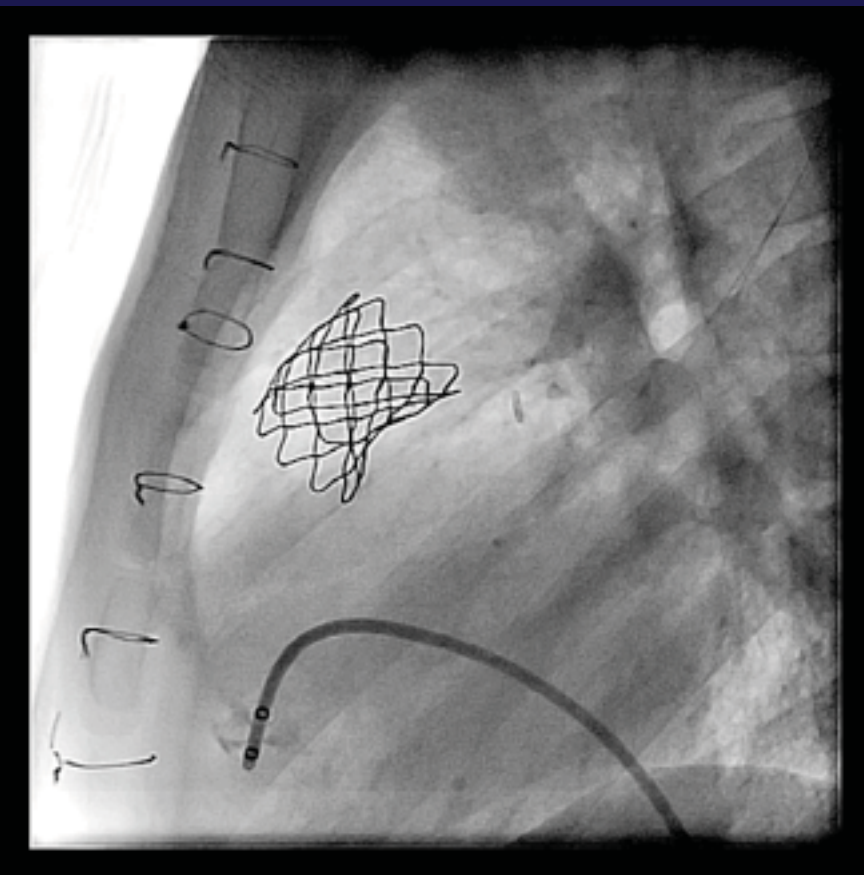
Post Melody implant

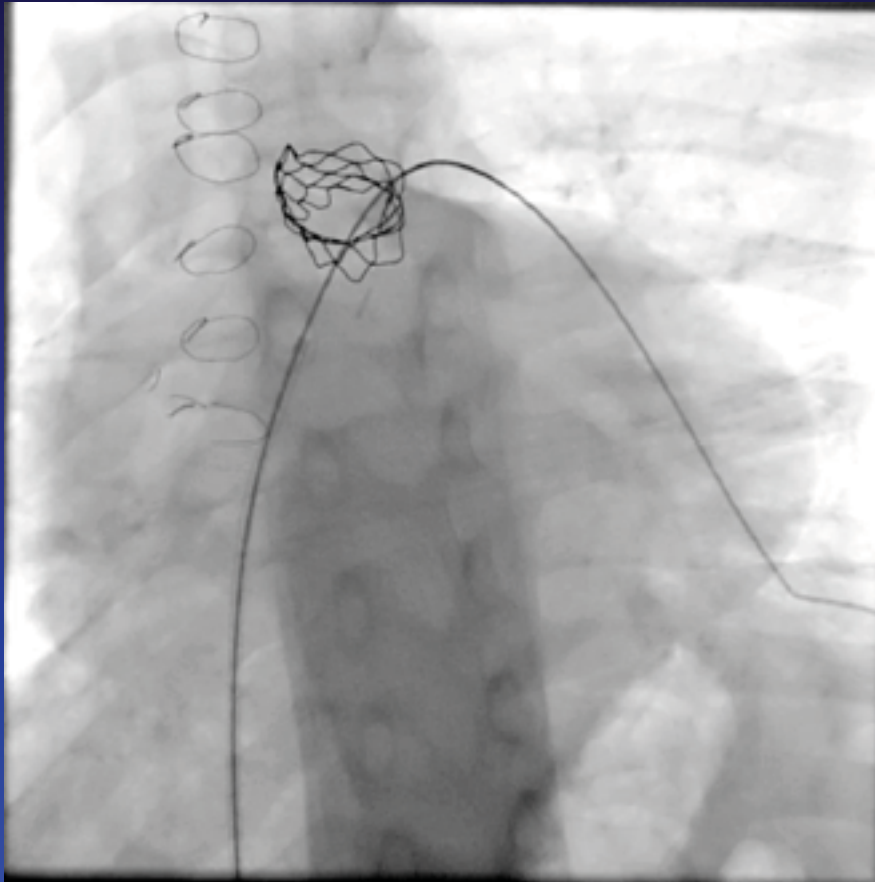
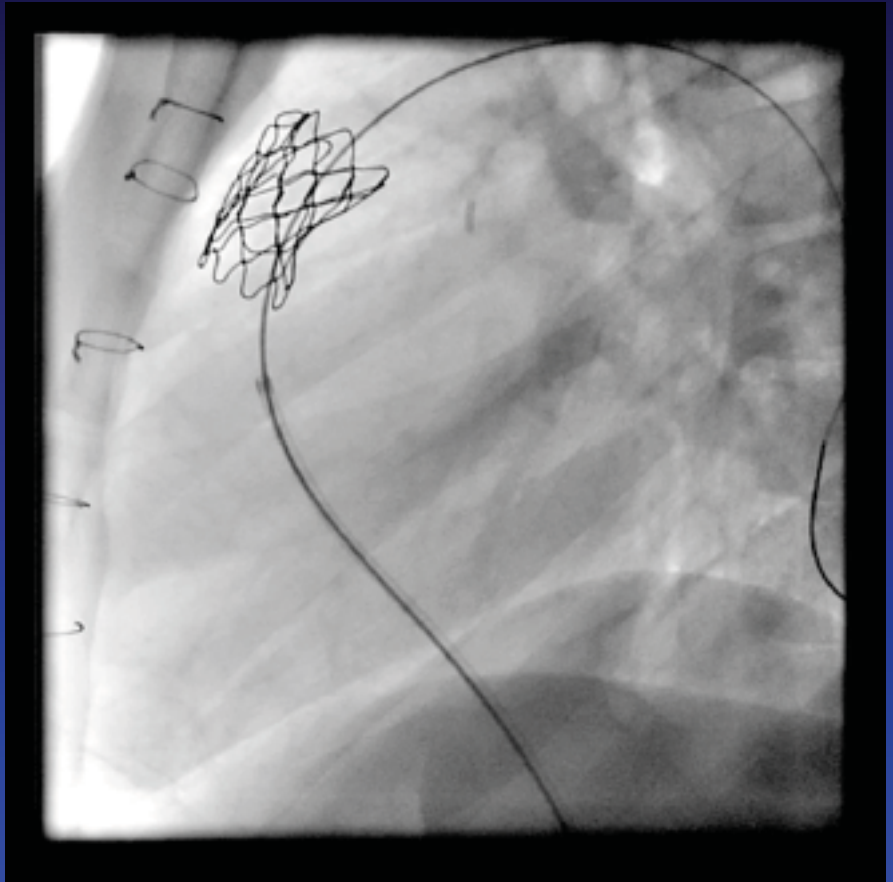
6 month later...

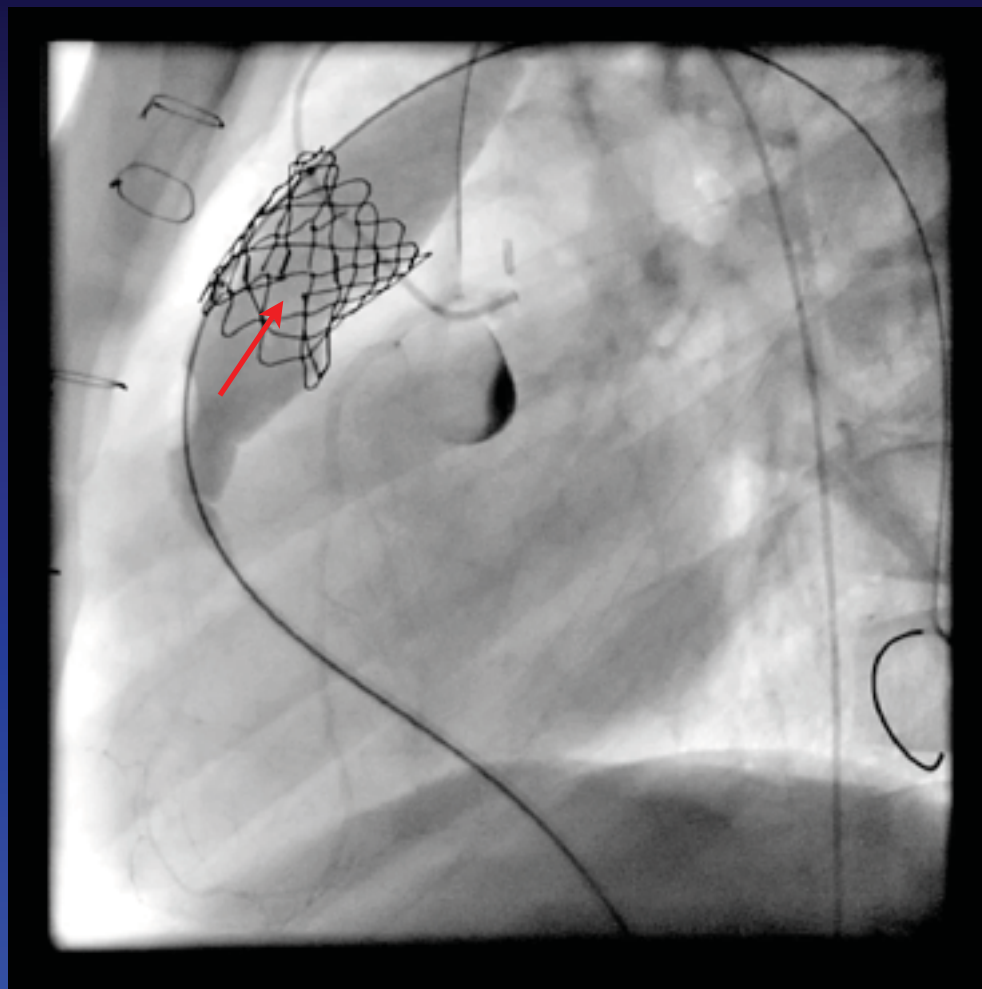
Melody valve stent fractures

Reinforce with additional stents

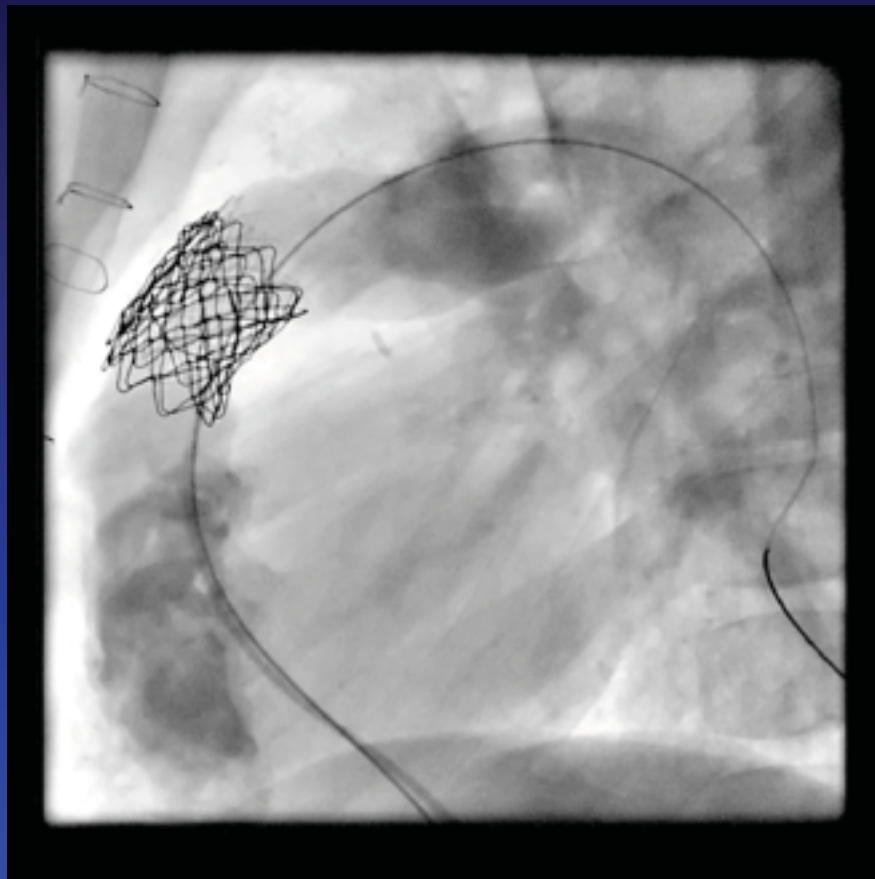
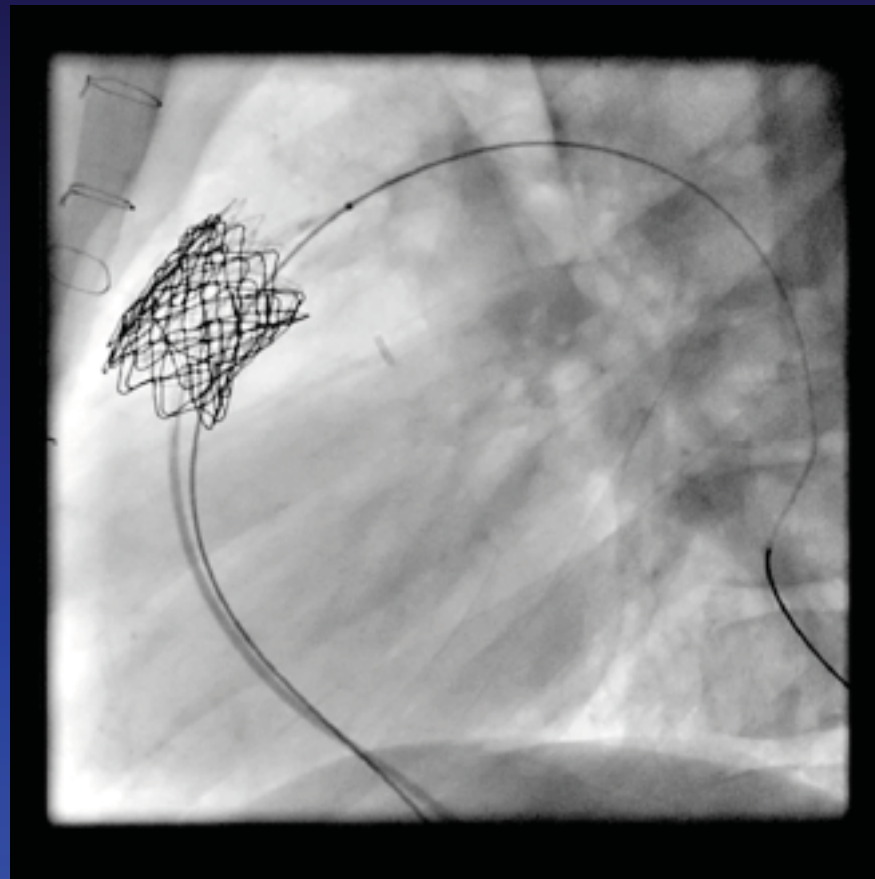
Post Melody implant

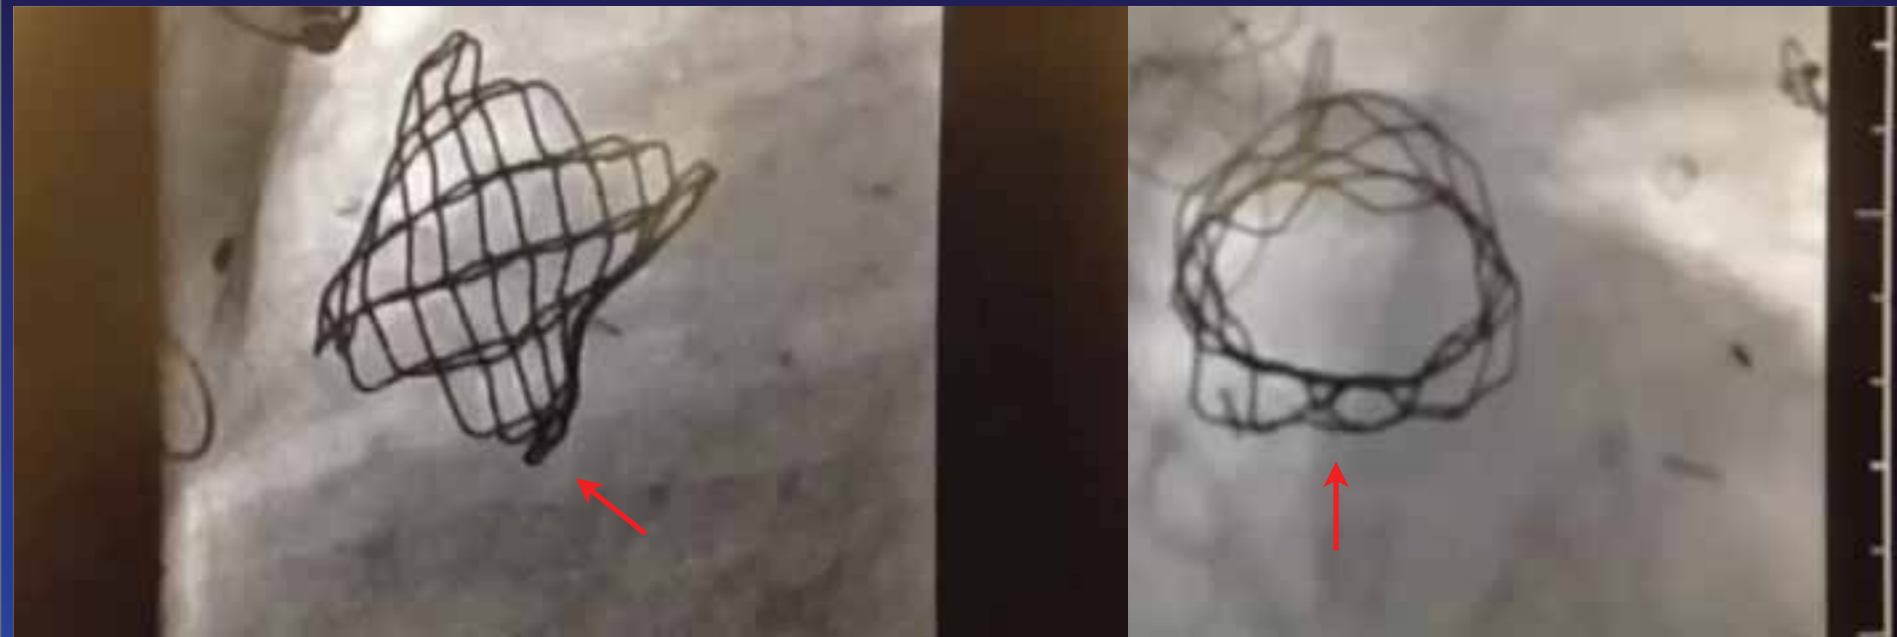
Subtle fracture may not be seen on CXR, but needs flourosocopy
