Melody transcatheter pulmonary valve implantation: Tips and tricks

Frank F. Ing, MD
Professor of Pediatrics
Children's Hospital Los Angeles
University of Southern California

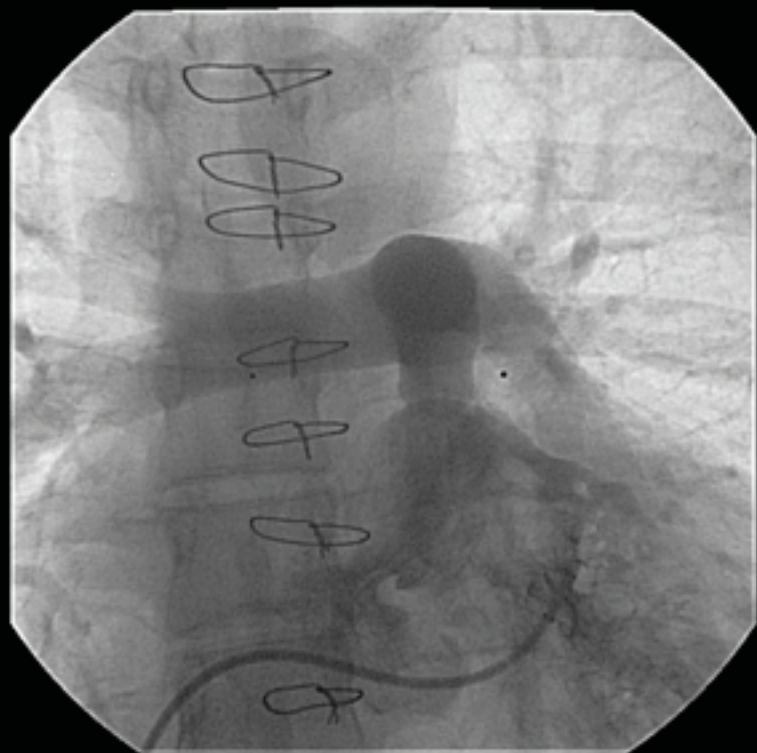
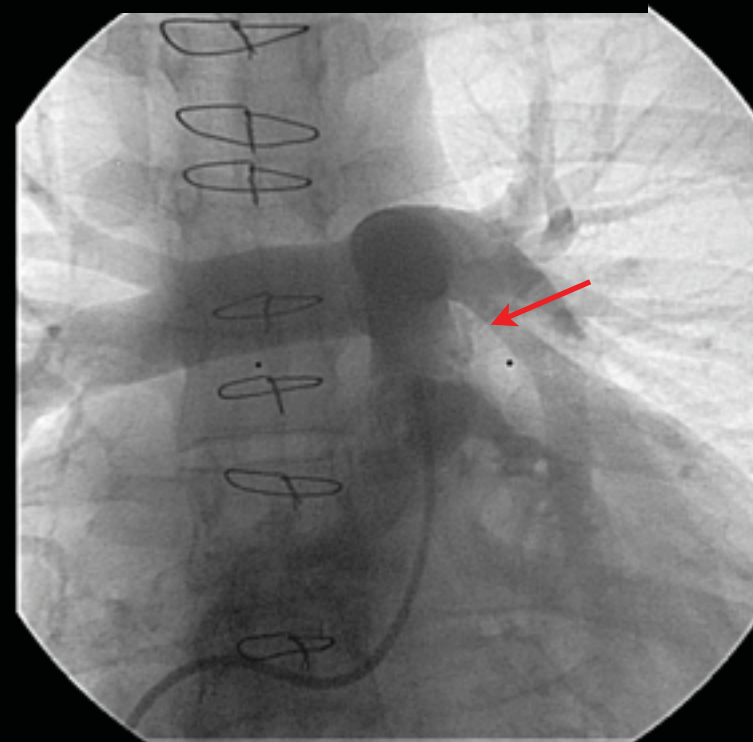
Complications: Dissections

Contained dissection

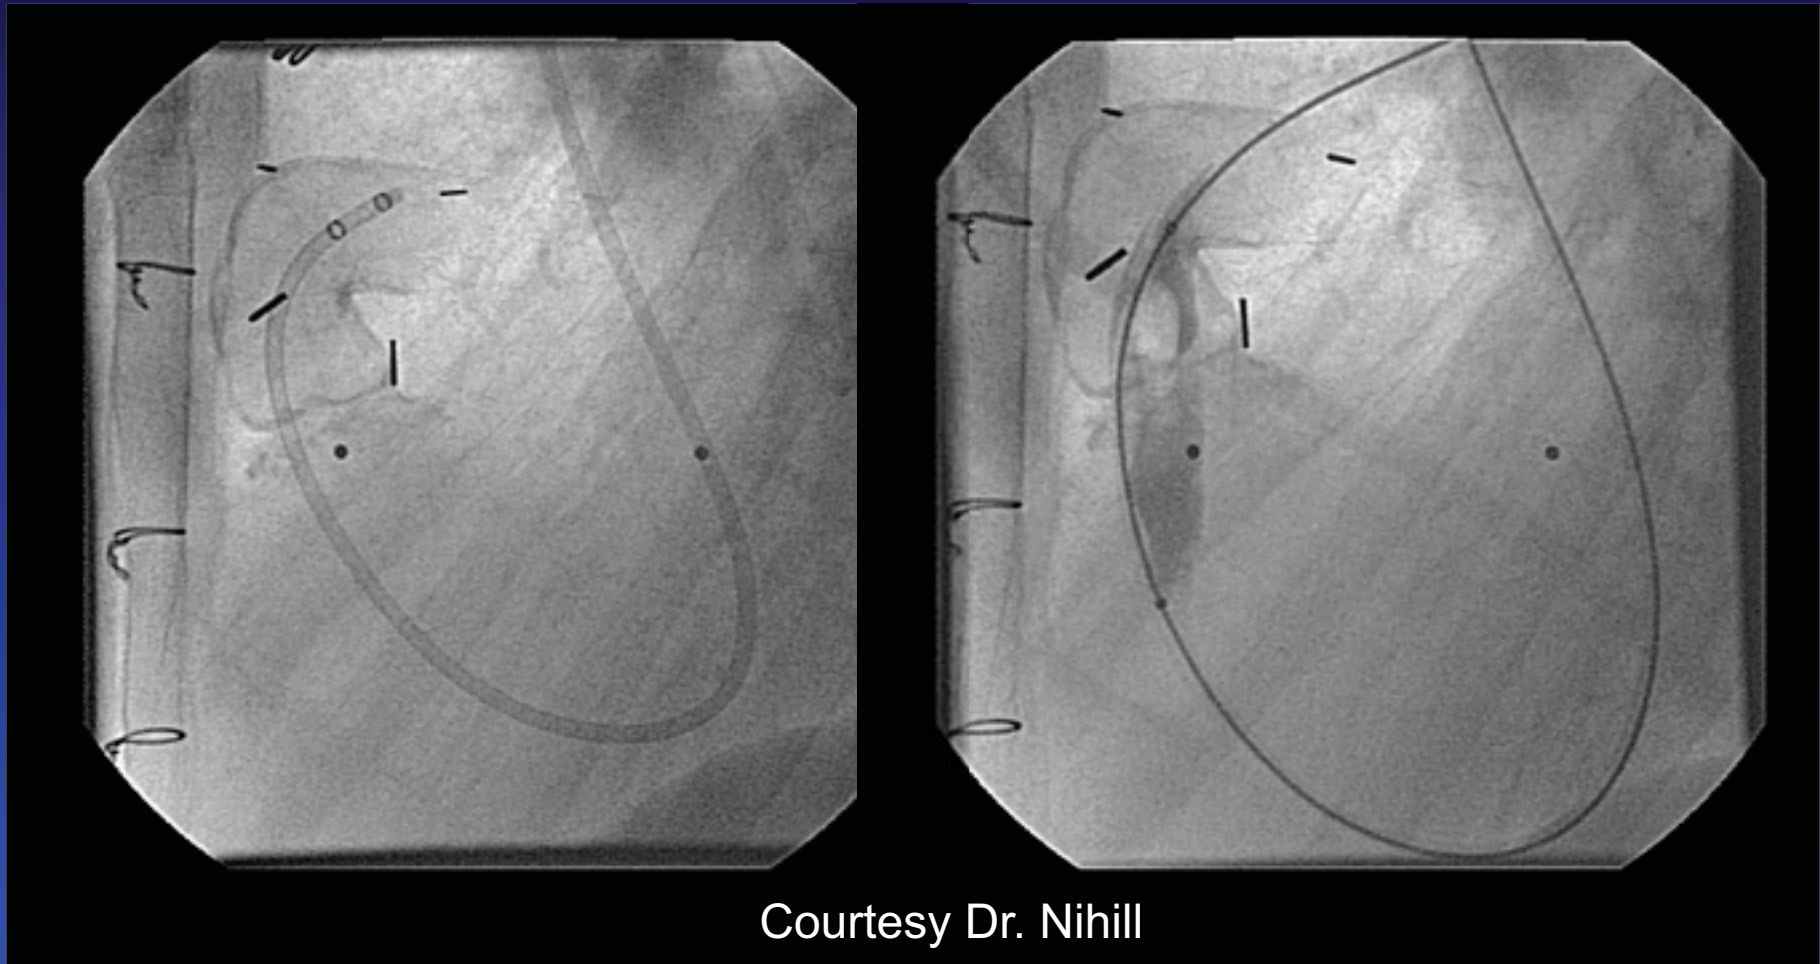
Heavily calcified conduit

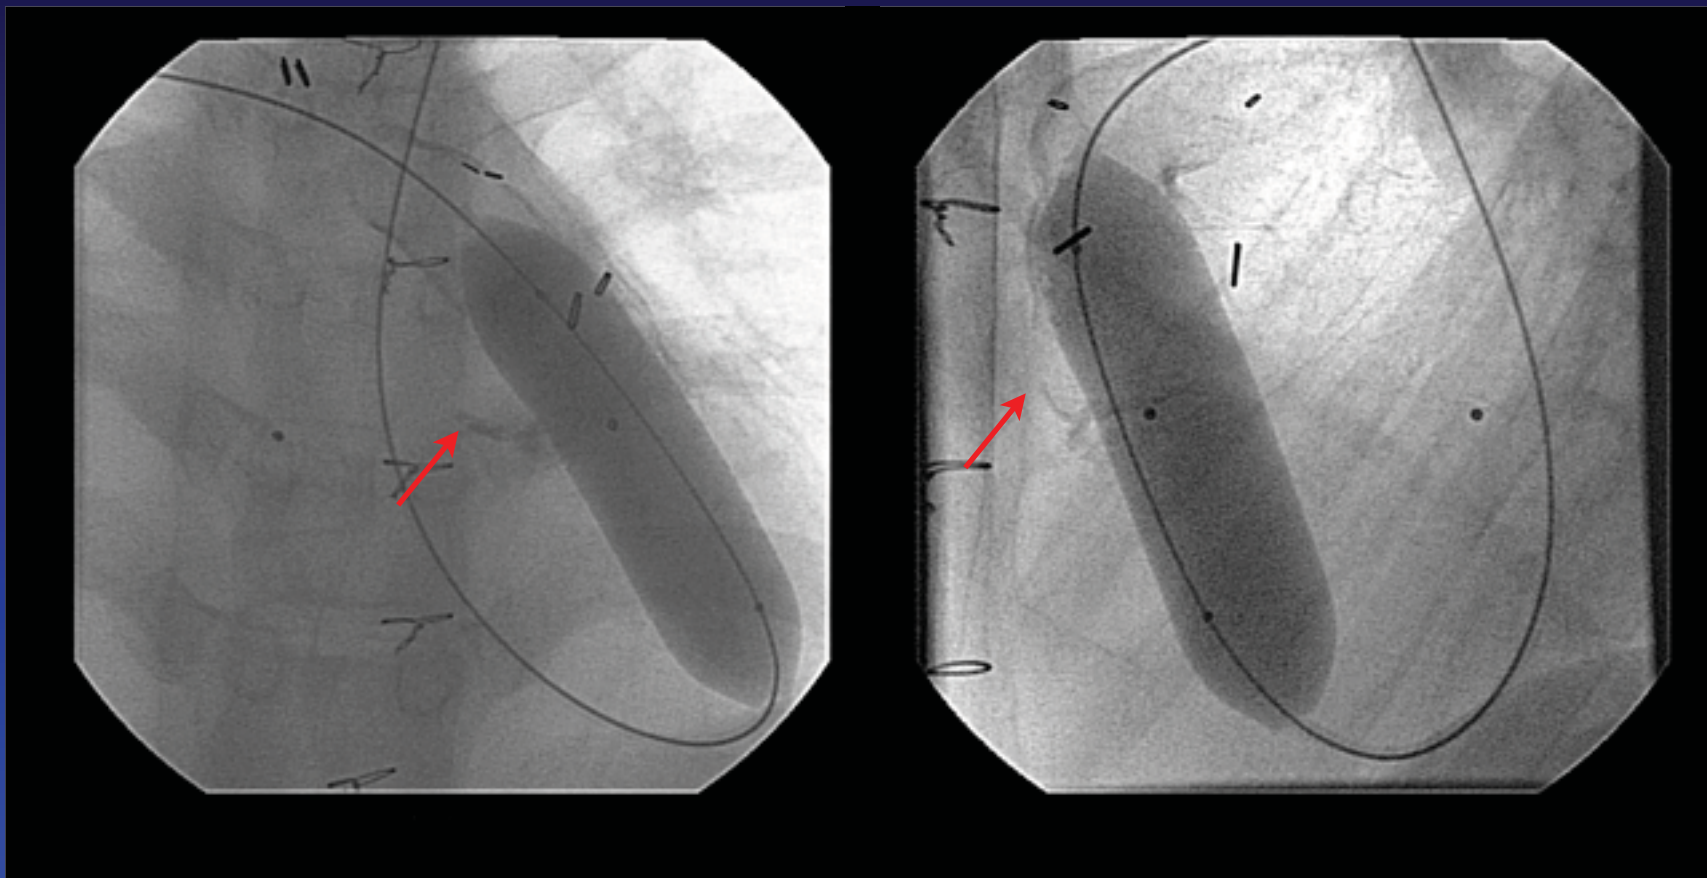
Calcified conduit rupture

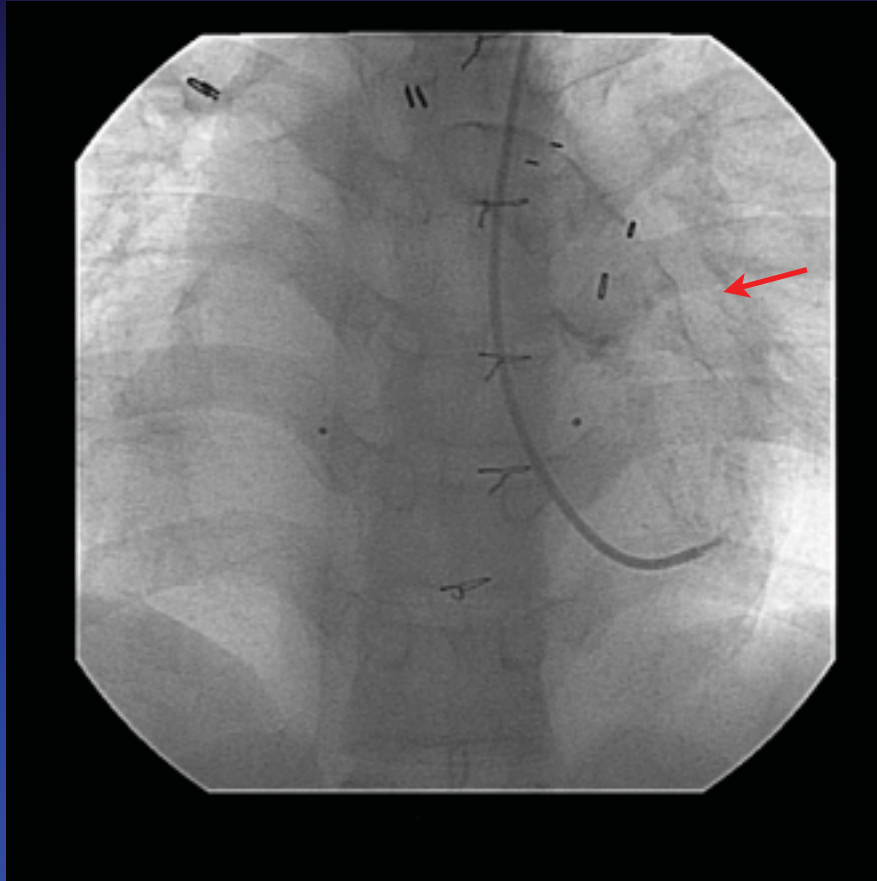
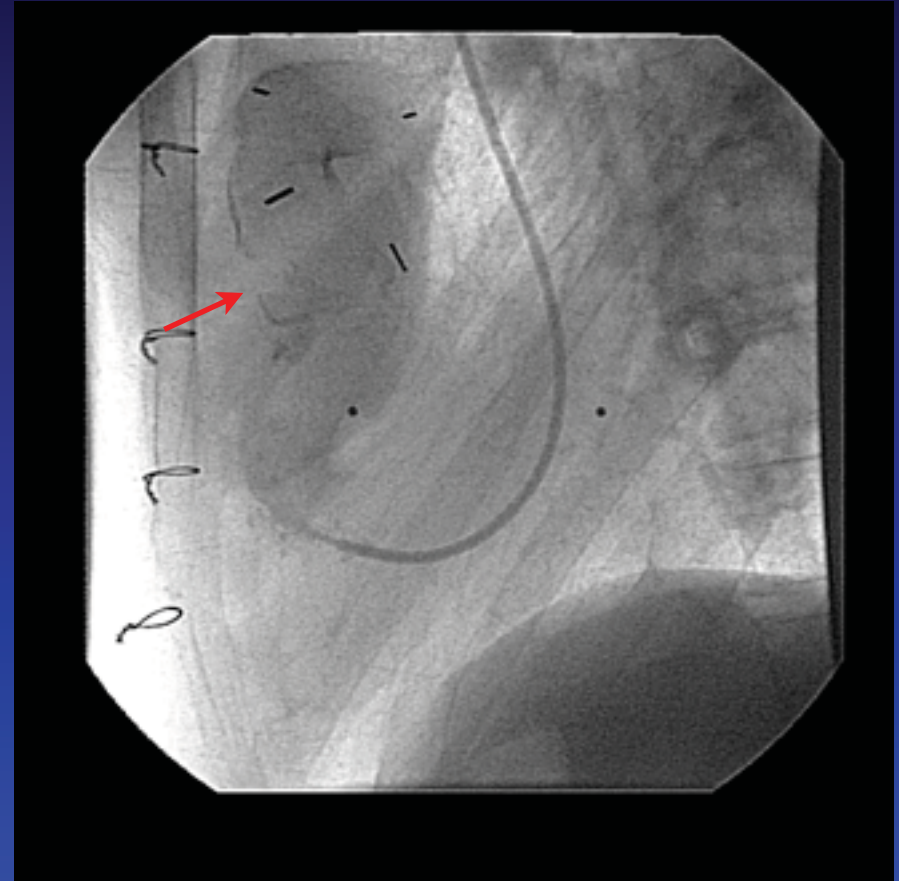
Post dilation angiogram: Extravasation of contrast

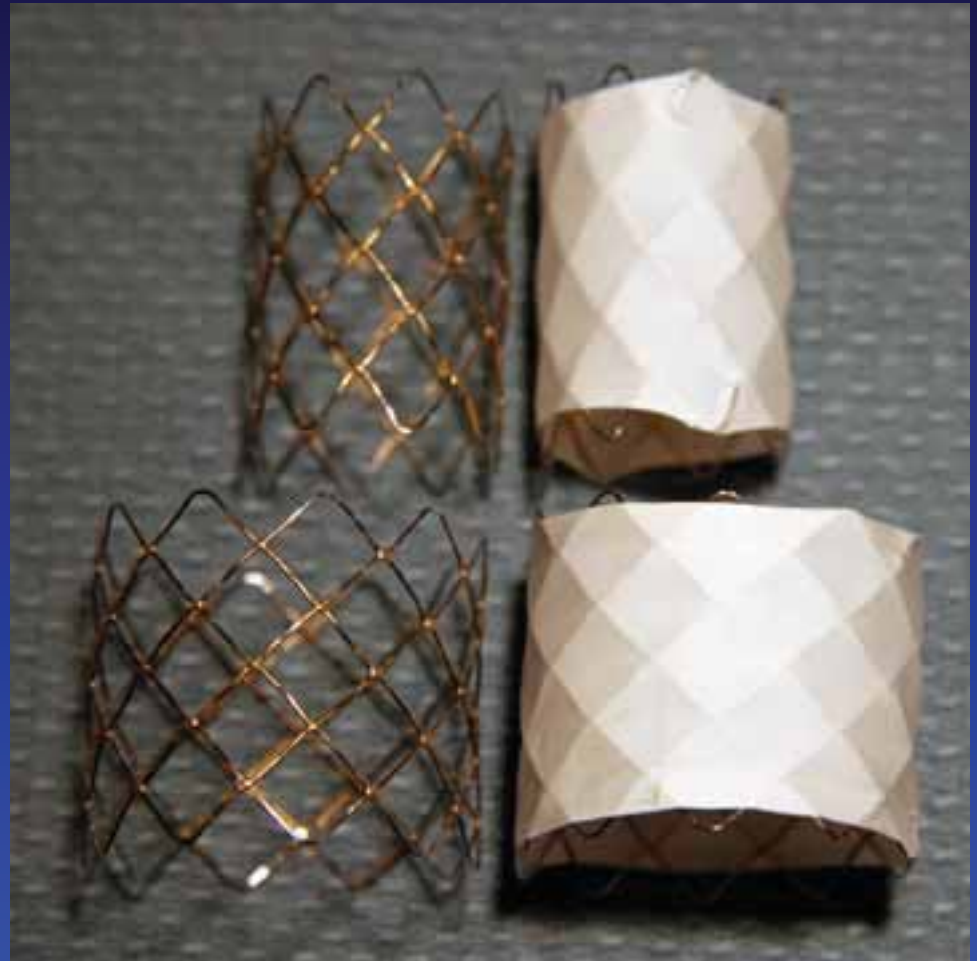
Covered stents

COAST II trial
PARCS trial

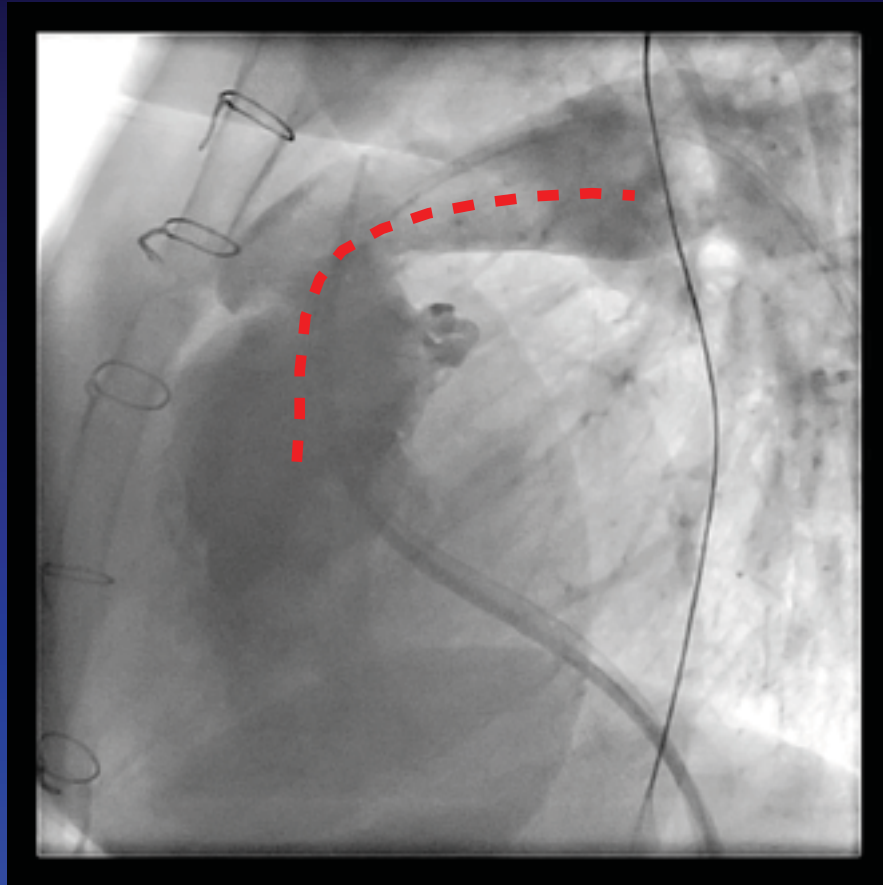
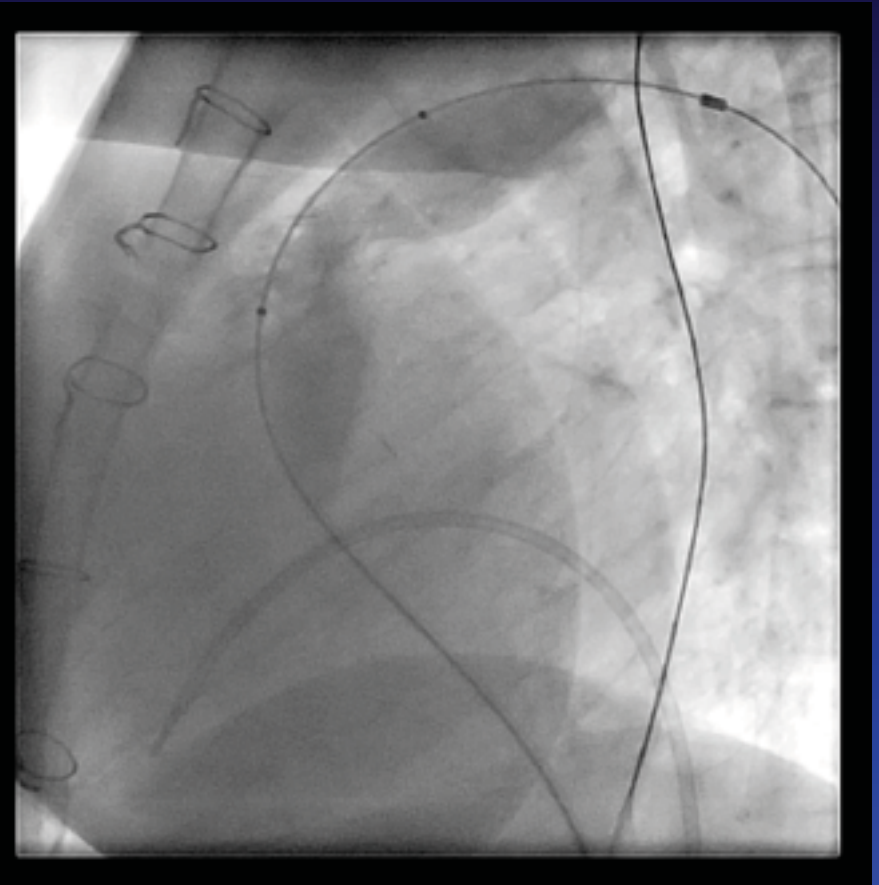
Angulated conduits

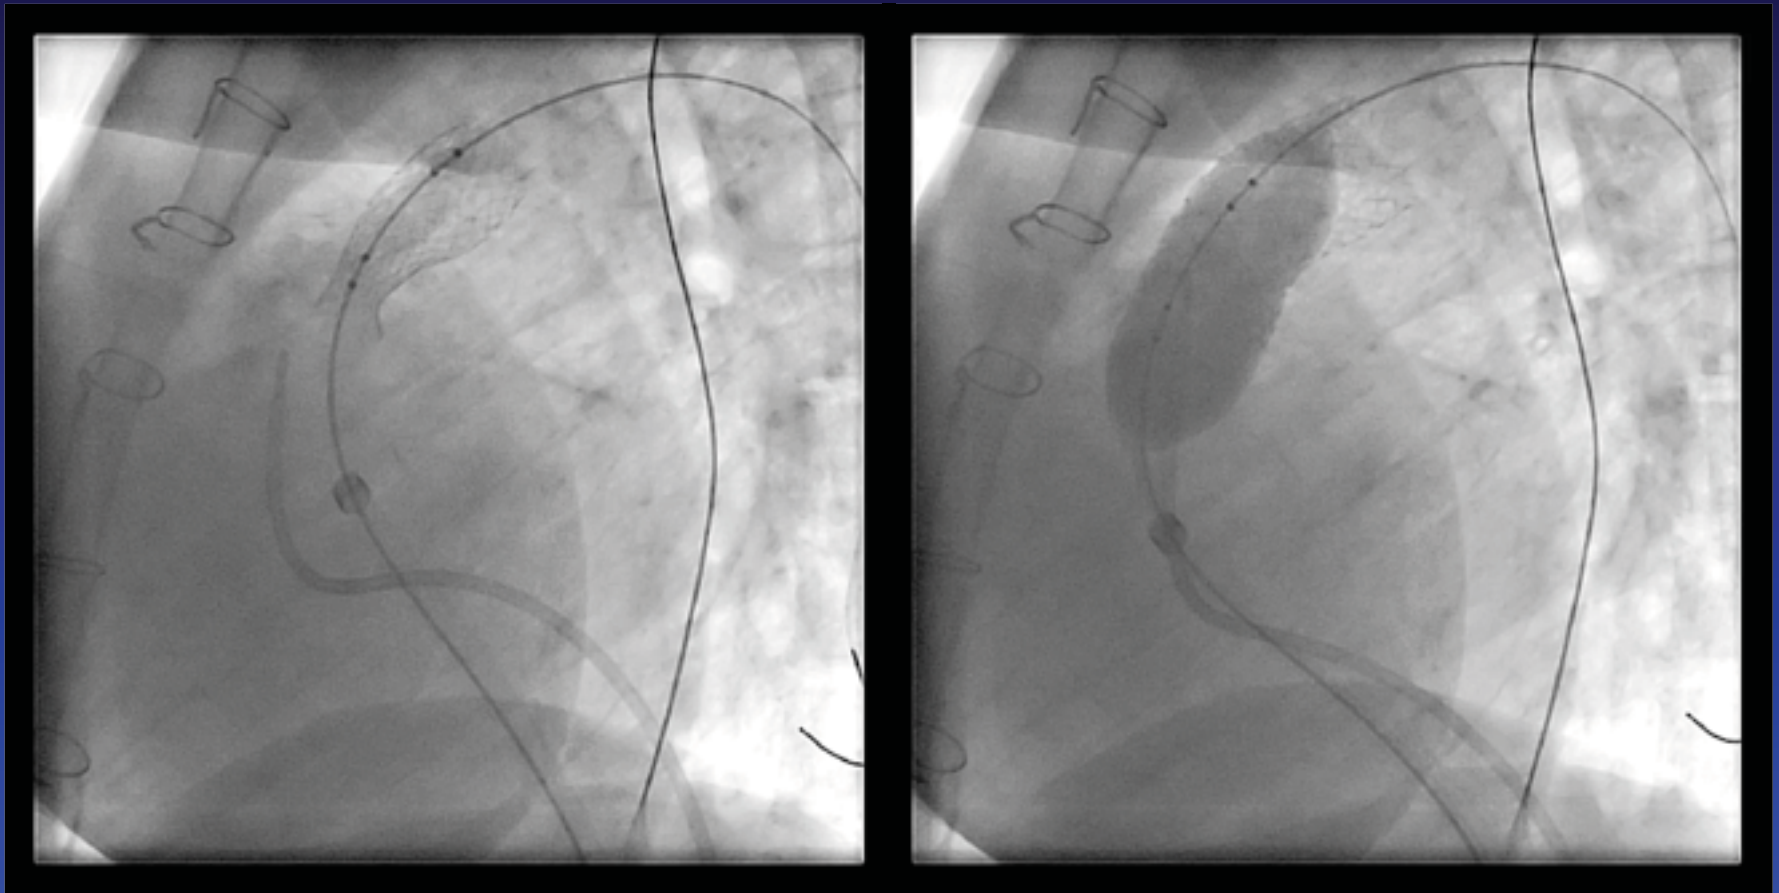
Implanting Maxi-LD stent

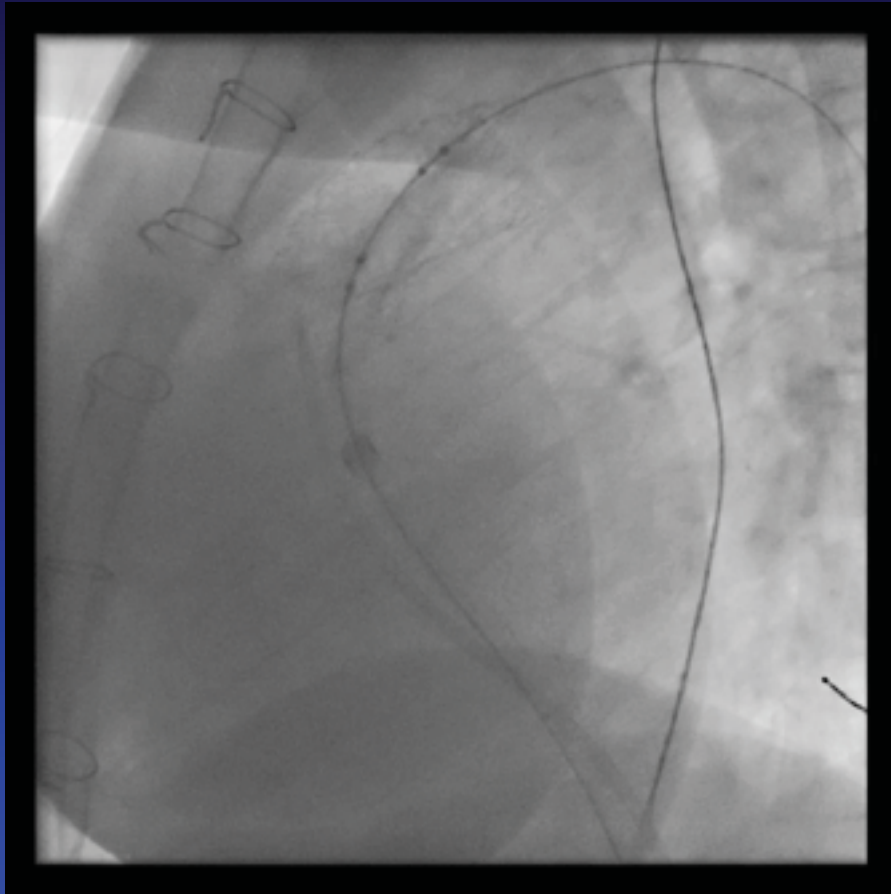
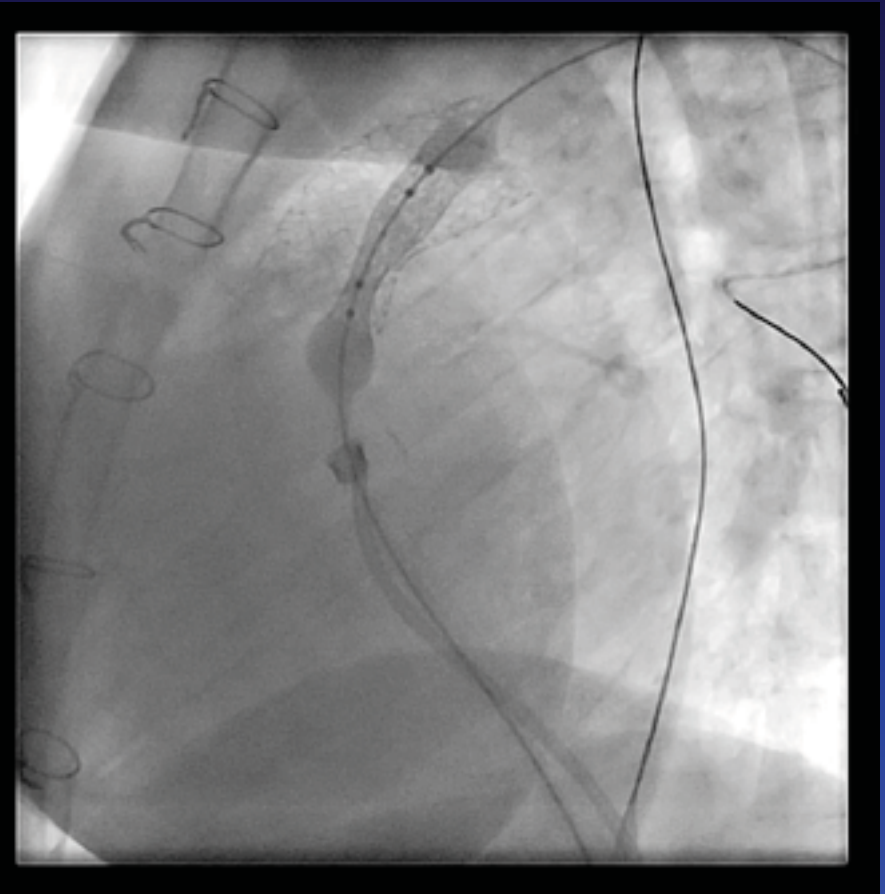
Implanting 2nd Maxi-LD stent

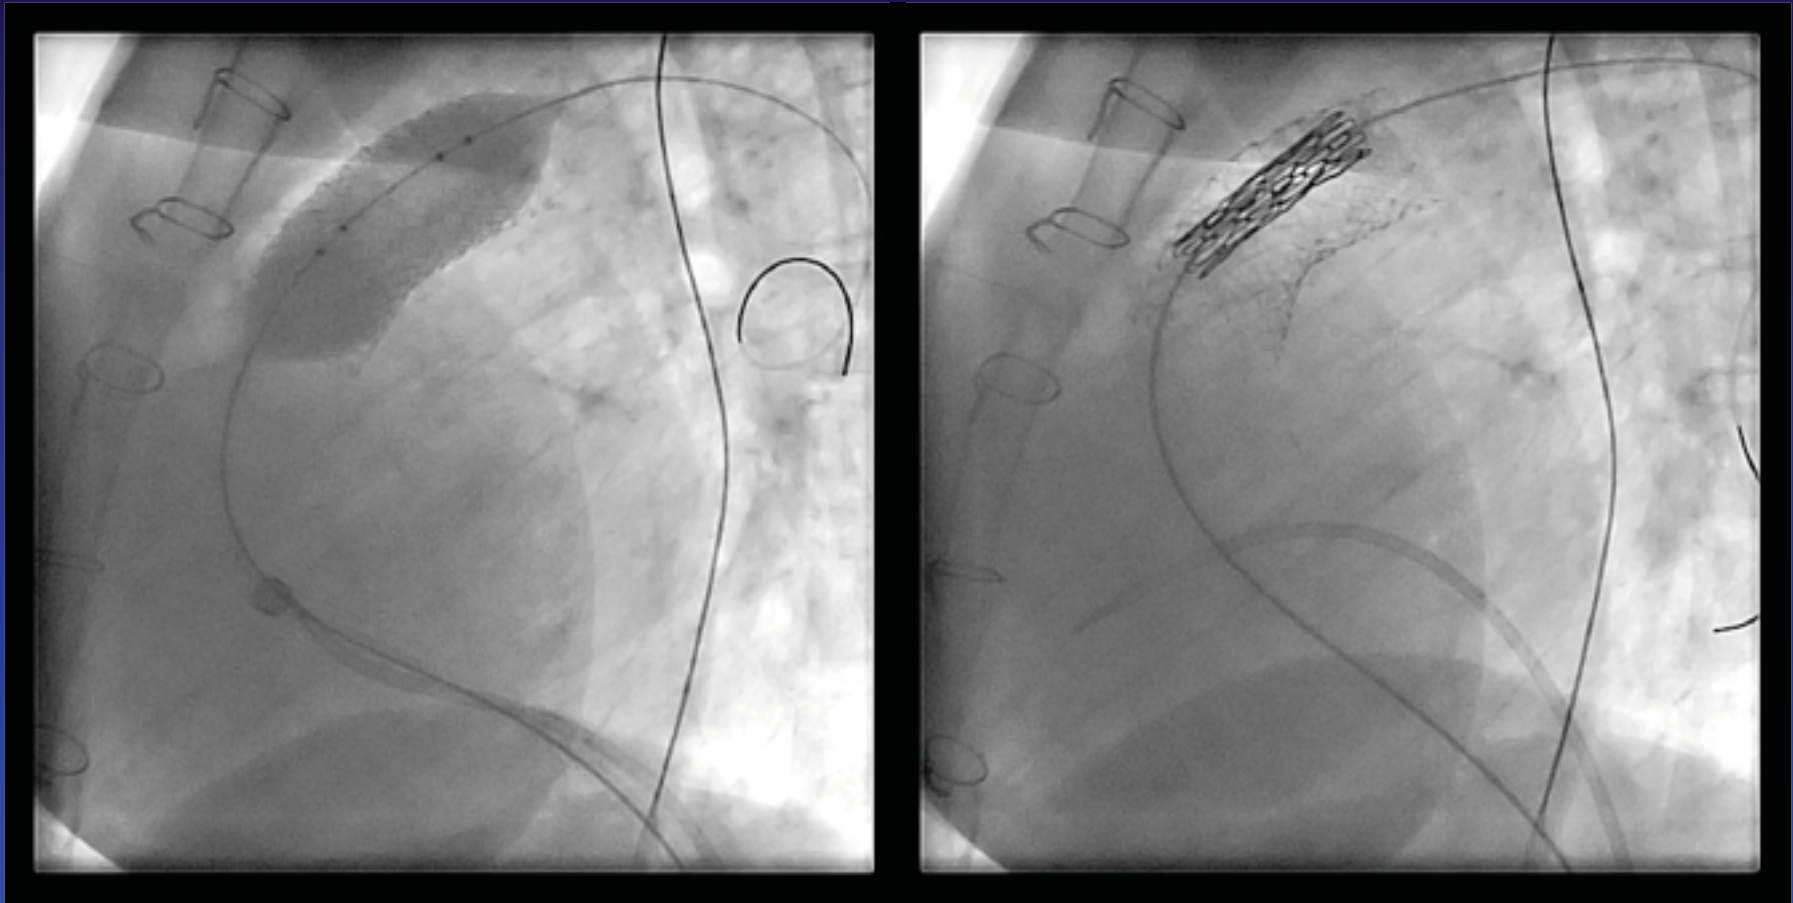
Implanting Melody valve

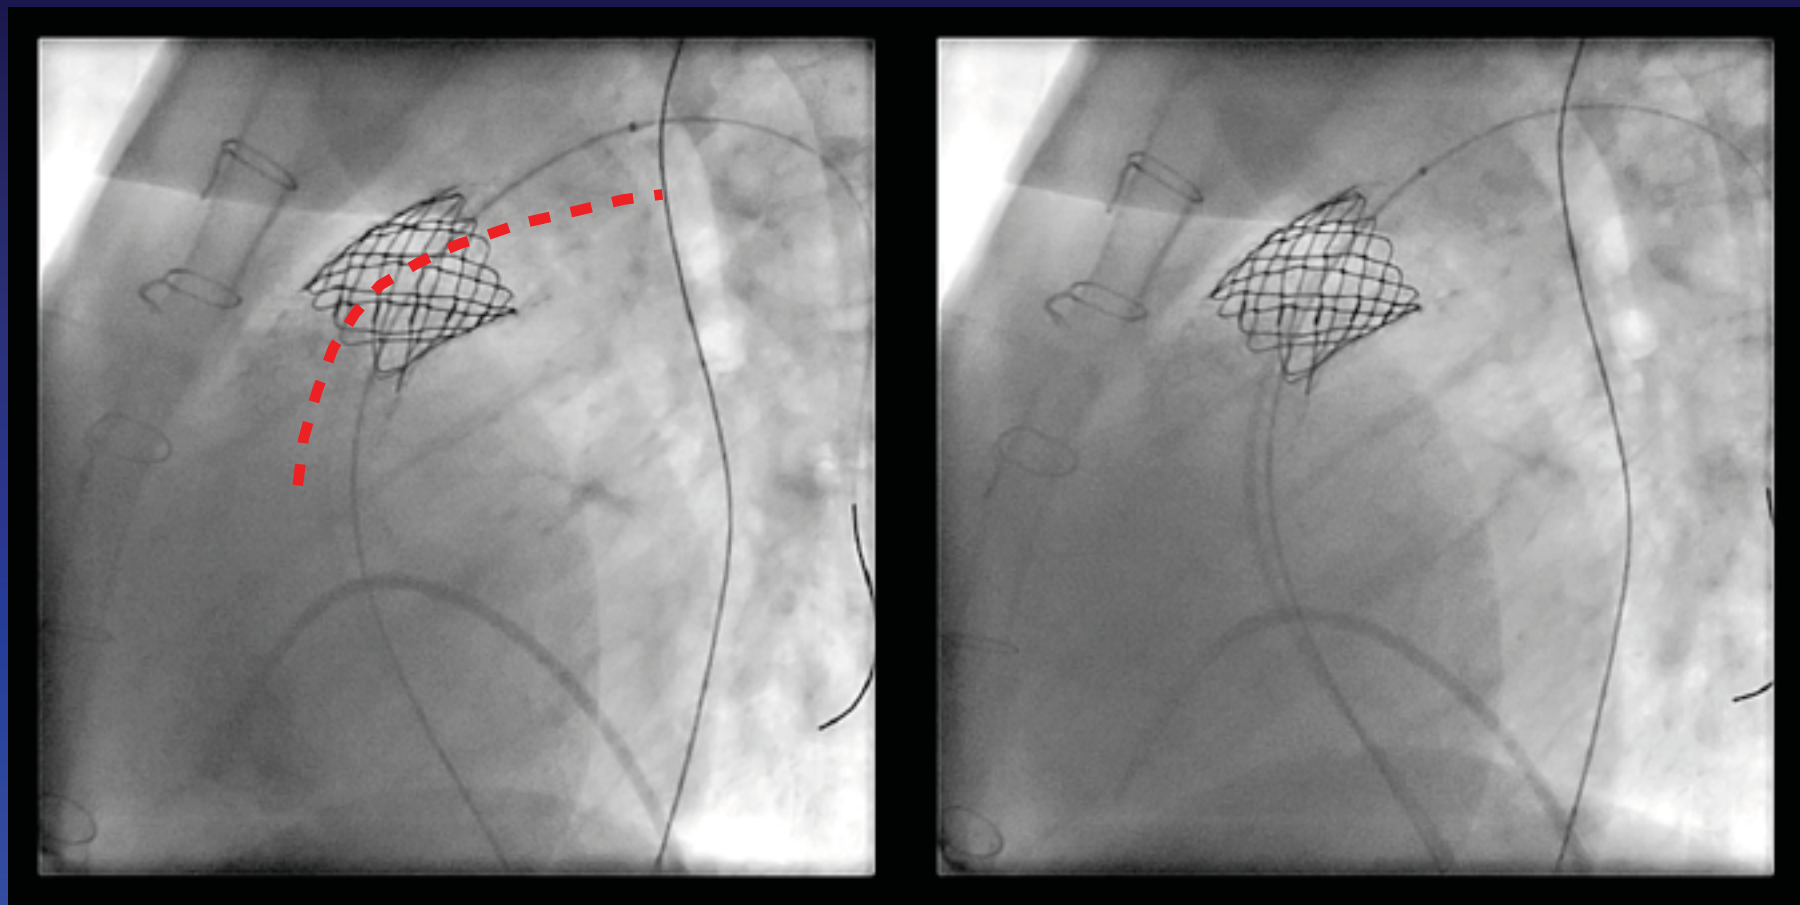
Post Melody angiograms

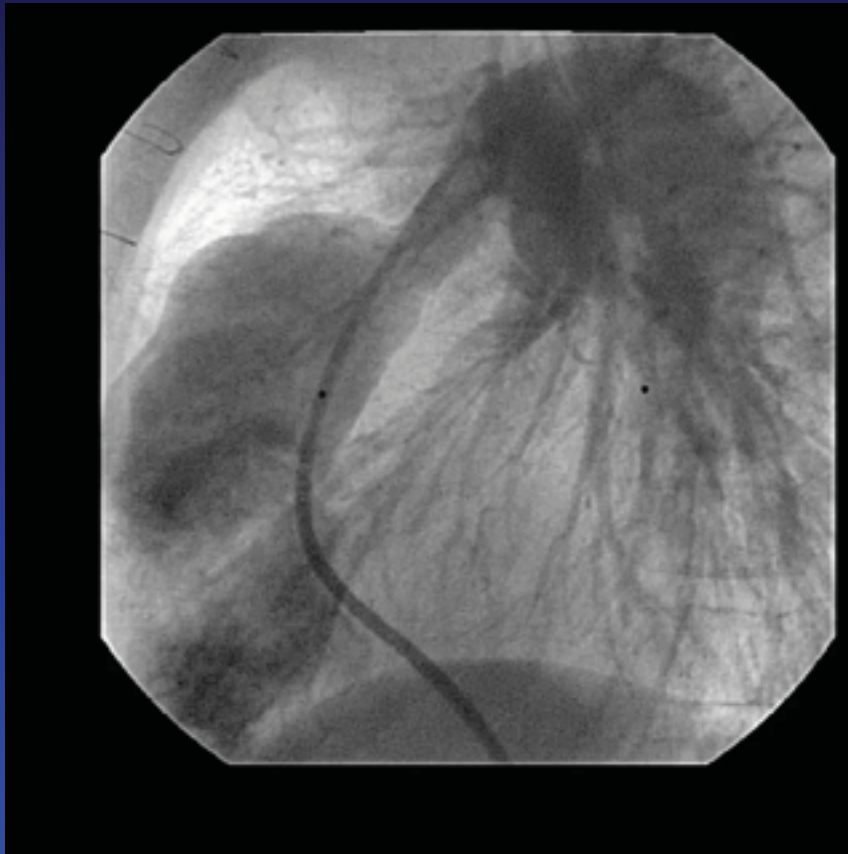
12 mm pulmonary homograft

Diameter 9.6 mm

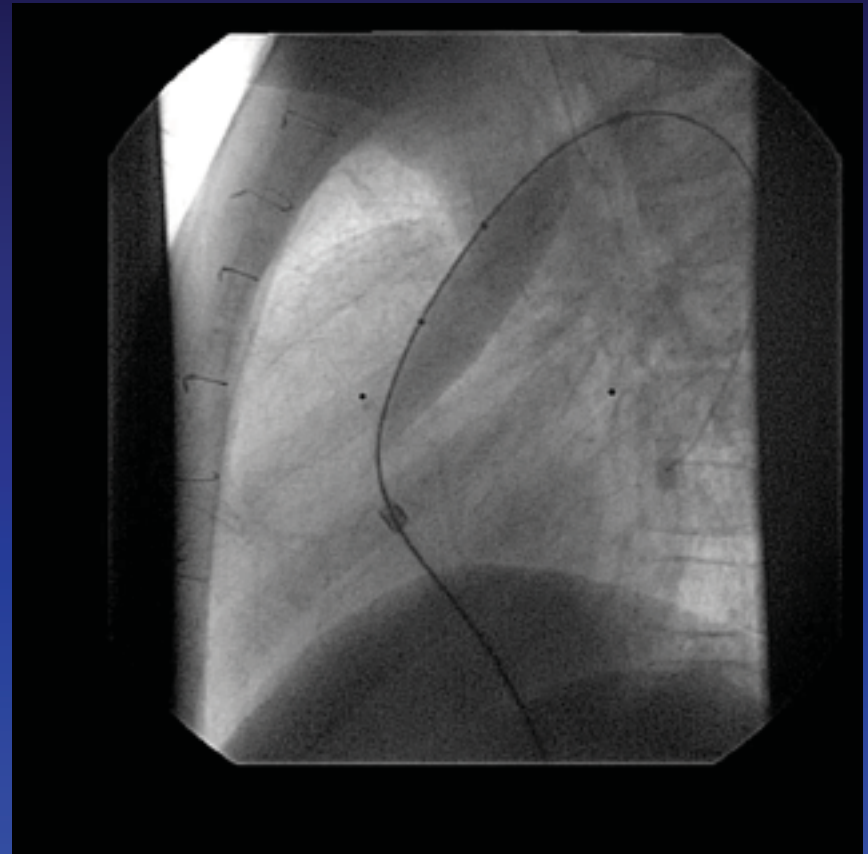
Angioplasty with 12 mm balloon

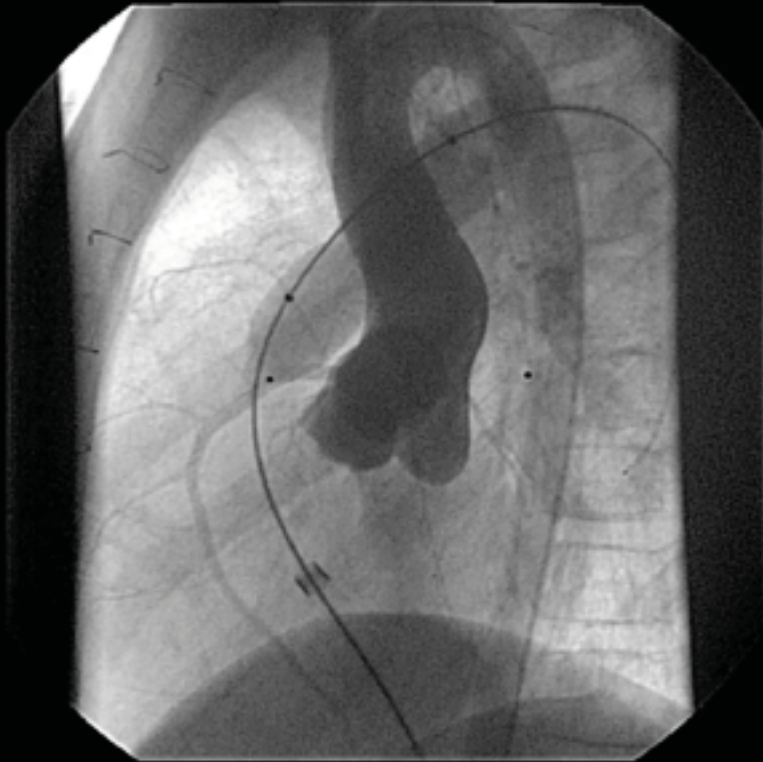
Initial stent implant

Angioplasty with 14 mm balloon

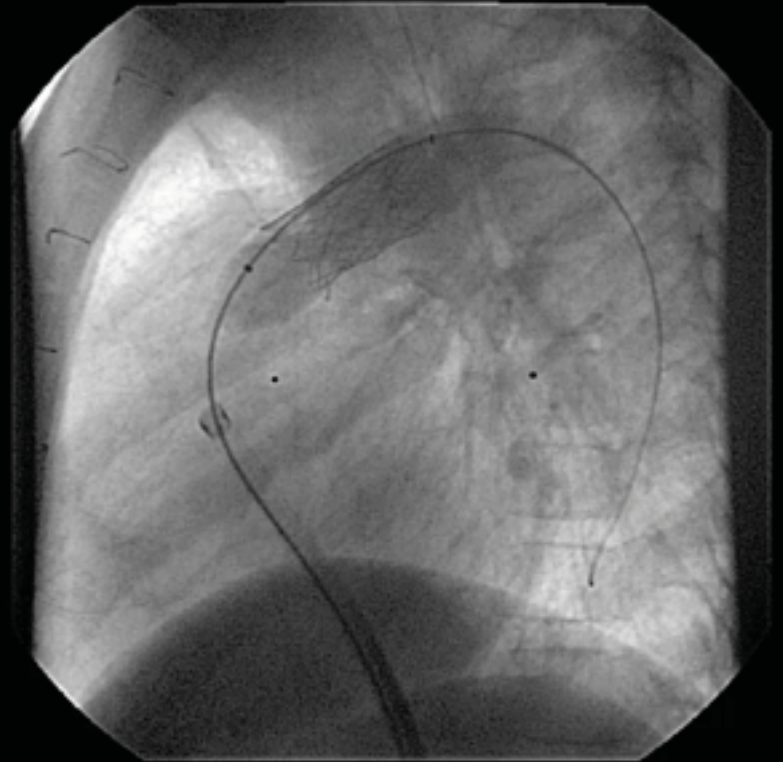
Stent implant with 14 mm balloon

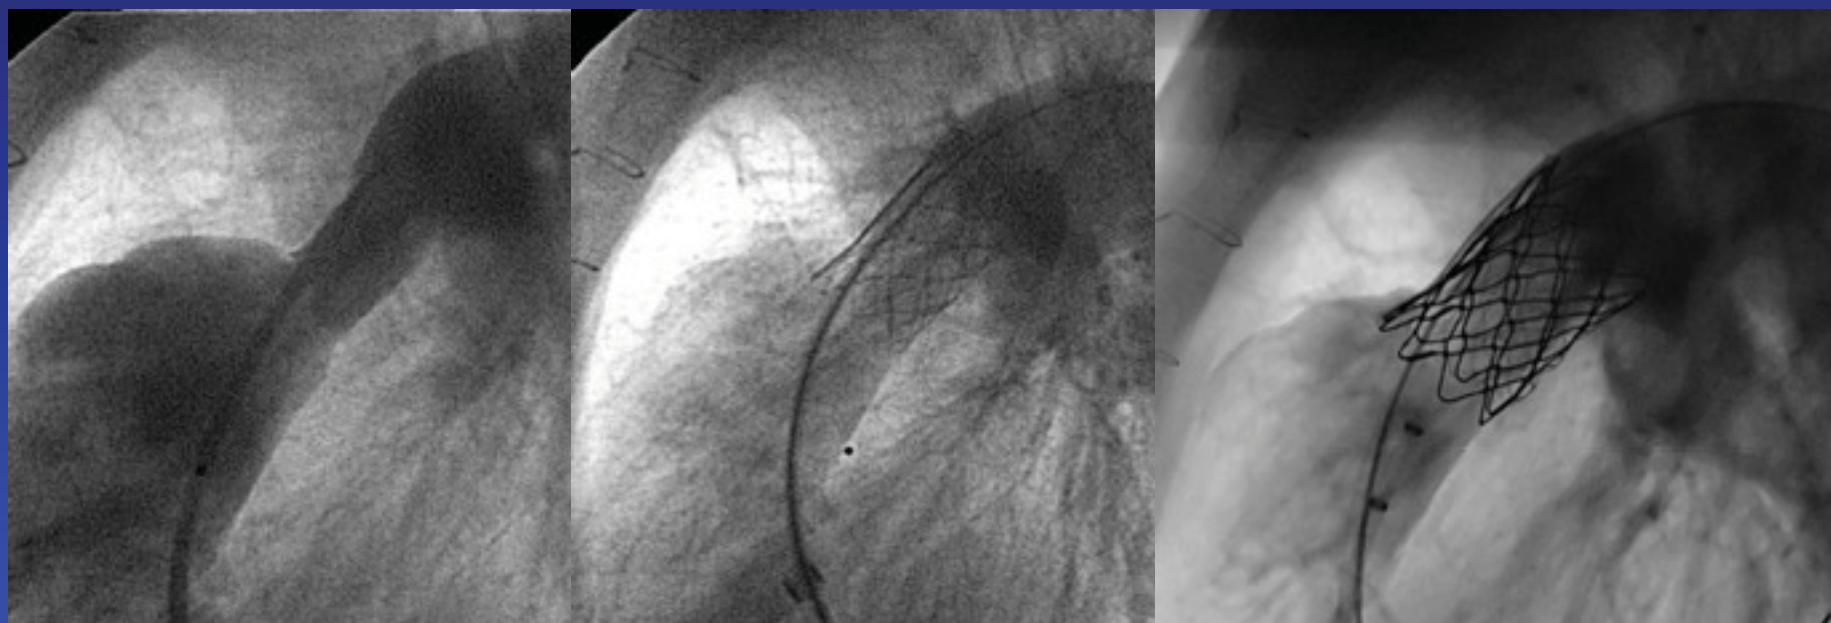
Lat

12 mm pulmonary homograft over-expanded with Melody on 18 mm ensemble system

Pre
9.6 mm

S/P 16mm stent
15.5 mm

S/P 18mm Melody
16.5 mm

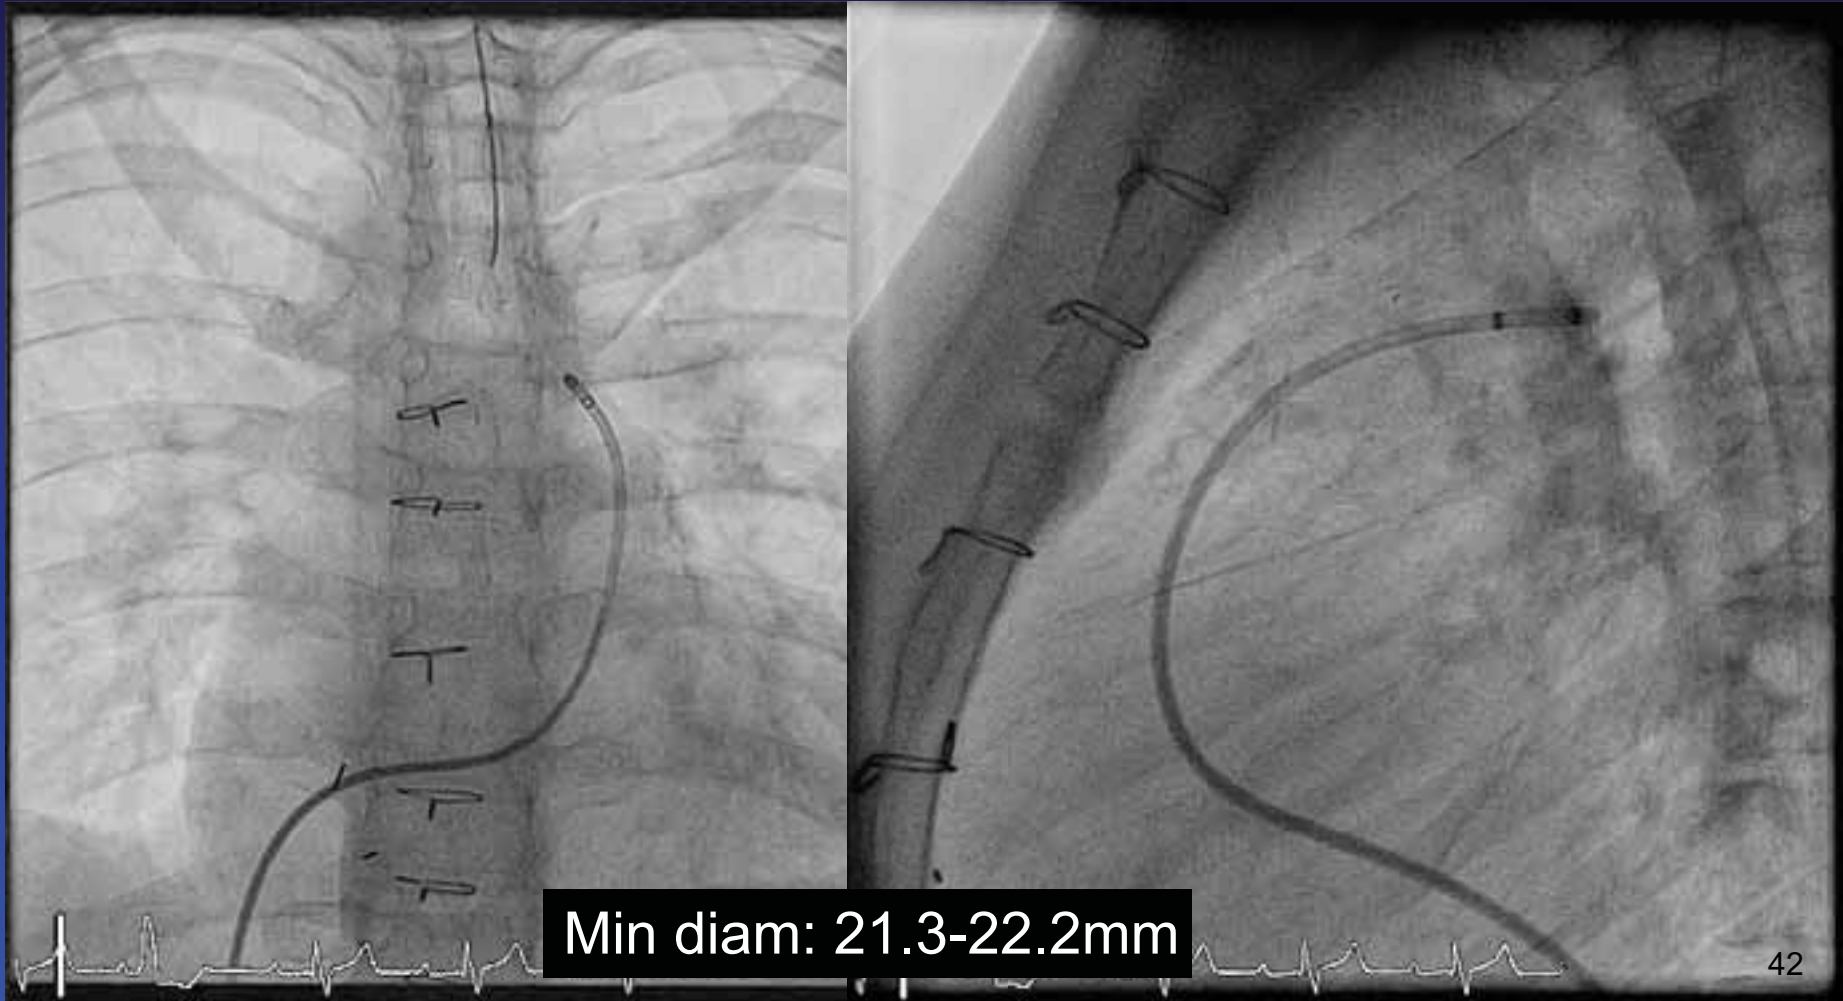
19 yo F s/p 24 mm Rv-PA conduit

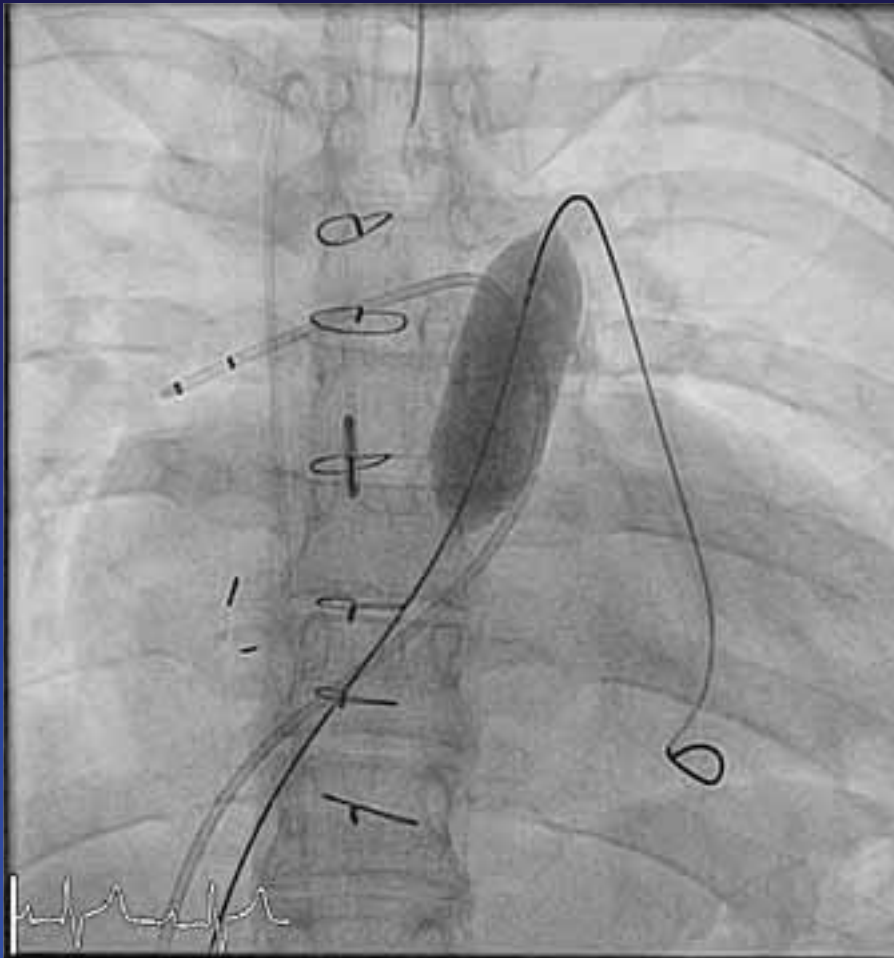
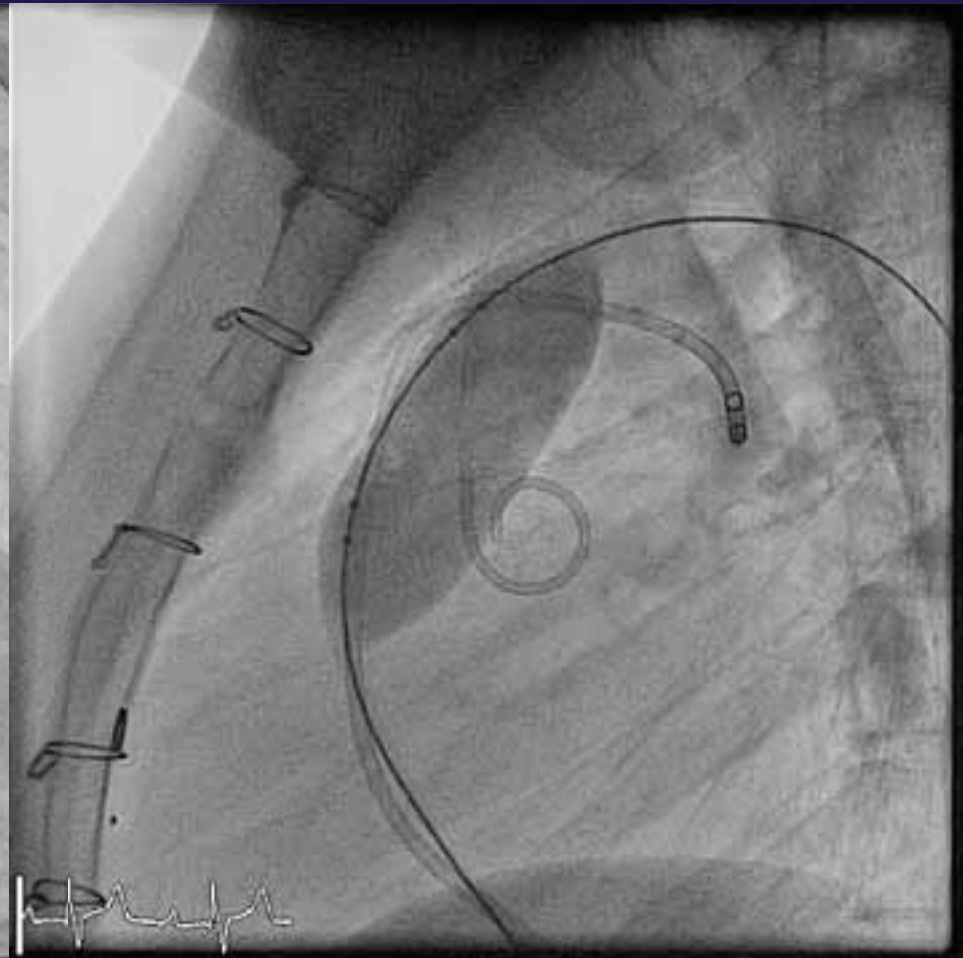
Testing with 22mm balloon No waist
