Melody transcatheter pulmonary valve implantation: Tips and tricks

Frank F. Ing, MD
Professor of Pediatrics
Children's Hospital Los Angeles
University of Southern California

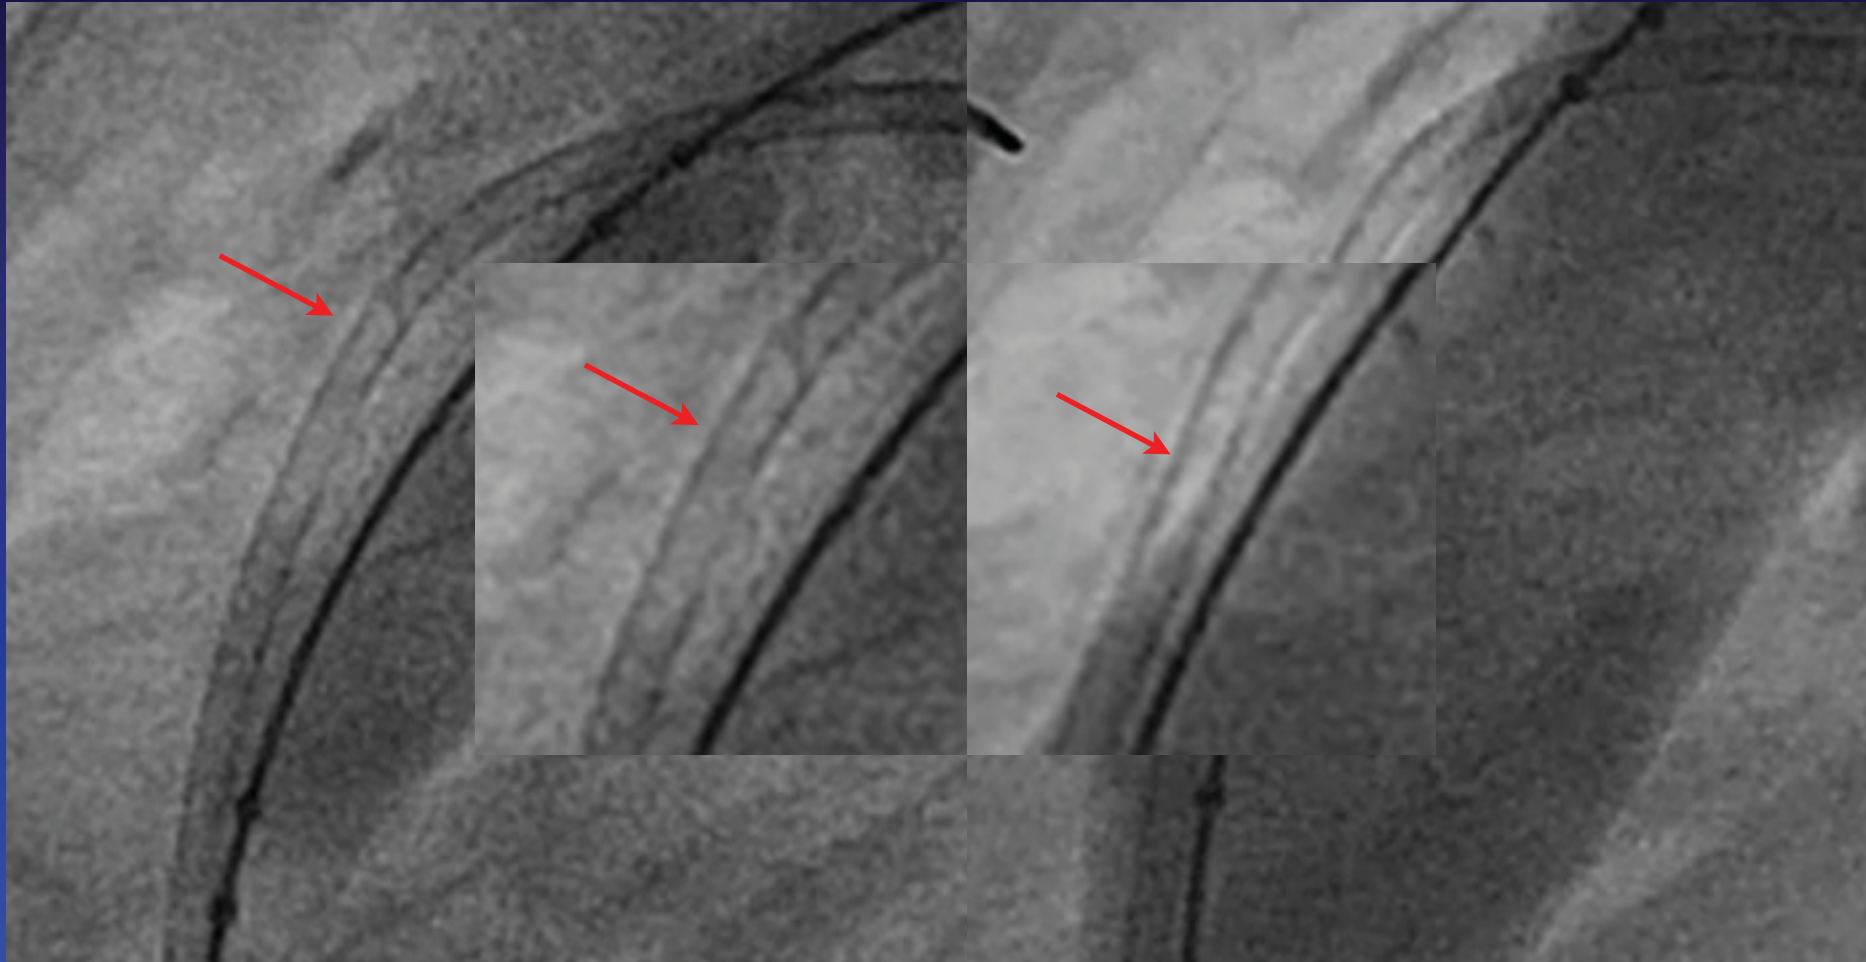
Testing with 24mm balloon: Subtle waist (see compressed catheter)

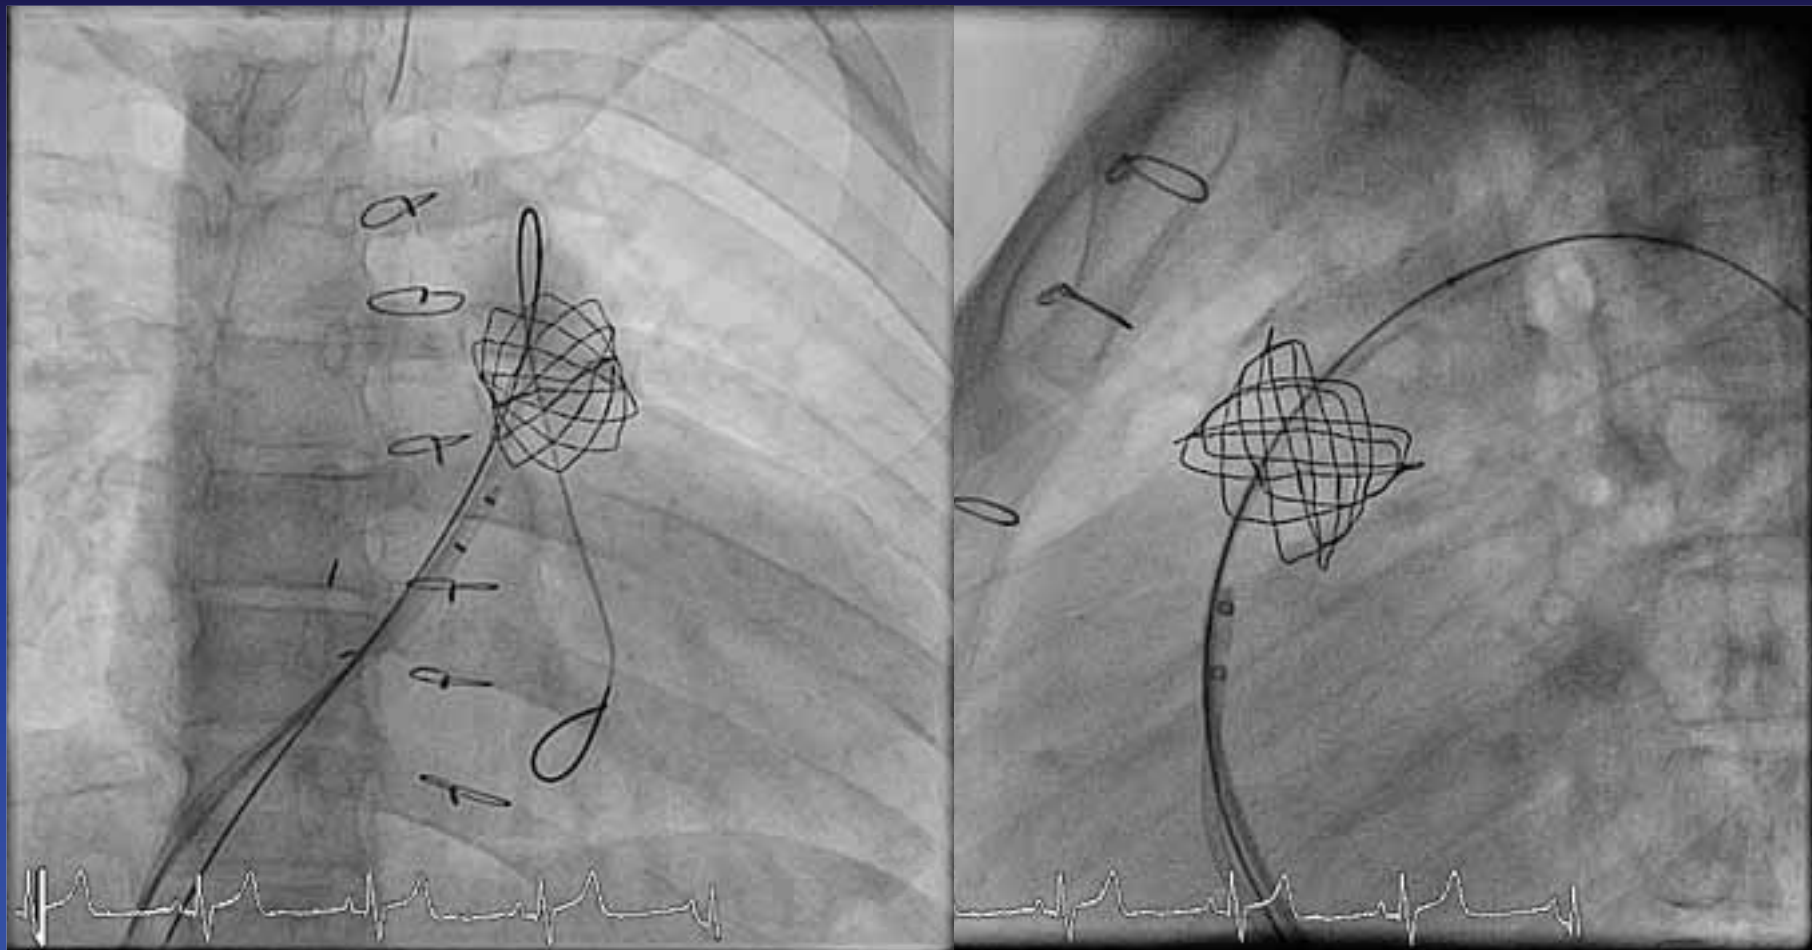
Melody implant on 24 mm BIB

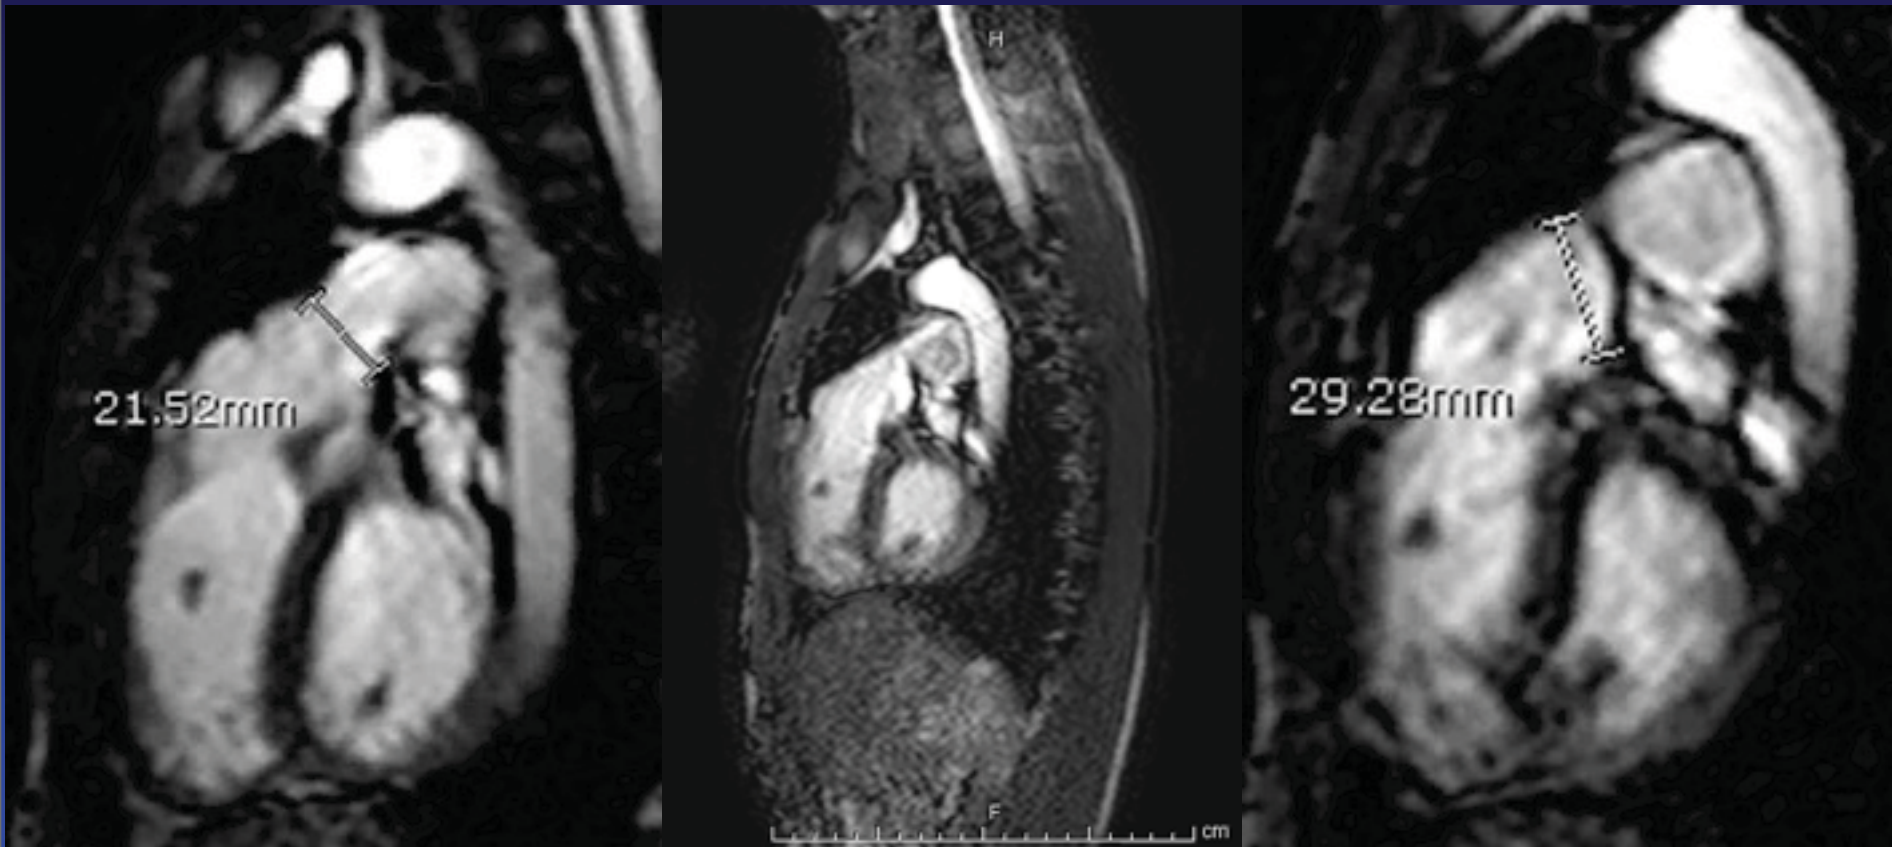
TOF, S/P transannular patch with PI and dilated RVOT

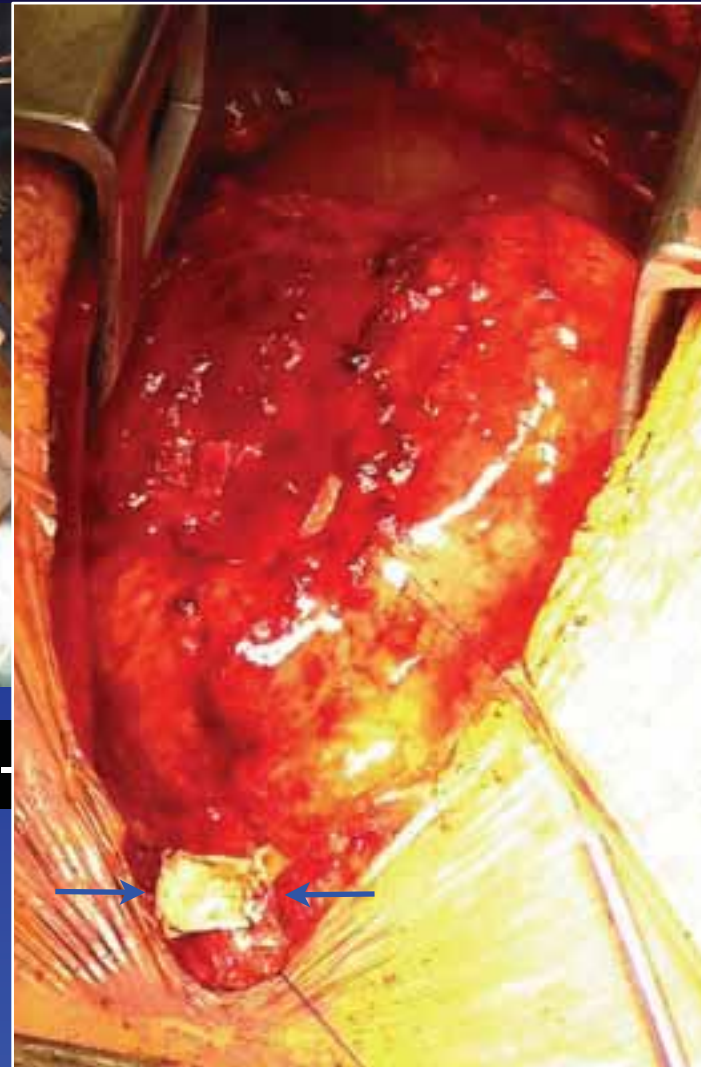
Preparing the MPA band

22 mm Gortex tube-

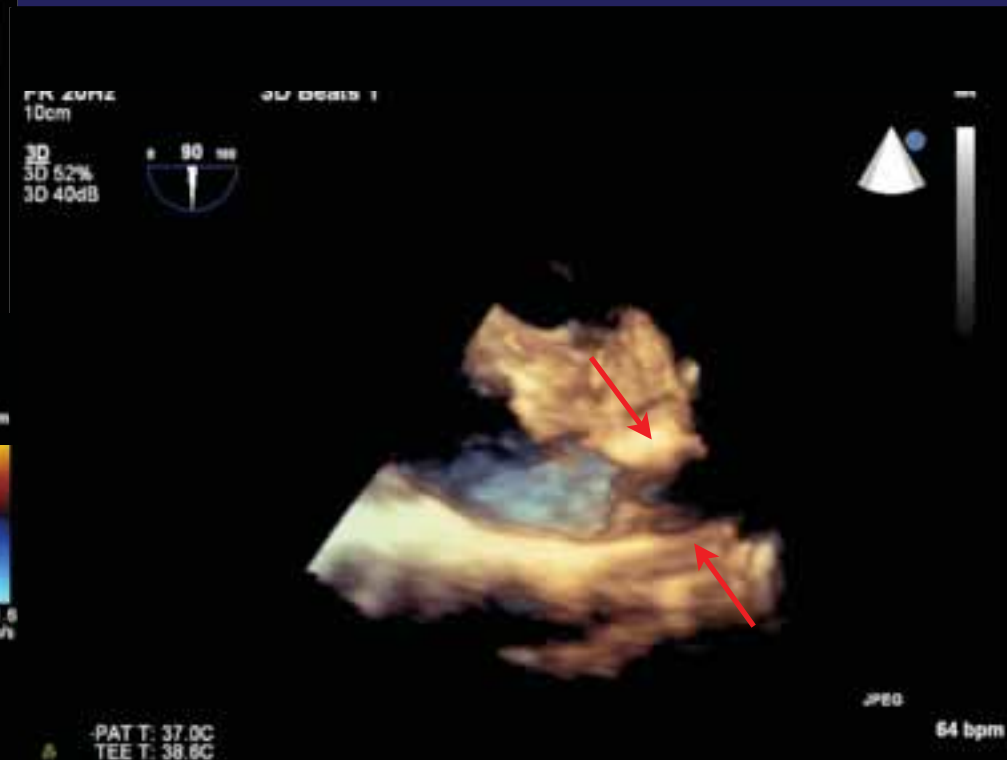
Place around MPA
(must avoid LCA)

S/P MPA band

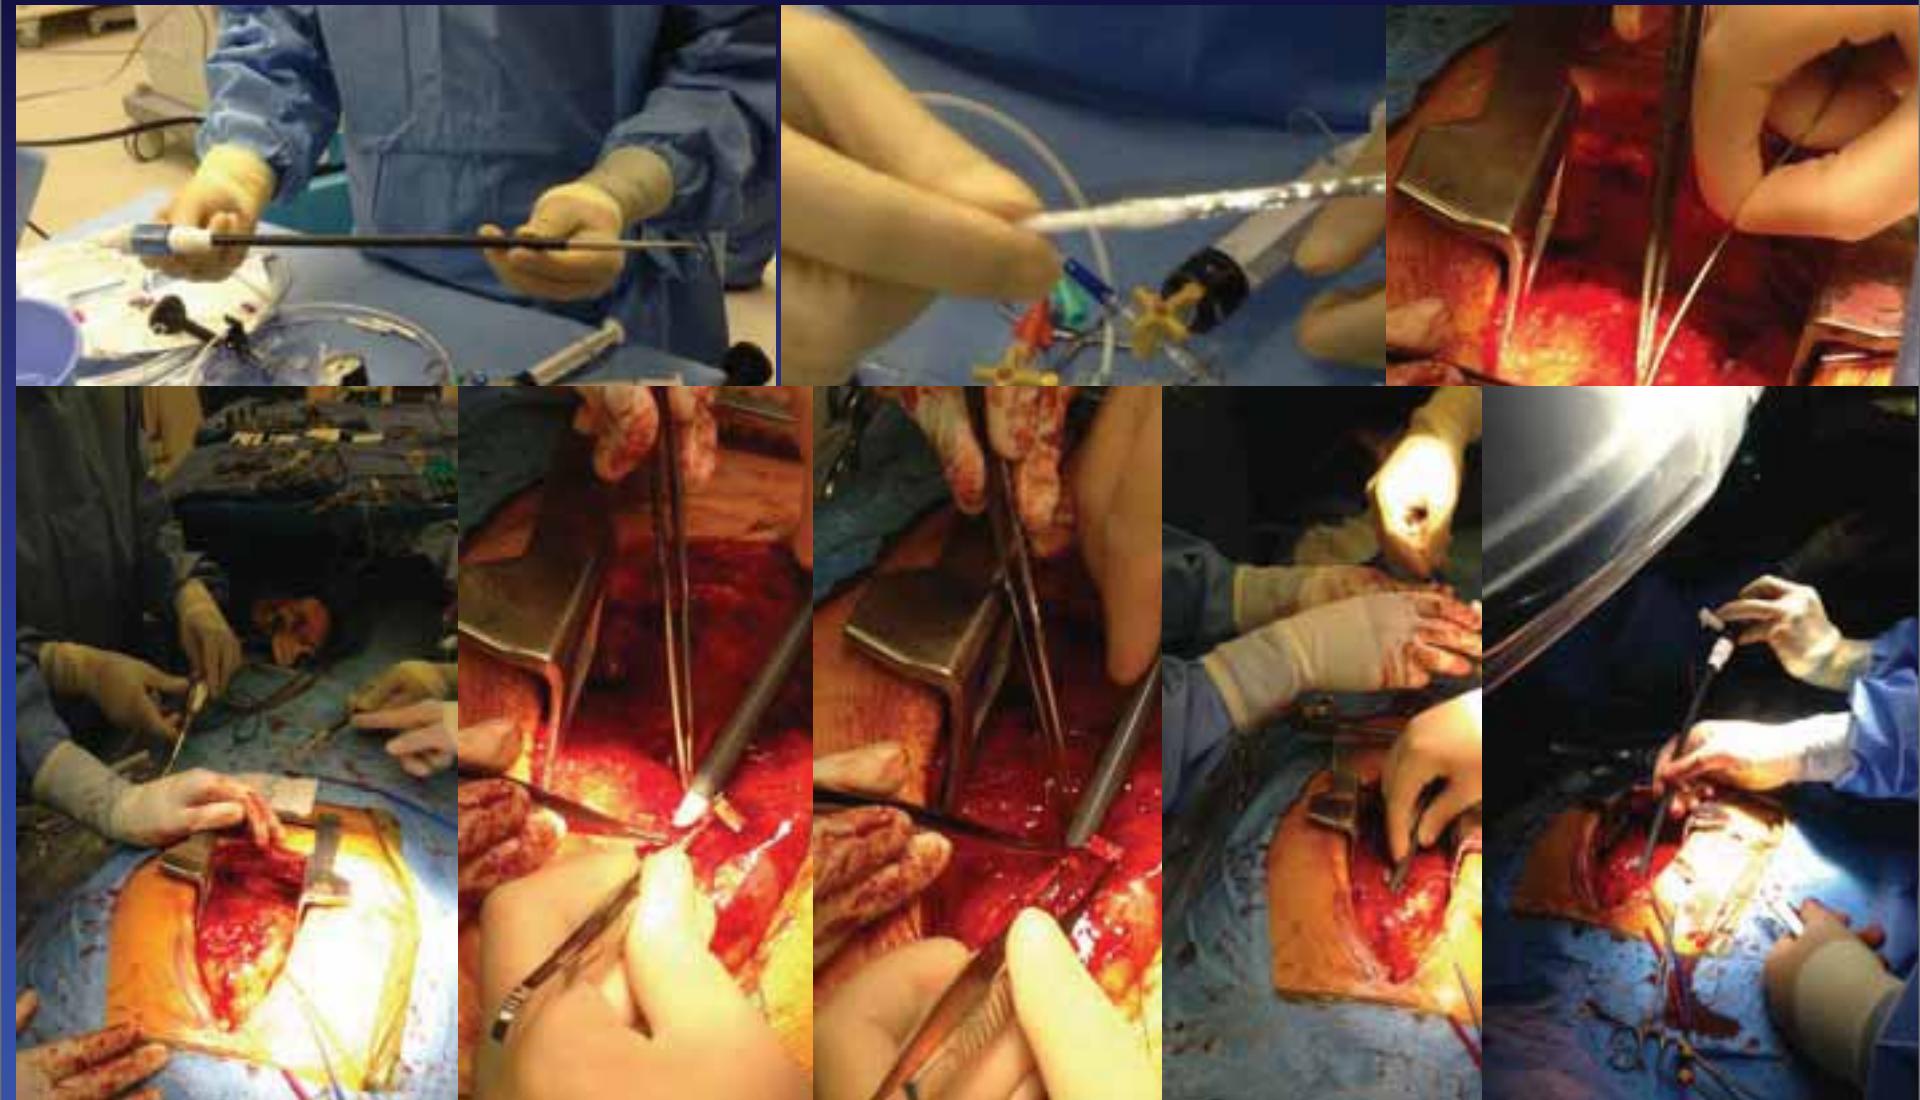
Preparing 22 fr sheath and 4110 Palmaz stent on 24 mm BIB

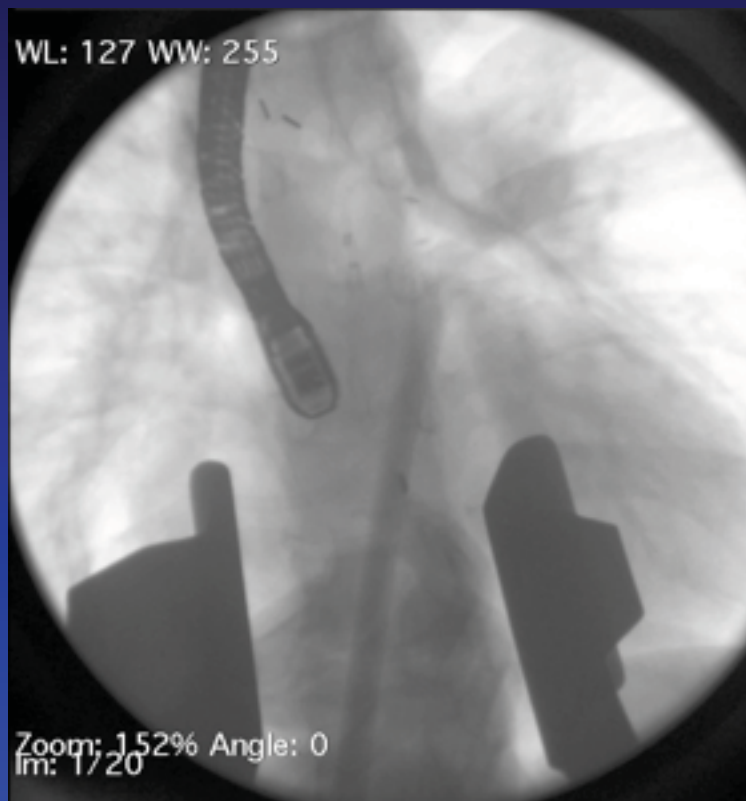
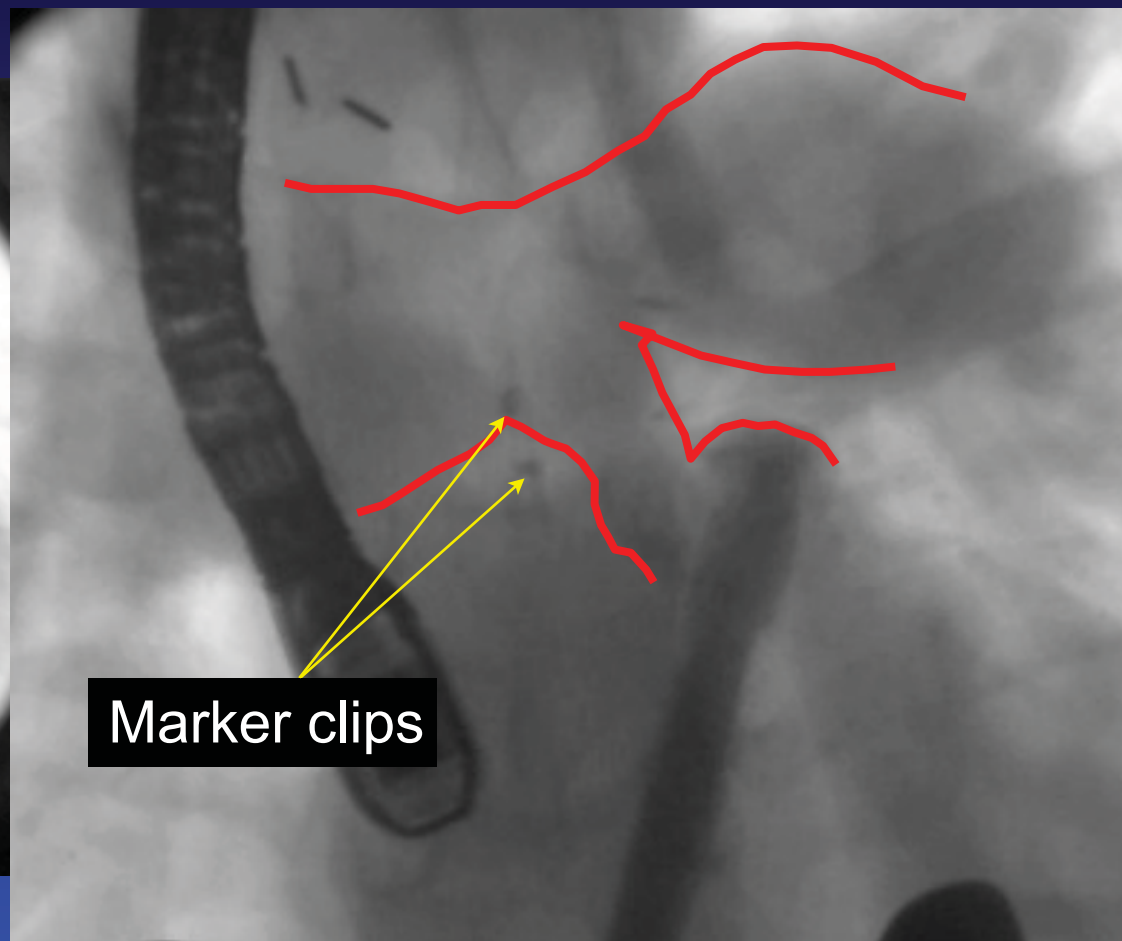
Flouroscopy guidance: 22 Fr sheath in RVOT

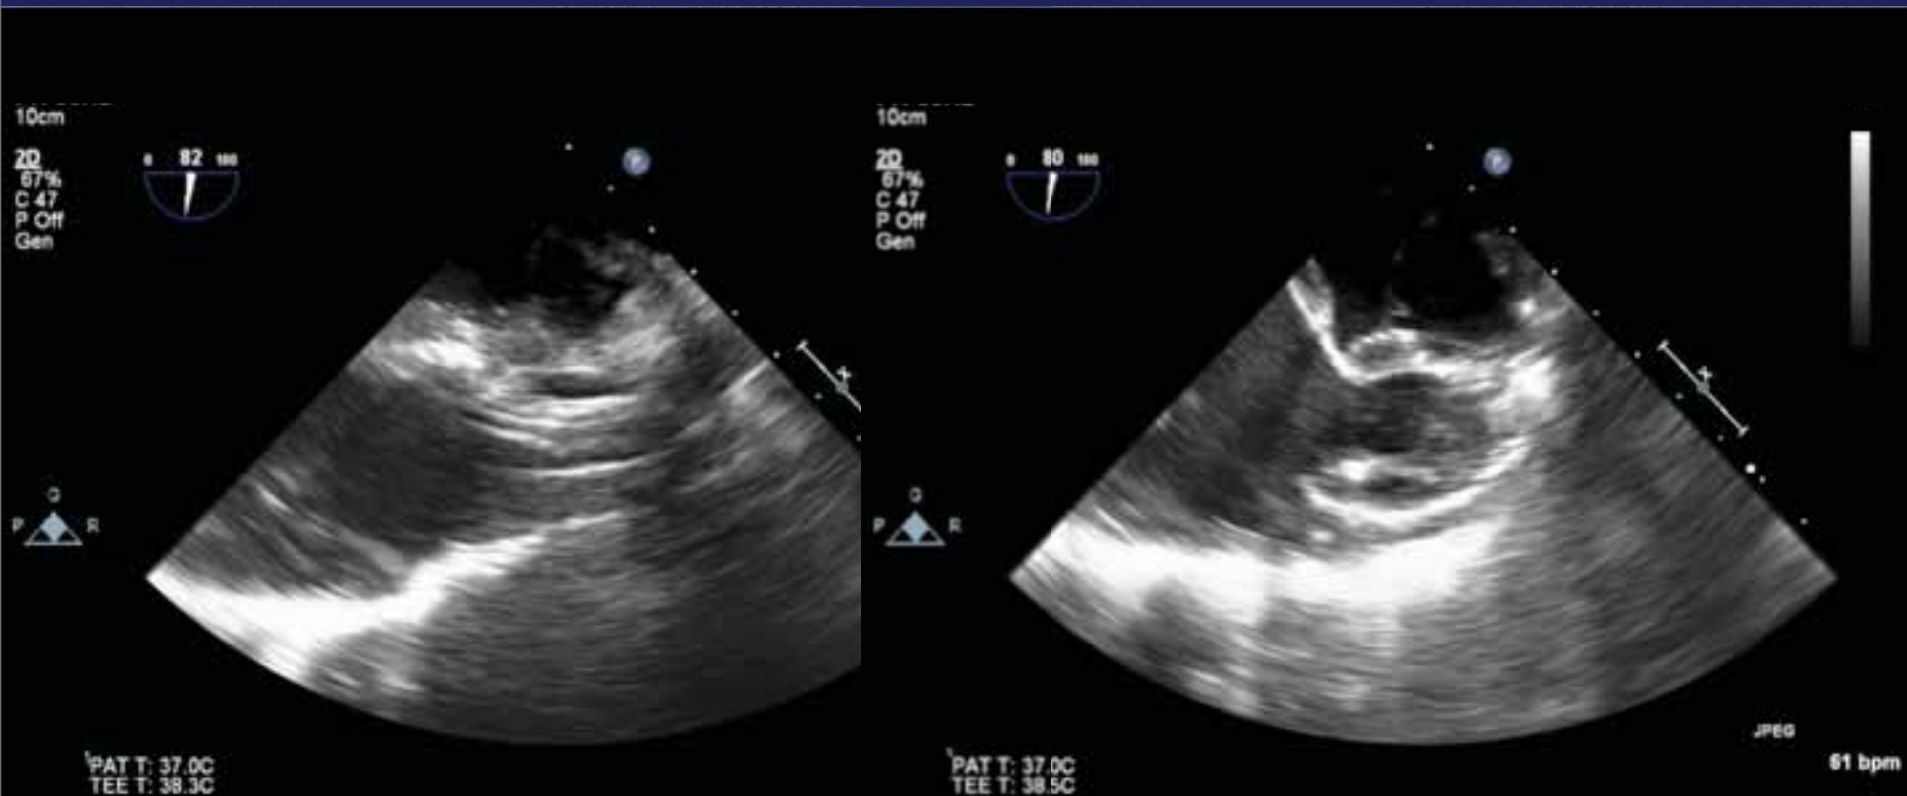
Implanting 4010XL stent at banded site

Wire-stent-balloon across PA band

Balloon inflation/stent implantation

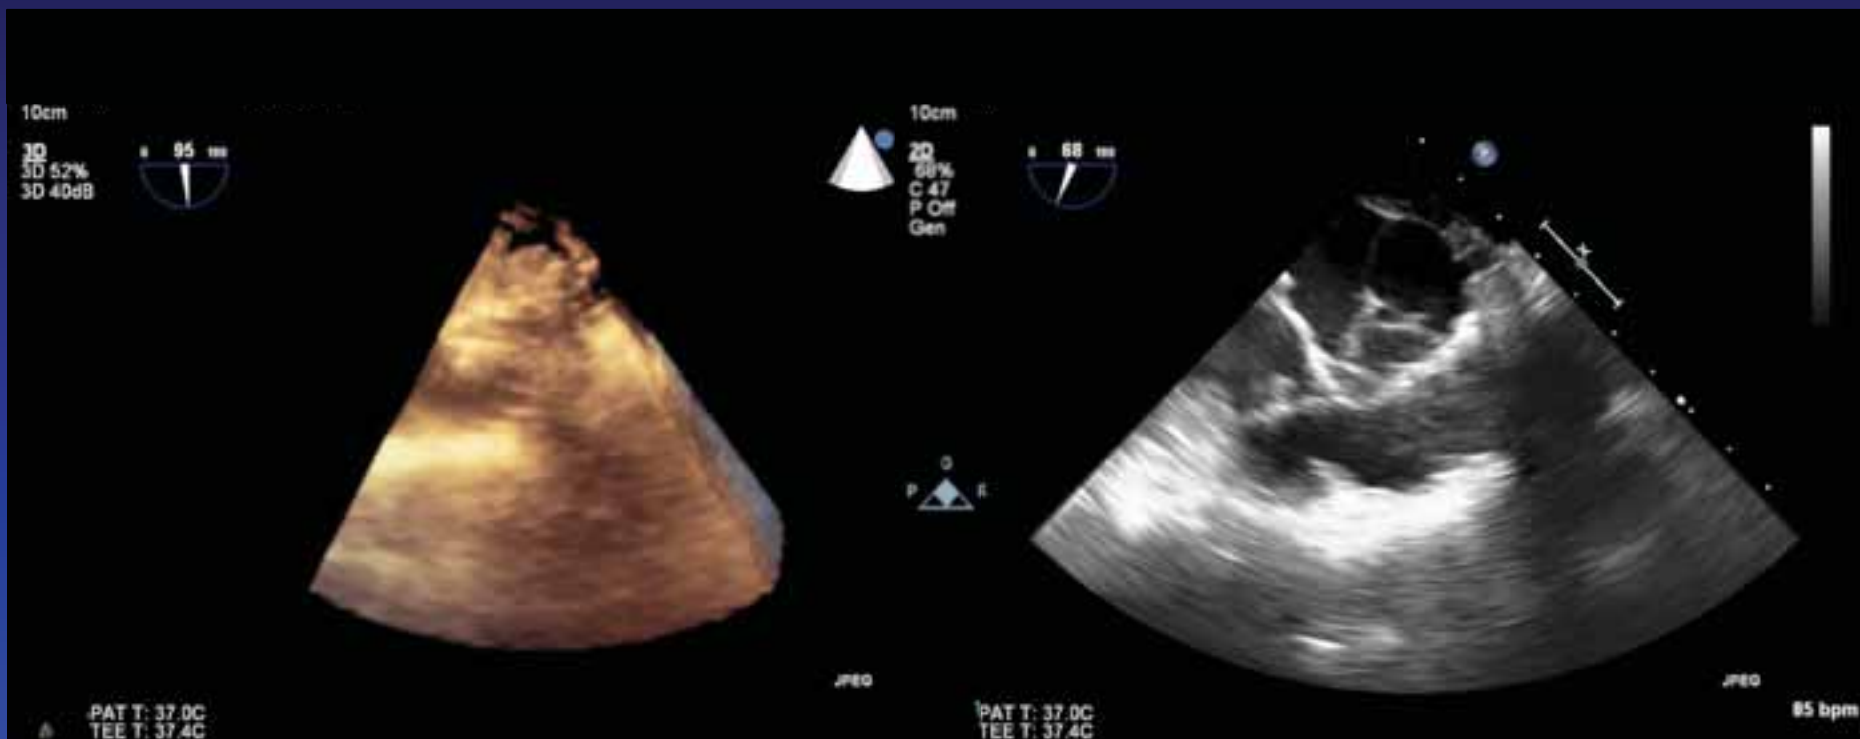
Stent implantation in RVOT

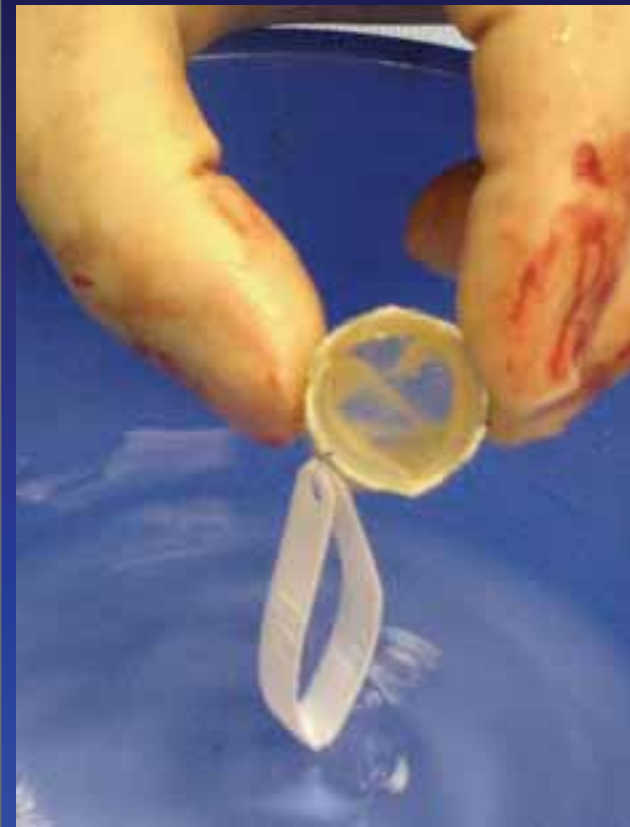
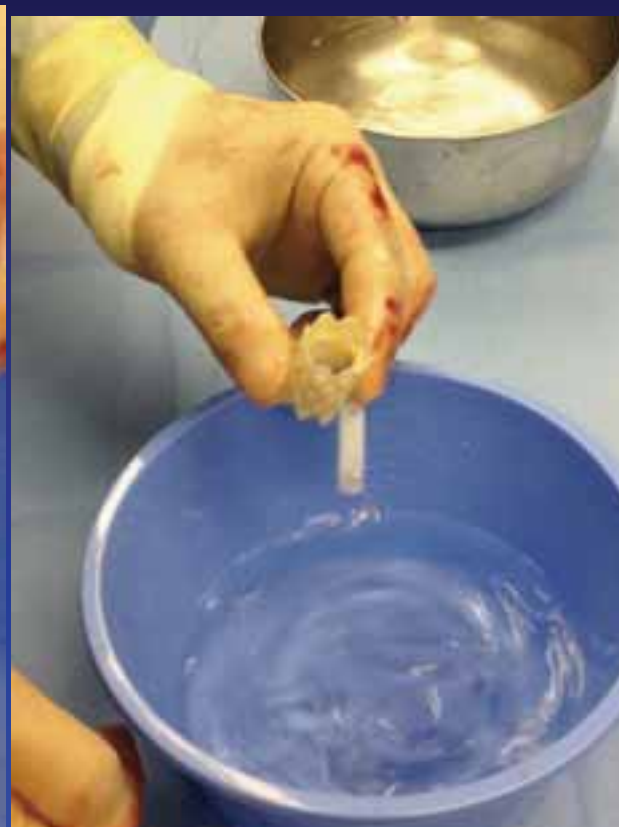
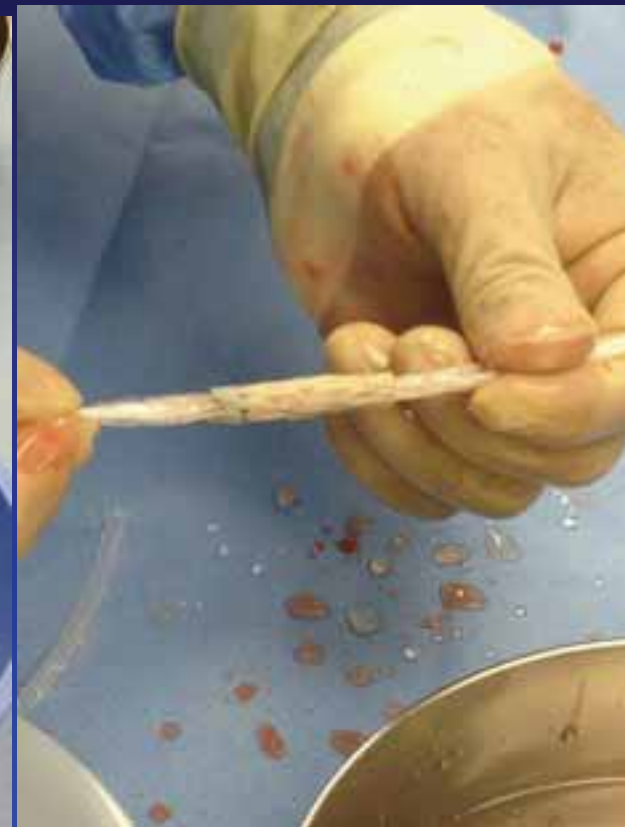
Melody valve mounted on 24 mm BIB

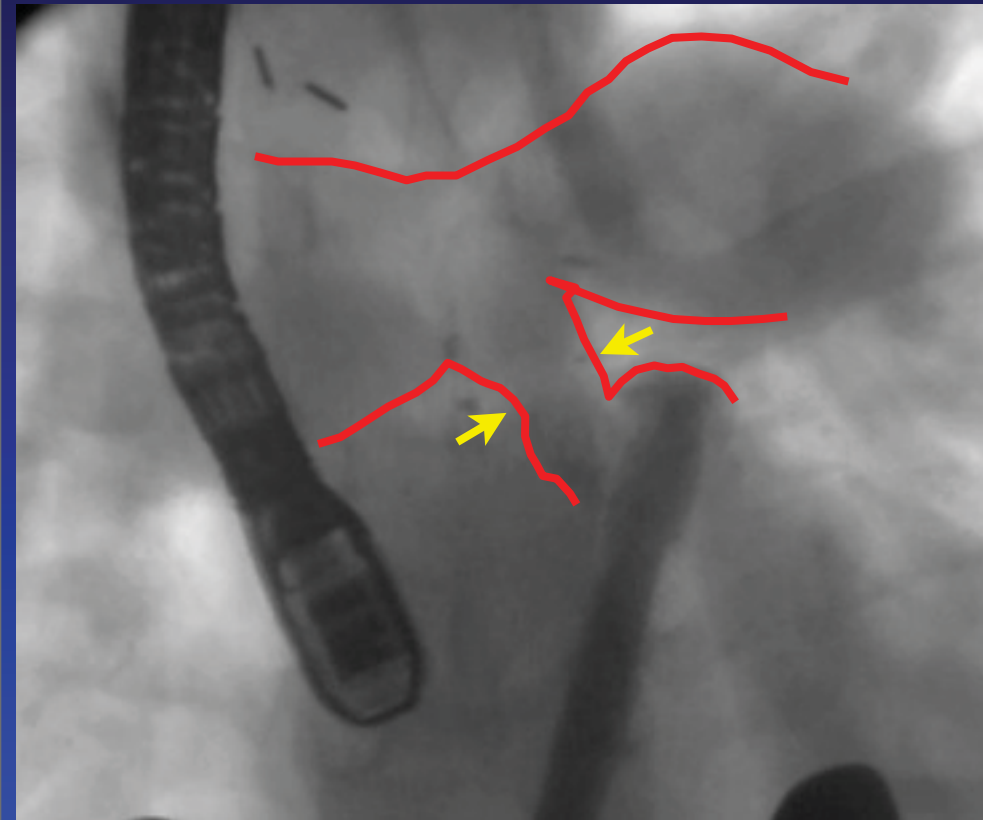
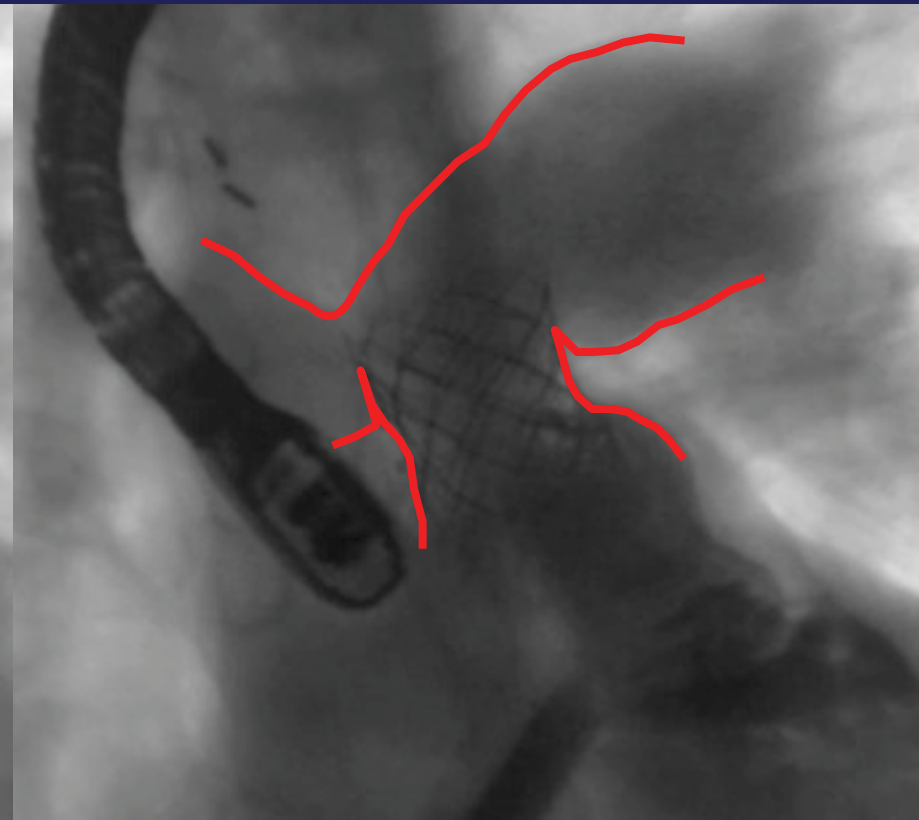
Pre and post angiogram

MPA band

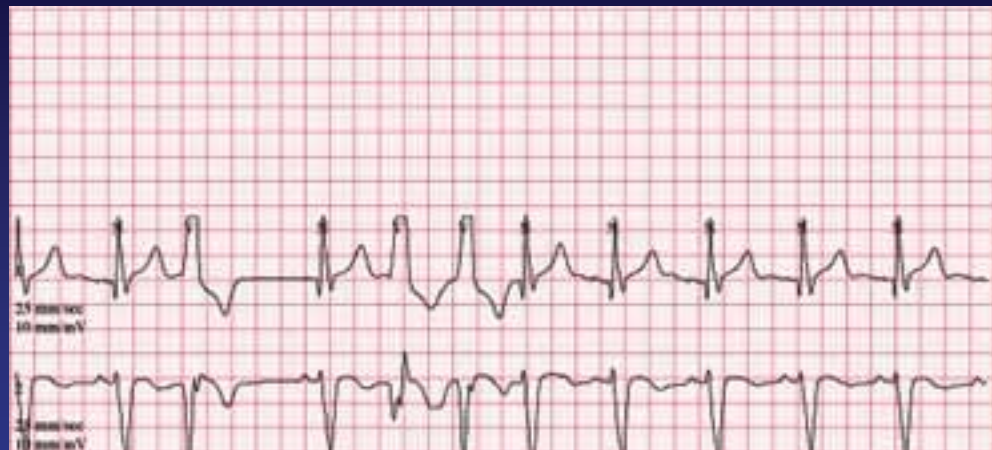
Post Melody implant arrhythmias

Treat with beta-blockers for 6 months,
then discontinue and re-holter

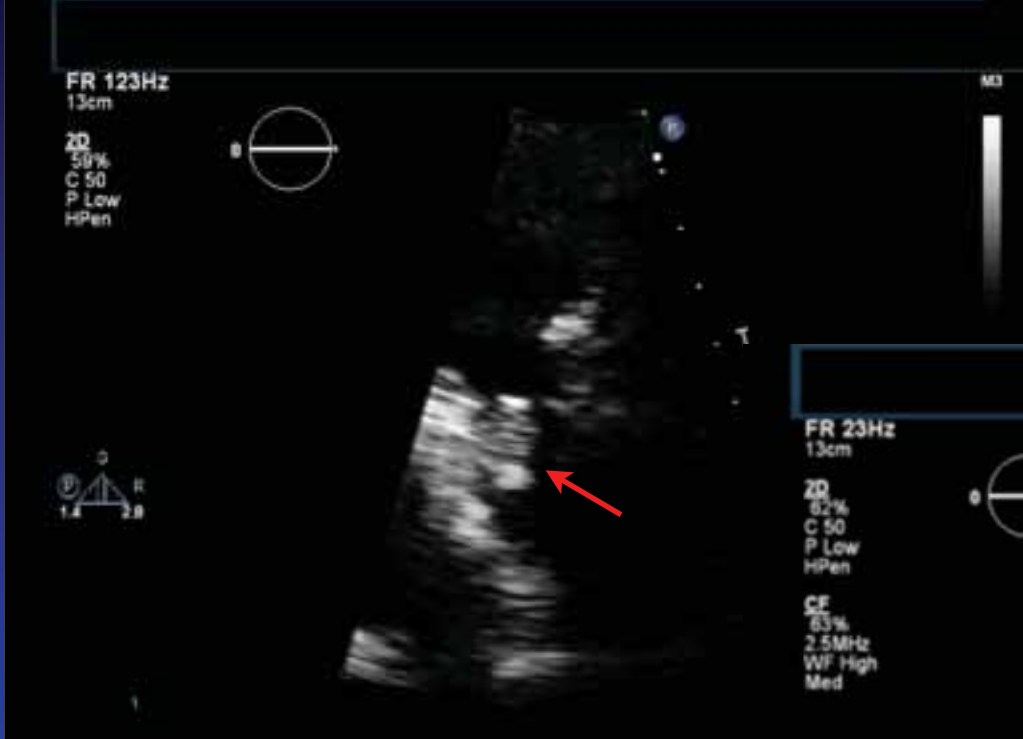
Post Melody valve implant: fever and bacteremia-diagnosis?

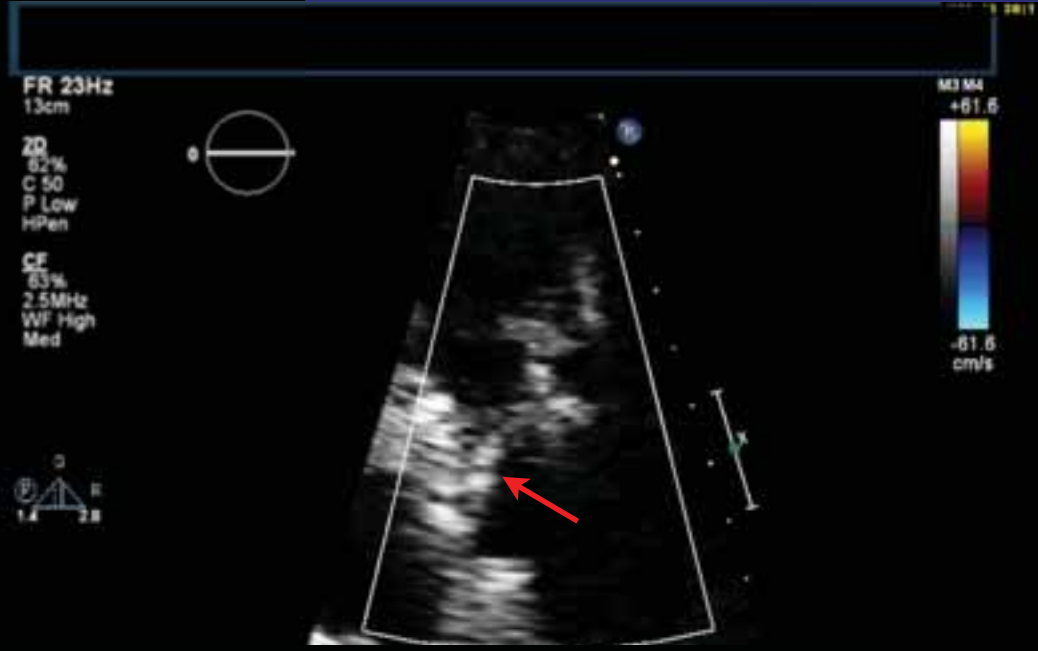
- Positive blood culture
- Dental flora

- Dental clearance before any device implant

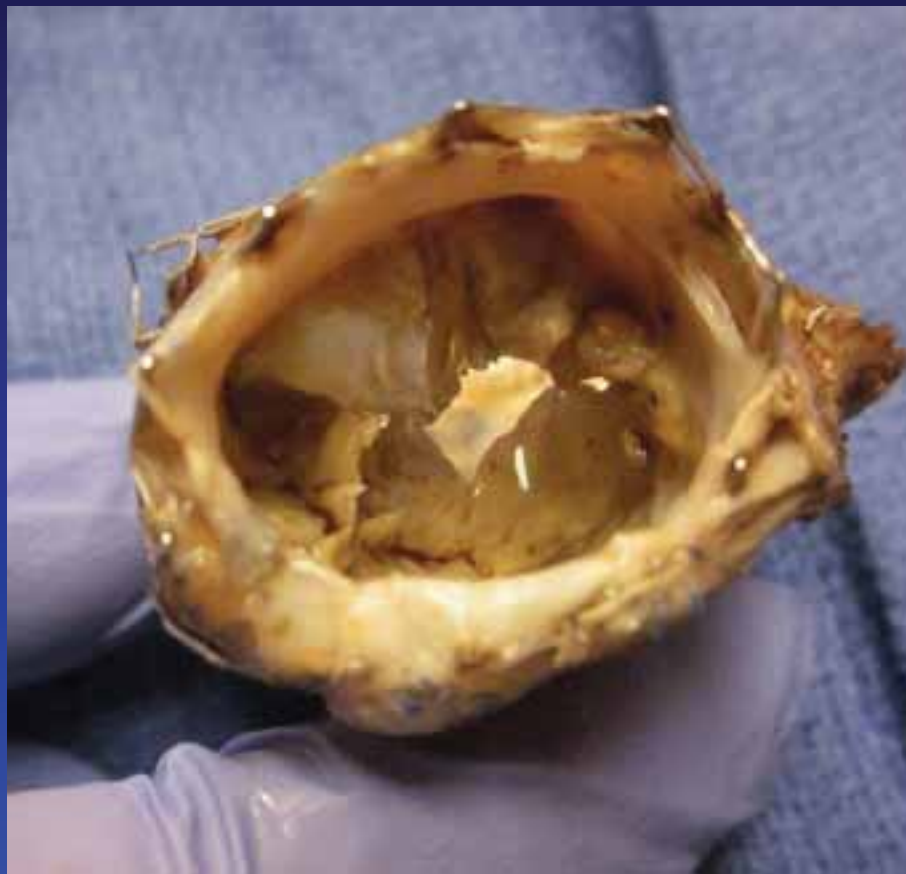
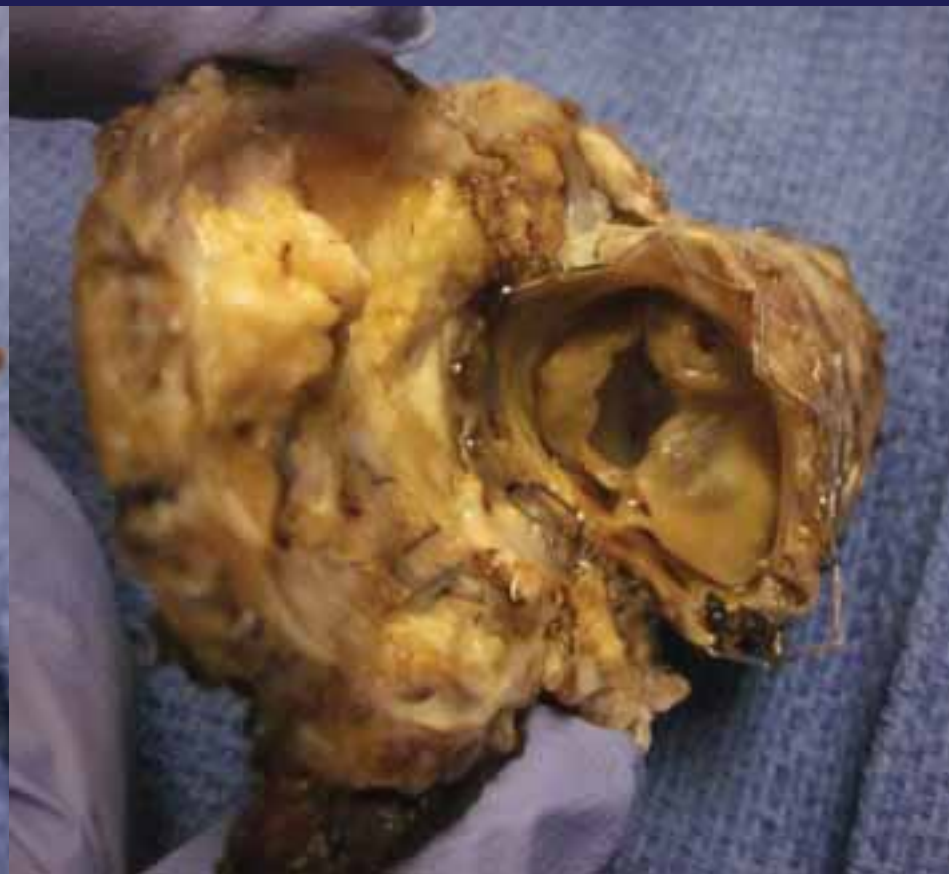
Path specimen

- No standards for antibiotics coverage
- Pre-implant dental clearance; repair all cavities
- Pre-implant antibiotics x 1
- Change gloves when handling new Melody valve
- Lifetime SBE prophylaxis
- Medtronic- >5000 cases
 - 93 cases reported to them (1.9% incidence)
