A Nightmare Of Coronary Stent Balloon Non Deflation And Shaft Fracture

Prashanth Kulkarni

Consultant Cardiologist

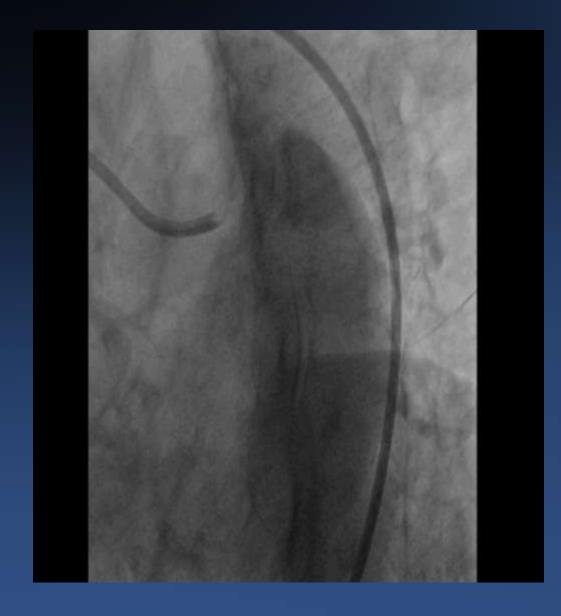
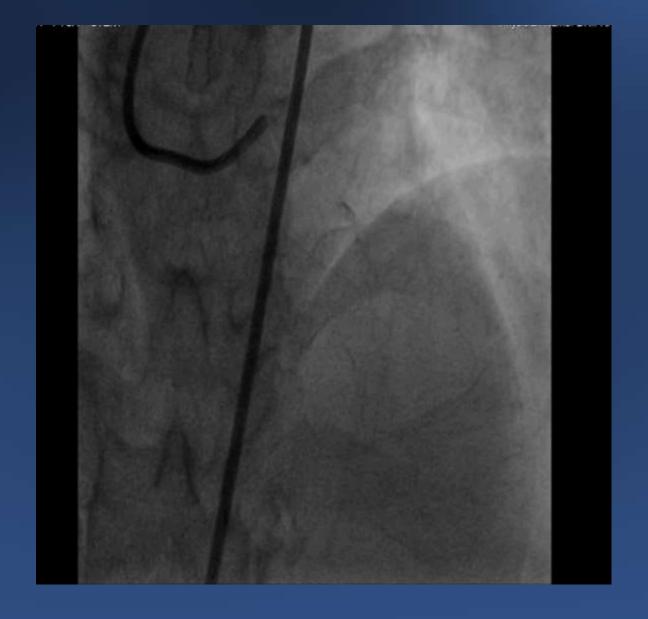
- Coronary angiogram done through right femoral artery approach revealed single vessel disease of left anterior descending artery 99 % subtotal occlusion and a normal large diagonal artery branch abutting it
- There was also retrograde filling of the left anterior descending artery from the right coronary artery

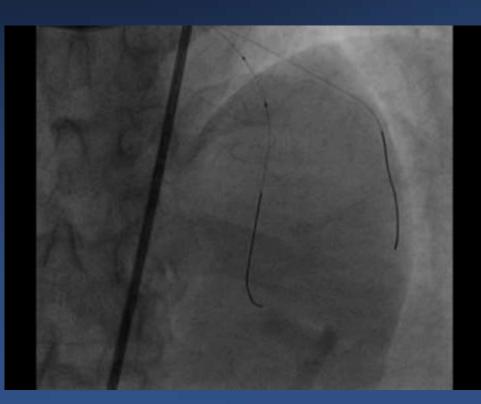
The patient was taken up for angioplasty with provisional stenting of LAD

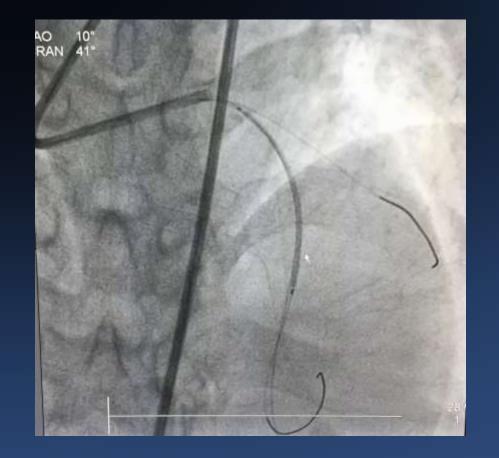
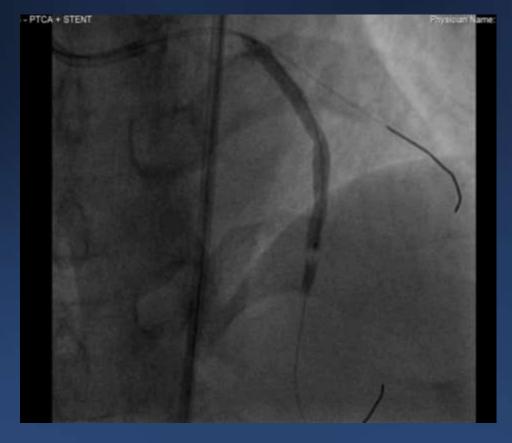
The lesion was pre-dilated with 2.50x 15 mm and 3.0 x 15 mm semi-compliant balloon

Despite multiple attempts deflation of the balloon could not be achieved

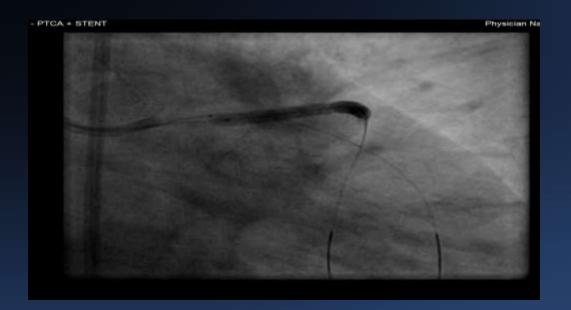
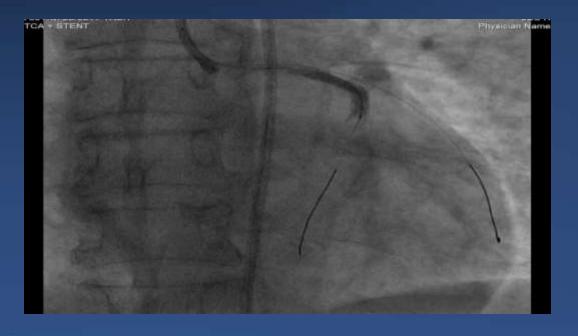
3.50 x 44 mm drug eluting stent was placed in LAD, inflated at nominal pressure

With saline in indeflator, multiple rapid inflation, deflation of the balloon at burst pressure was attempted but without any success.

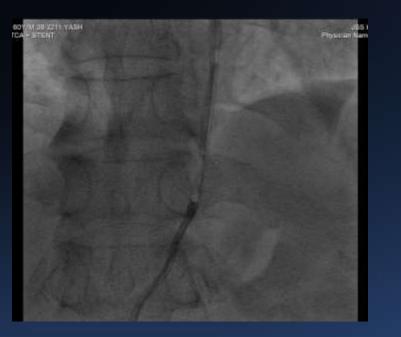
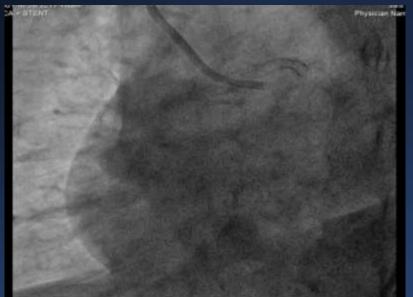
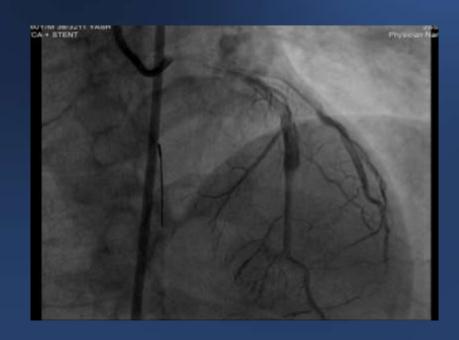
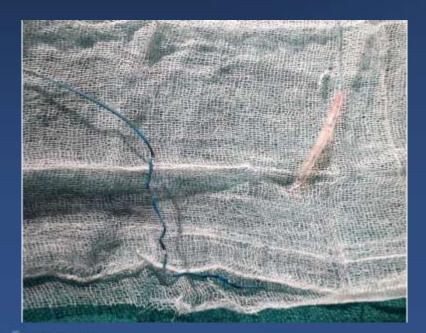
A micro-catheter was placed in the proximal end of the balloon, using reverse end of a stiff coronary wire multiple puncture was done, there was only slight, slow deflation of the balloon.

When attempts were made to pull the balloon out, the shaft fractured, got dislodged

3 x 15 mm non-compliant balloon was placed in diagonal, inflated at 4 atmospheric pressure, the entire system of wires, balloon, shaft was successfully pulled out

Angiogram revealed normal stent in-situ, TIMI III flow, no dissection and thrombus
