Successful Bailout of Stent Deformation by FD-OCT Guidance

Nara Medical University

First Department of Internal Medicine

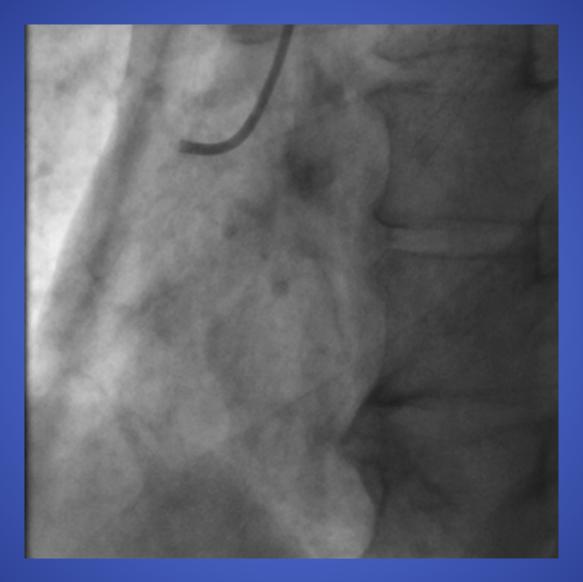
Angiography of the RCA

RCA angiography showed,

- 1) severe stenotic lesion in the middle part of RCA,
- 2) diffuse atherosclerotic changes.

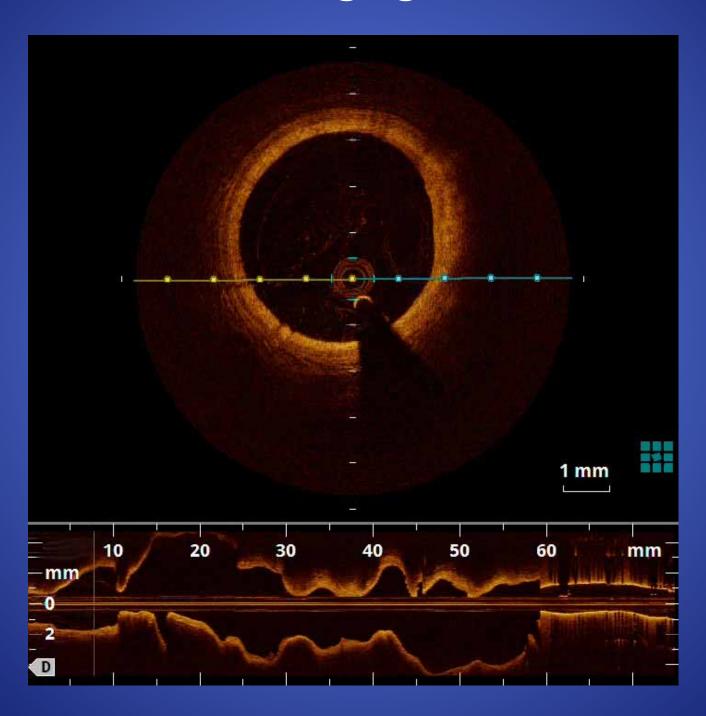
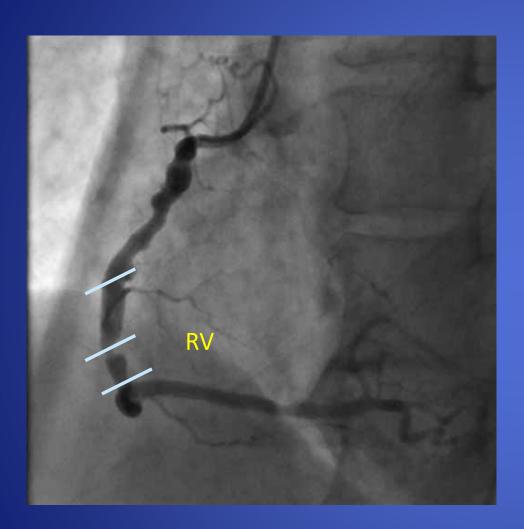
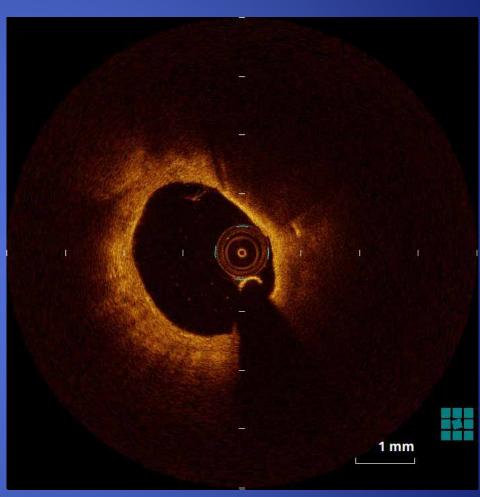
FD-OCT Imaging before PCI

FD-OCT showed plaque rupture, large lipid pool, macrophage infiltration around culprit lesion.

We decided to use distal protection device (Filtrap).

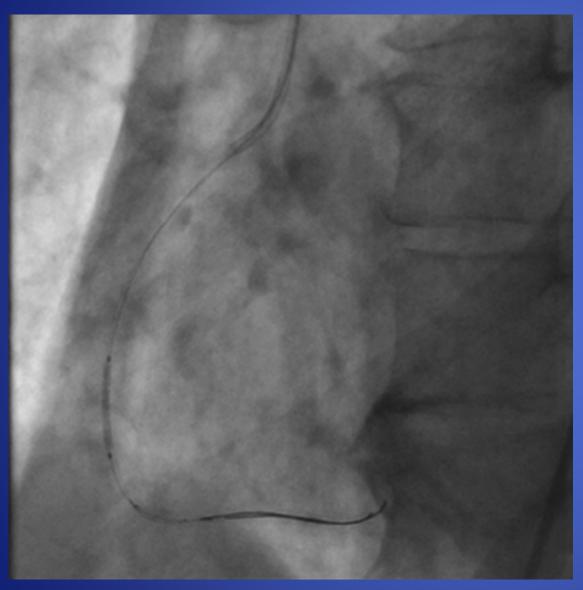
PCI Procedure

Lt. TFI
6Fr JR4.0
Guide wire TGV NEXT

Filtrap

BES (Nobori 3.5/14mm)
Post-stent dilatation
Maverick 4.5/12mm

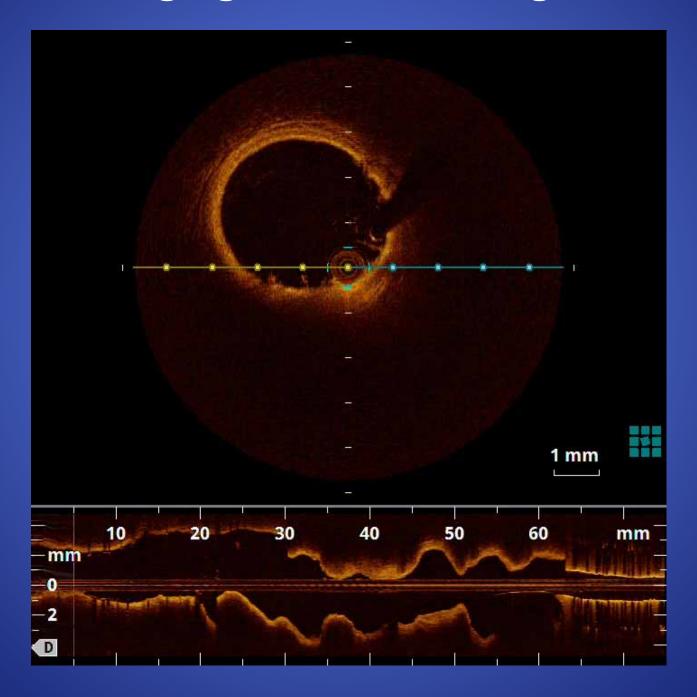
FD-OCT Imaging after Retrieving of Filtrap

- 1) Stent implantation with distal protection (Filtrap)
- 2) Stent deformation occurred when we retrieved Filtrap after stent implantation.
- 3) First guidewire recrossing: OCT showed inappropriate wire position and stent deformation.
- 4) Second guidewire recrossing: By inducing the second guide wire to the opposite side of RV branch, the wire appropriately crossed into true stent lumen.
- 5) OCT confirmation of appropriate wire position.
- 6) Bailout balloon dilatation.

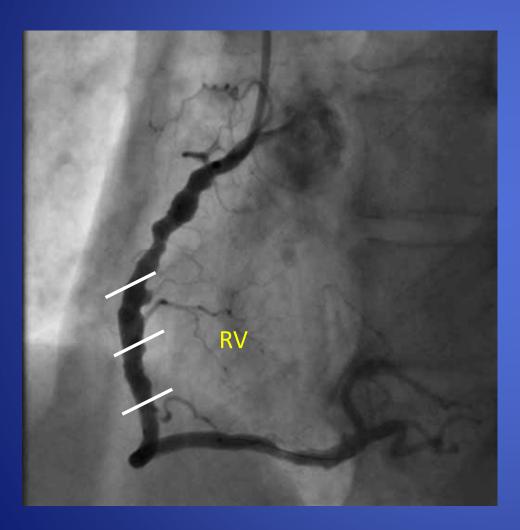
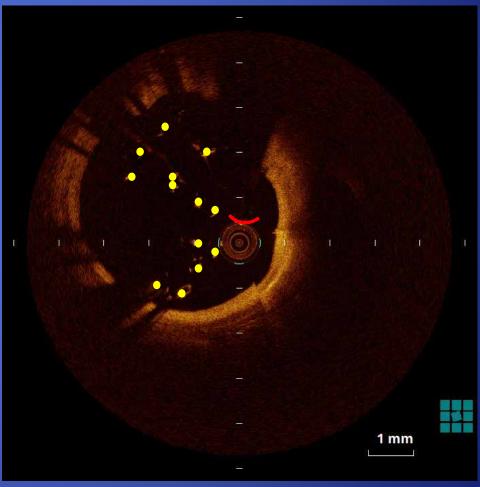
First Recrossing Guide Wire was Incorrectly Positioned outside of the Stent Lumen

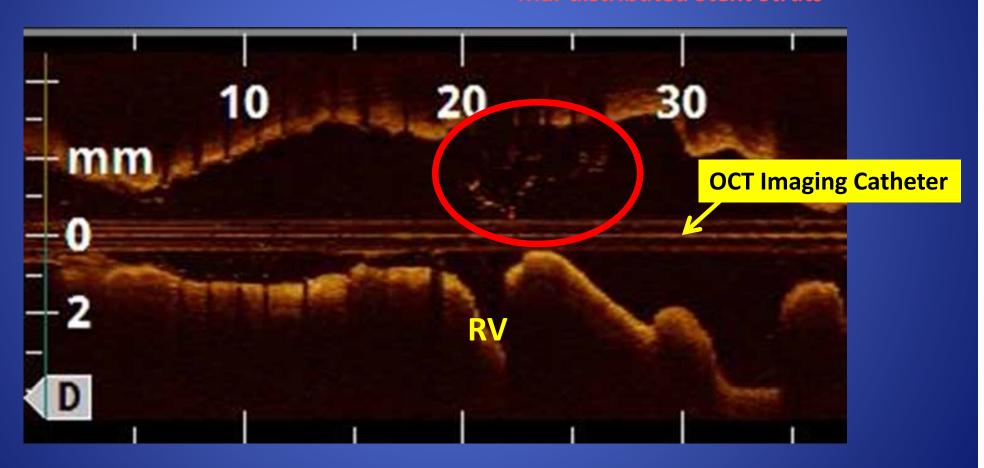
Long-Axis View of Deformed Stent

Mal-distributed Stent Struts

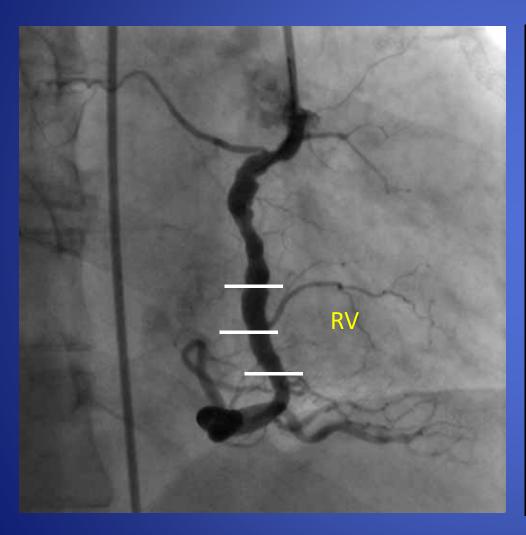
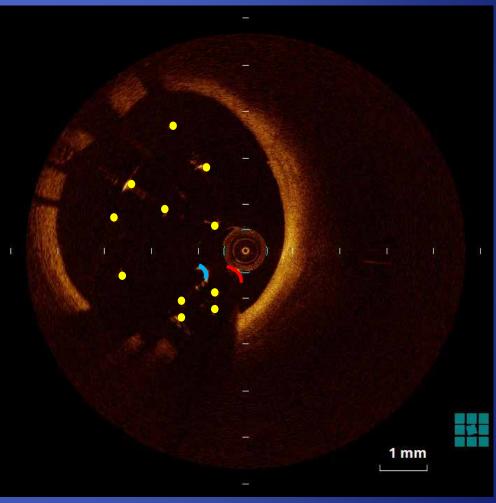
Second Guide Wire Successful Recrossed into Deformed Stent Lumen

By referring the findings of both **FD-OCT** and RAO view of **CAG**, we tried to correctly induce the second guide-wire into the deformed stent lumen.

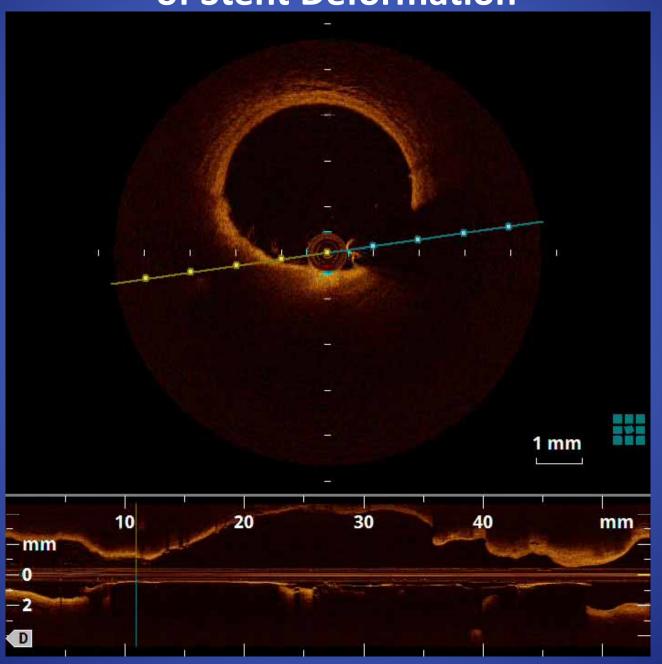
FD-OCT Imaging after Bailout Balloon Dilation of Stent Deformation

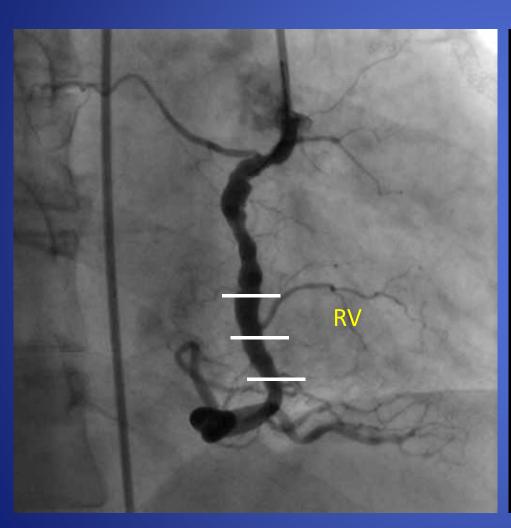
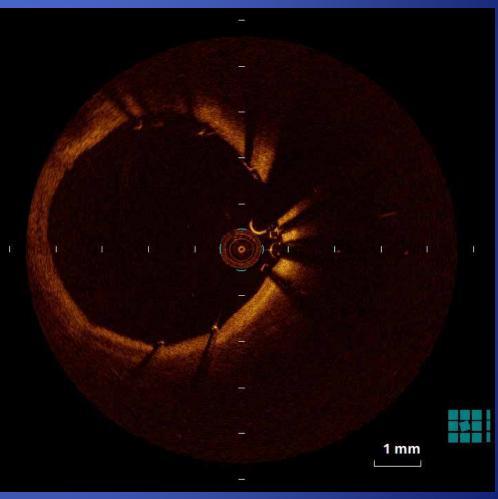
FD-OCT Imaging after Bailing Balloon Dilation of Stent Deformation
