# ~~My~~ Most Frightening Rotablation Case ~ Nightmares Follow ~

**KASHIMA Yoshifumi, MD**  
**Sapporo Cardio Vascular Clinic,**  
**Sapporo Heart Center, JAPAN**

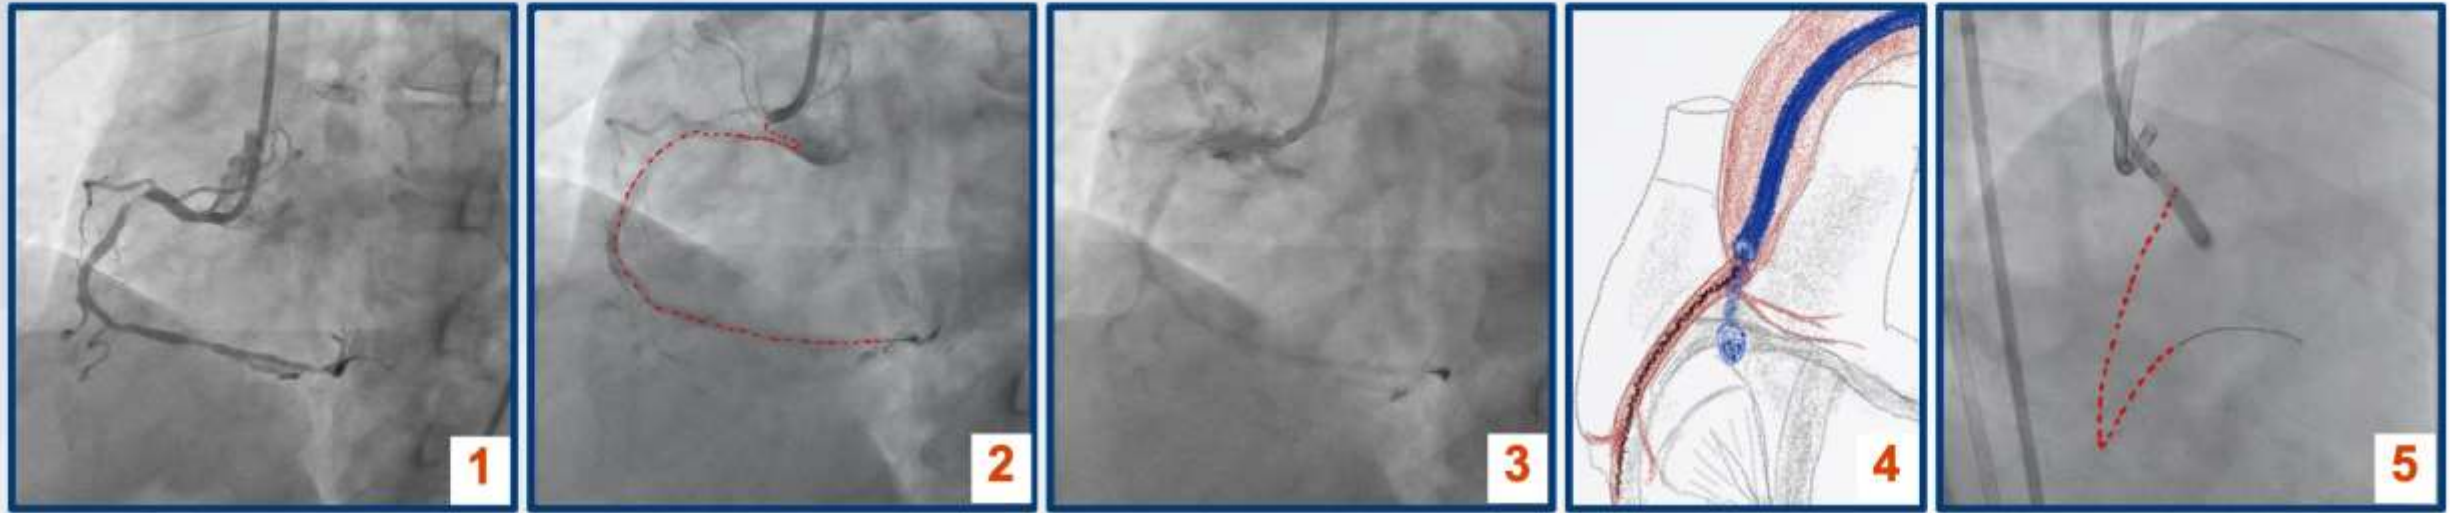
# Nightmare case shared in HKSTENT @ TCTAP 2019

- ☐ Severe stenosis with heavily calcification on proximal RCA (1).
- ☐ He didn't notice the wire flexing when the GC was coming out (2).
- ☐ When the rotablator activated, the wire rupture and the huge perforation was happened (3).
- ☐ The burr had broken through the coronary artery wall and plunged into the myocardium (4, 5).

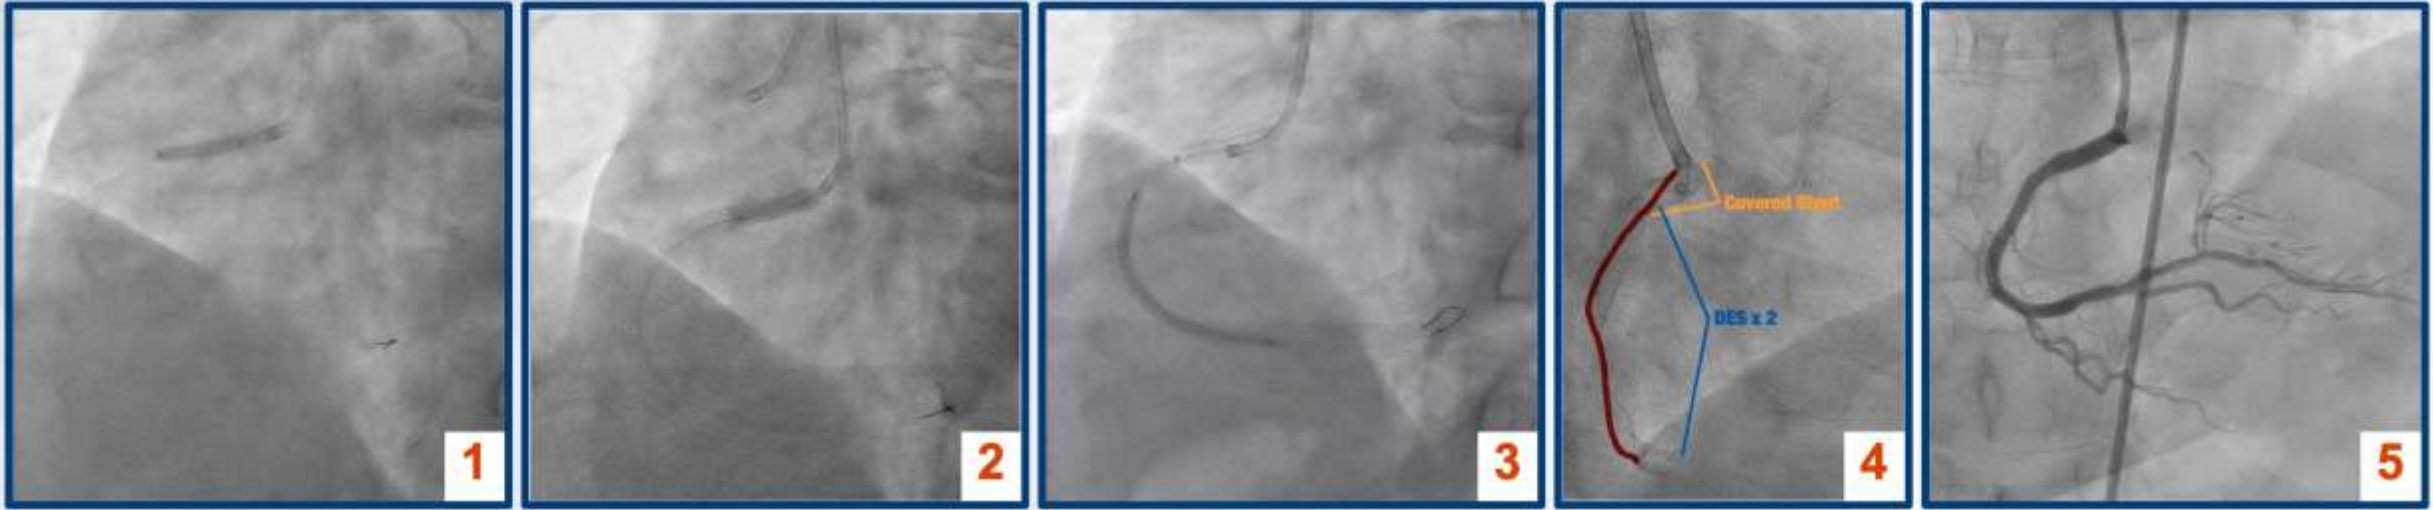
# Nightmare case shared in HKSTENT @ TCTAP 2019

- ❑ Covered Stent was implanted on the perforation site (1).
- ❑ 5.0mm NC balloon was made a dilatation for the completely apposition (2).
- ❑ 3.5mm and 3.0mm DESs were implanted for pressing down the remaining rota-wire (3, 4).
  - ♣ Red line shows the remained rota-wire.
- ❑ Final CAG (5).

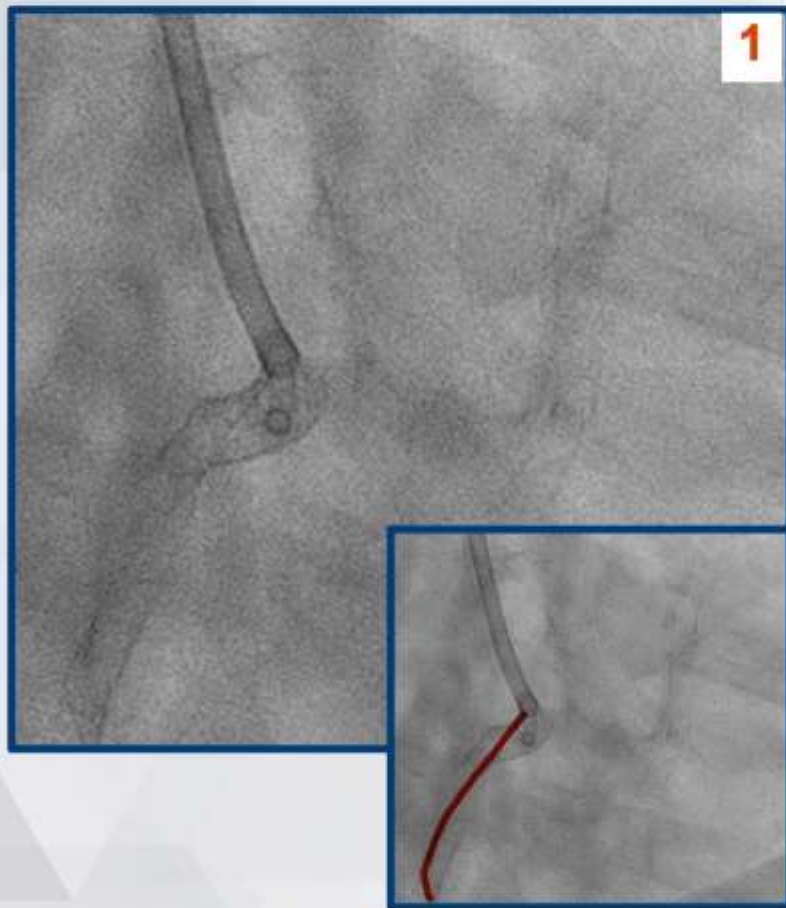
PCI

- ❑ PCI: Rotablation for proximal RCA, then the wire rupture and huge perforation were happened. But, the bailout was success.
  - **Must check a rota-wire position when GC is coming out.**
- ❑ 8M later: No problem.
- ❑ 20M later: Remained rota-wire looked a little out of place, but judged it to be a difference in CAG angle.
  - **Even small changes should be thoroughly examined.**
- ❑ 21M later: Remained rota-wire was big out of place and caused the massive AR. Surgical procedure was performed.

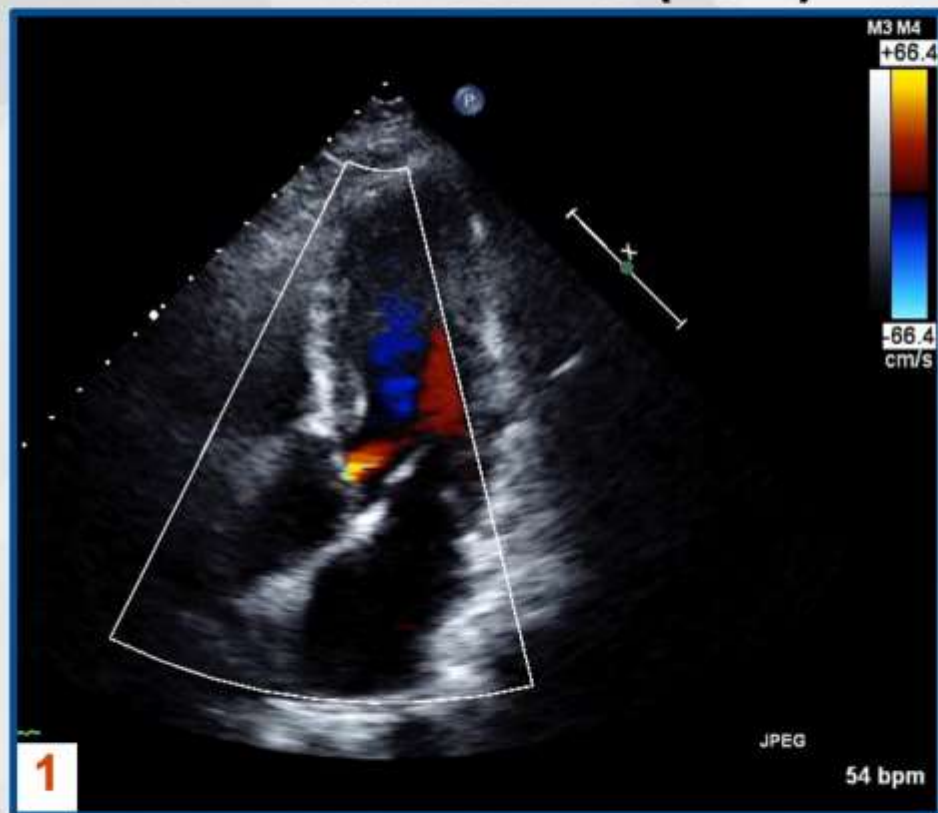
Trivial AR at last FU (20M)

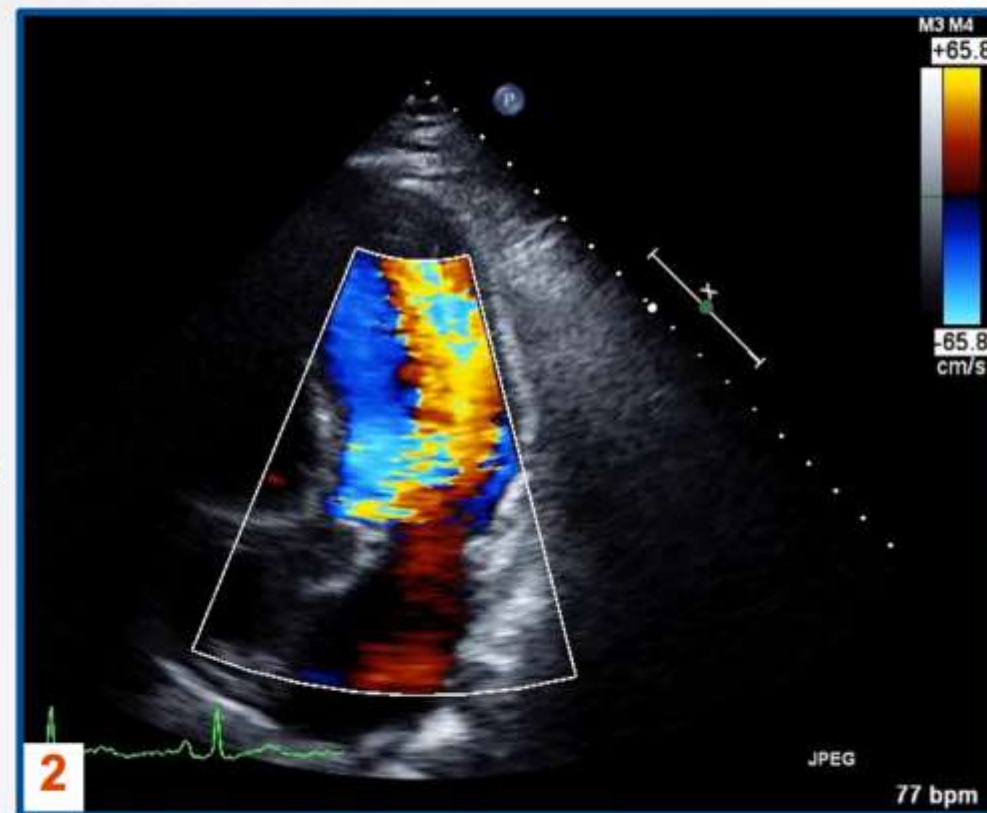
Massive AR

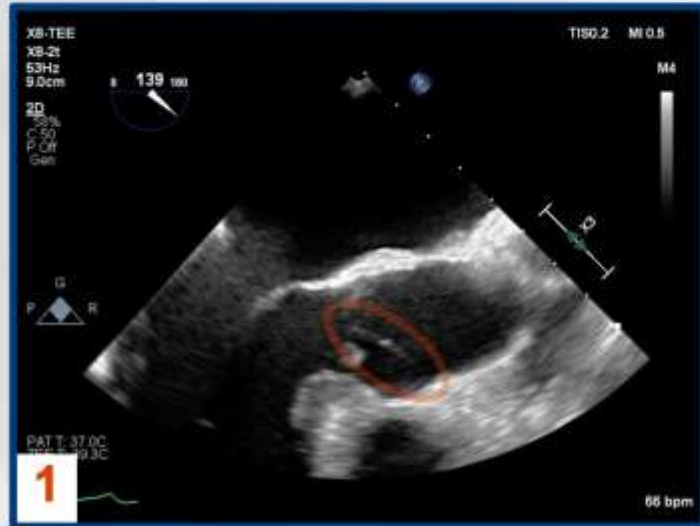
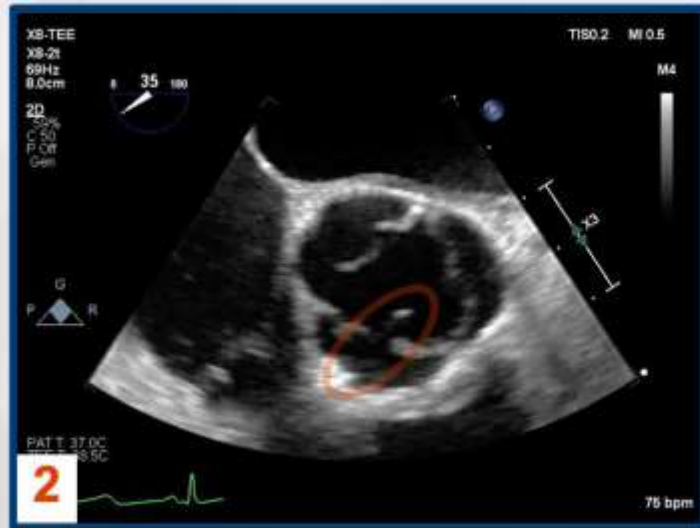
## TEE

# Cause of massive AR

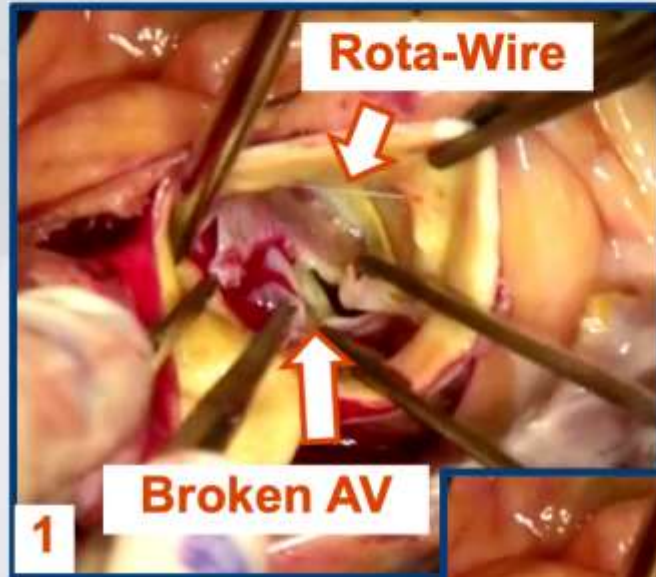
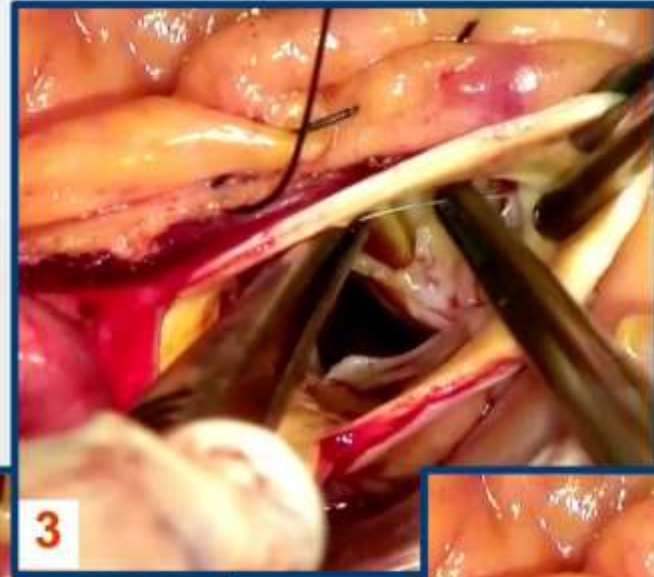
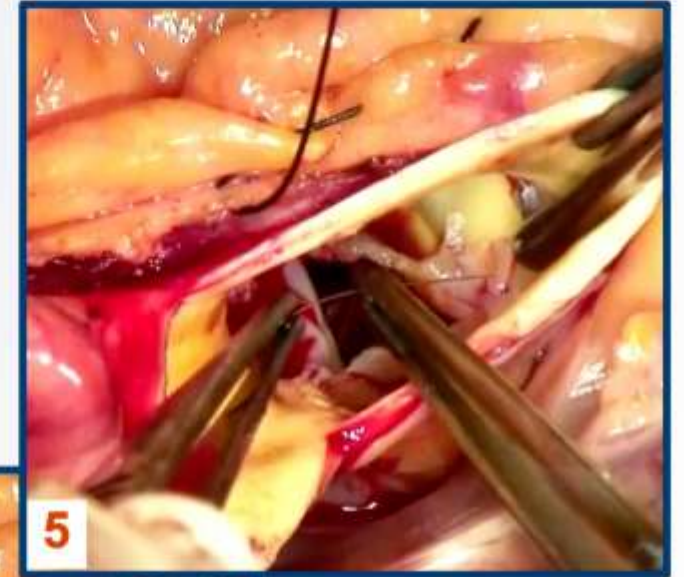
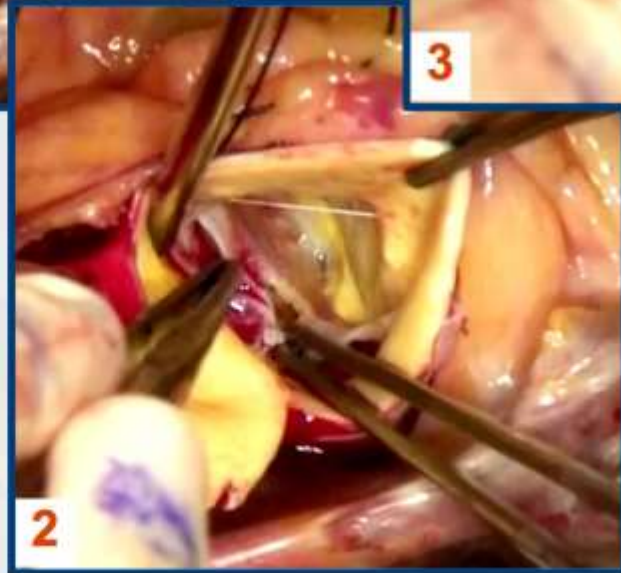
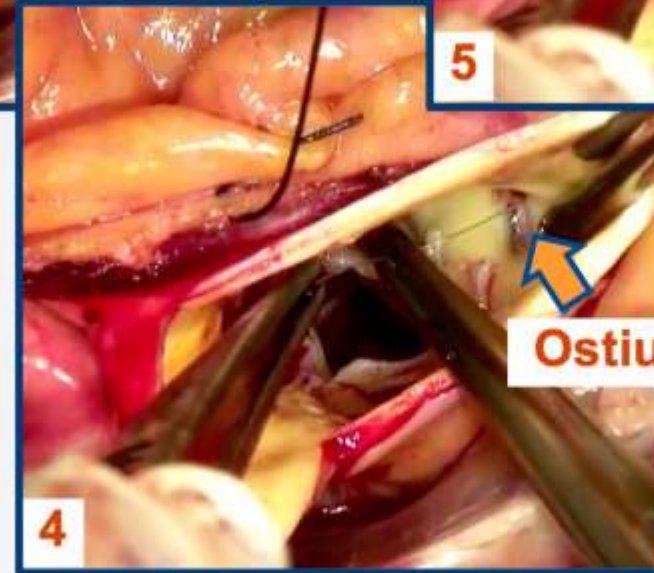
# Retrieving the remained rota-wire, and AVR
