Bioprosthetic Valve Fracture: In-Depth Techniques and Updated Data

David J. Cohen, M.D., M.Sc.

Director of Cardiovascular Research
Saint Luke's Mid America Heart Institute

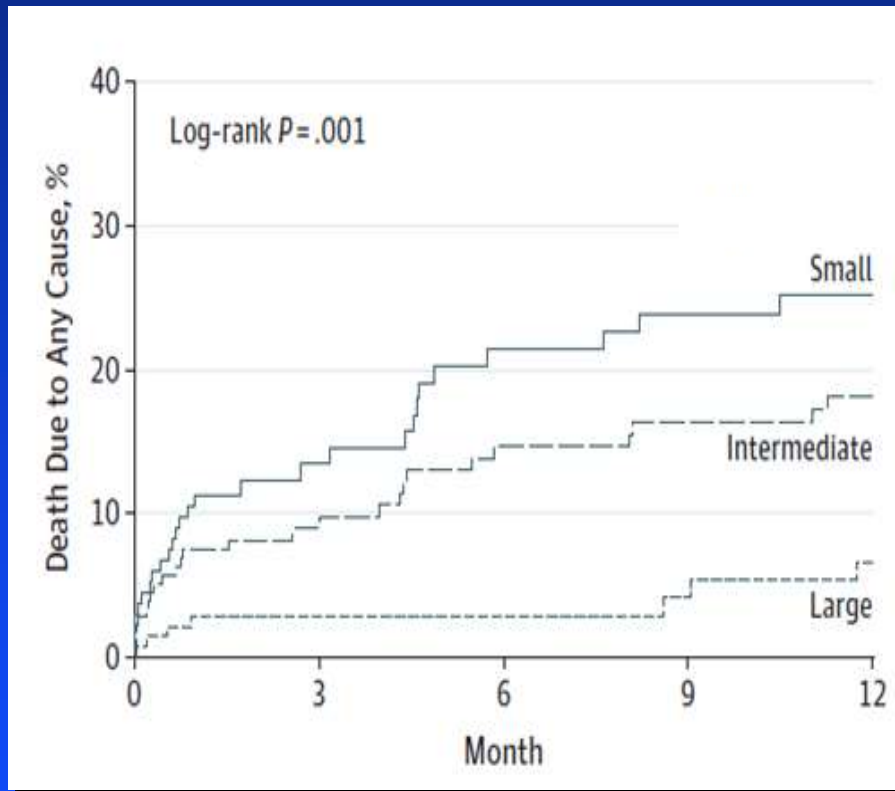
Impact of Surgical Valve Size on 1-Year Mortality

- 459 pts with failed surgical bioprostheses treated with ViV TAVR (59% balloon expandable, 41% self-expanding)
- Patients stratified based on size of original surgical valve
 - *Small* ≤ 21 ($n=133$)
 - *Medium* 22-24 ($n=176$)
 - *Large* ≥ 25 ($n=139$)
- Small surgical valve independently associated with 1-year mortality (HR 2.04, $p=0.02$)

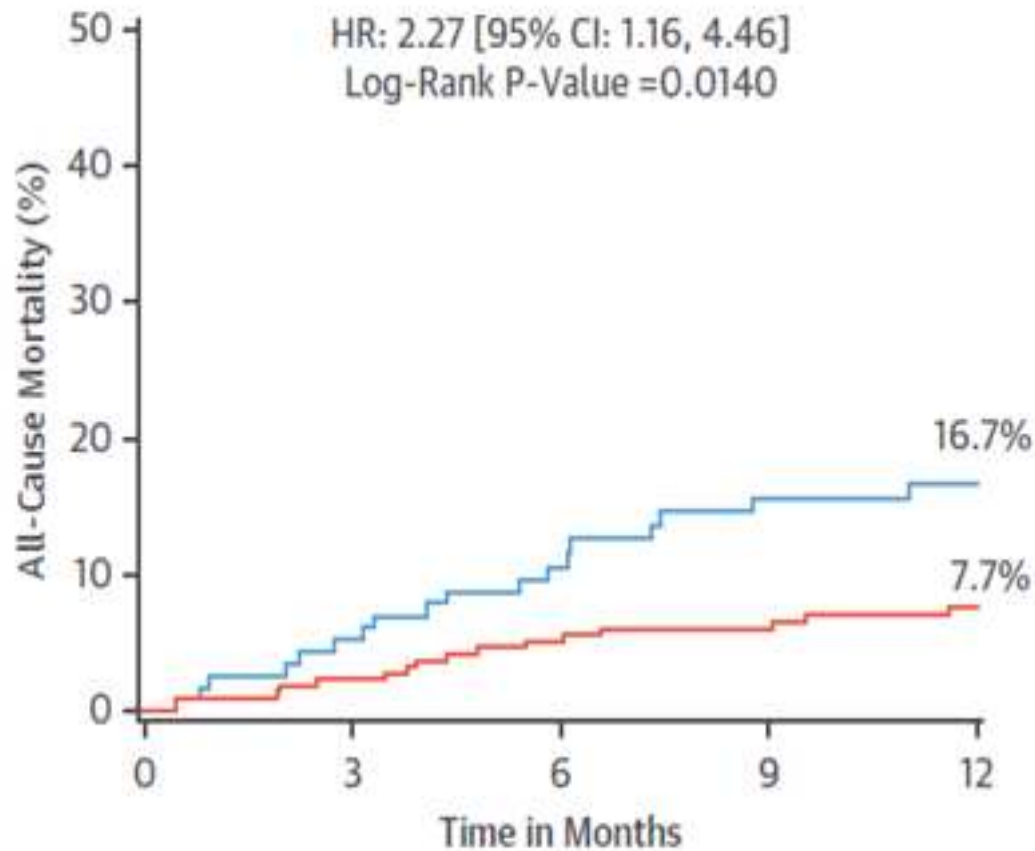
Impact of Residual Gradient on 1-Year Mortality

- Mean $\Delta \geq 20$ mmHg
- Mean $\Delta < 20$ mmHg

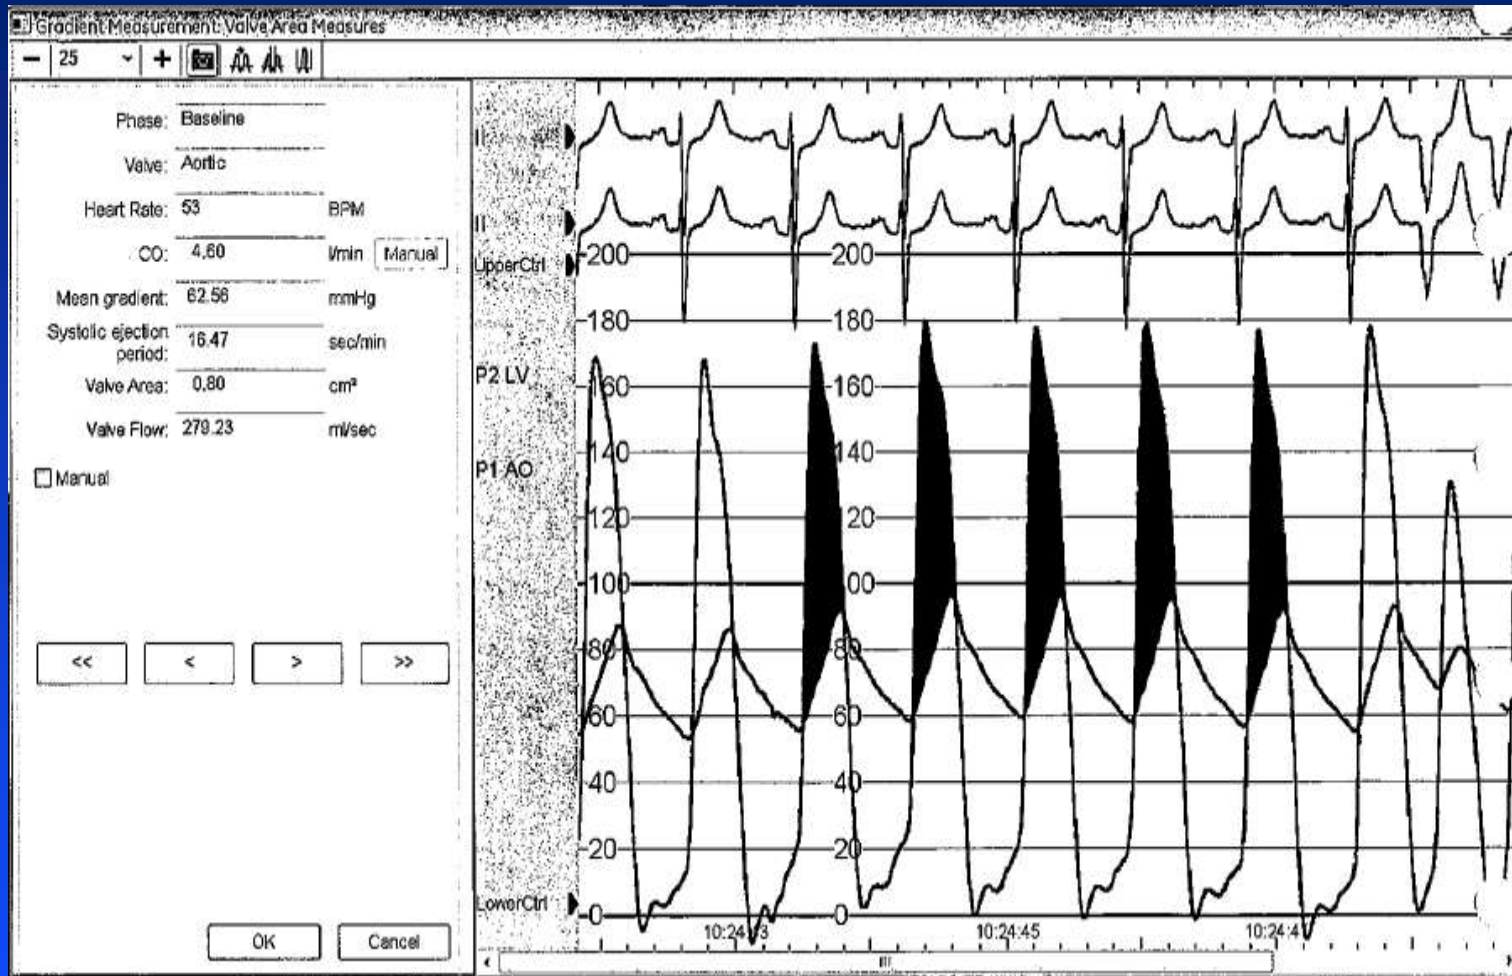
Baseline Hemodynamics

Mean gradient = 63 mmHg AVA 0.8 cm²

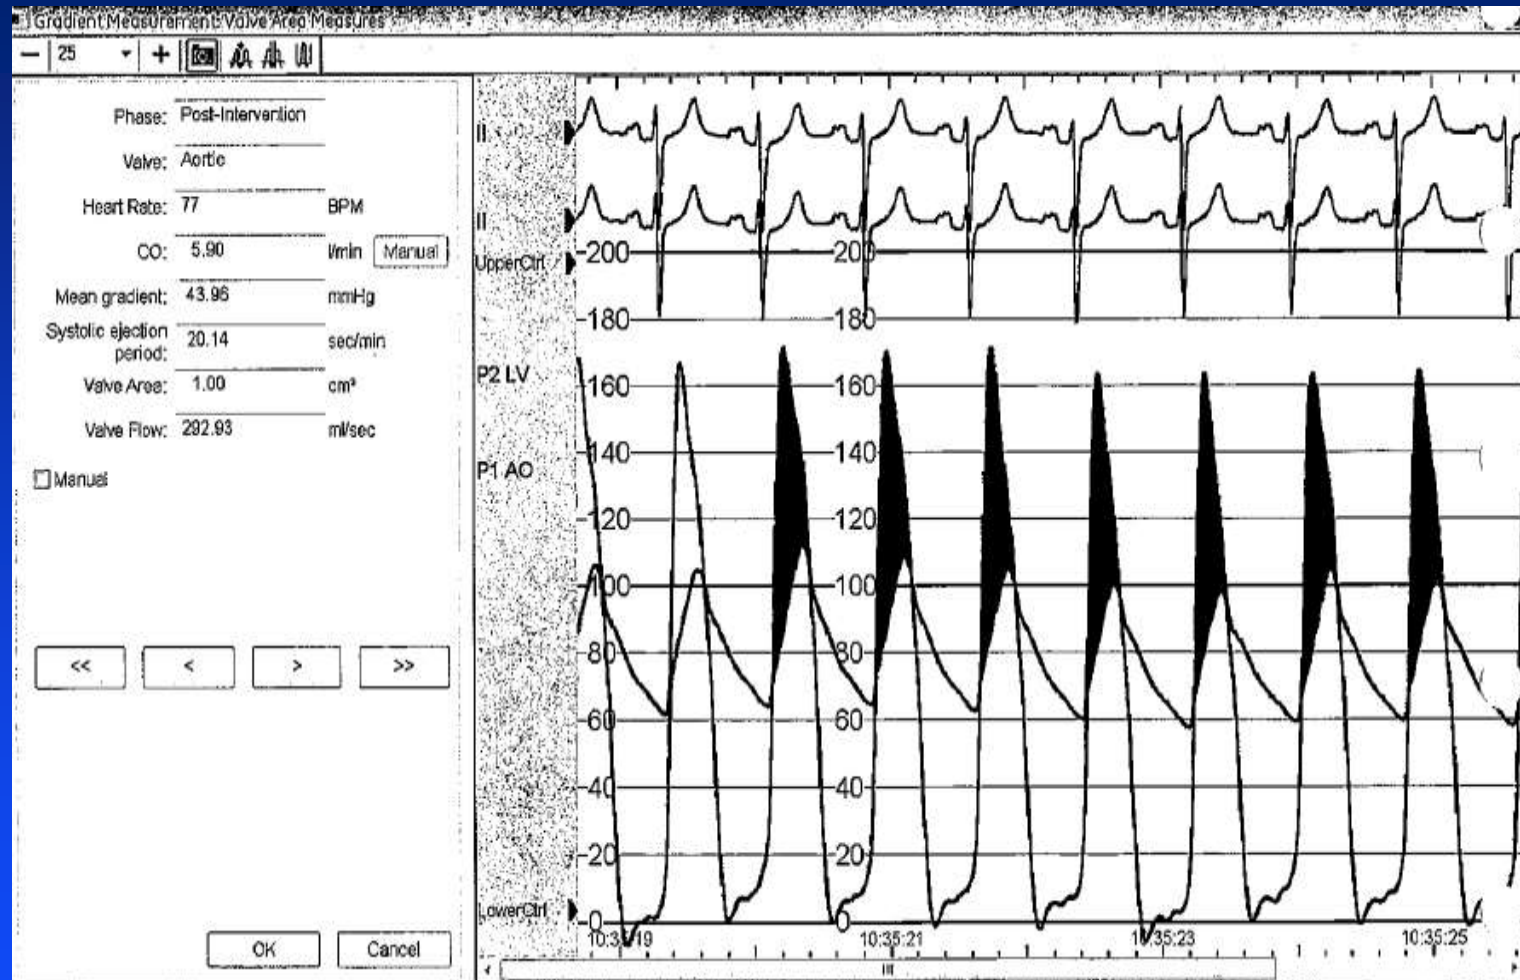
Post-TAVR and Post-Dilation

Mean gradient = 44 mmHg AVA 1.0 cm²

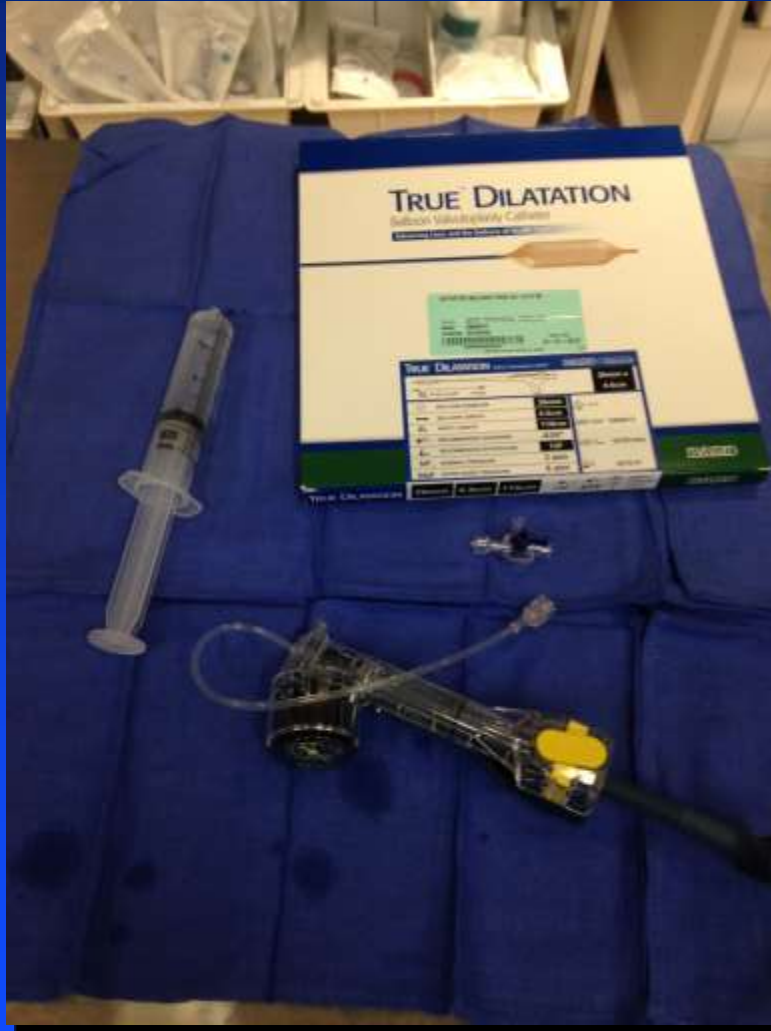
Here's what you'll need...

- 1 True Dilatation, ATLAS, or ATLAS-GOLD Balloon (Bard) → Kevlar wrapped
- 1 60 cc luer lock syringe filled with dilute contrast
- 1 PTCA inflator
- 1 high-pressure stopcock

** Disclaimer: This is 100% off-label use and may require exceeding balloon RBP considerably*

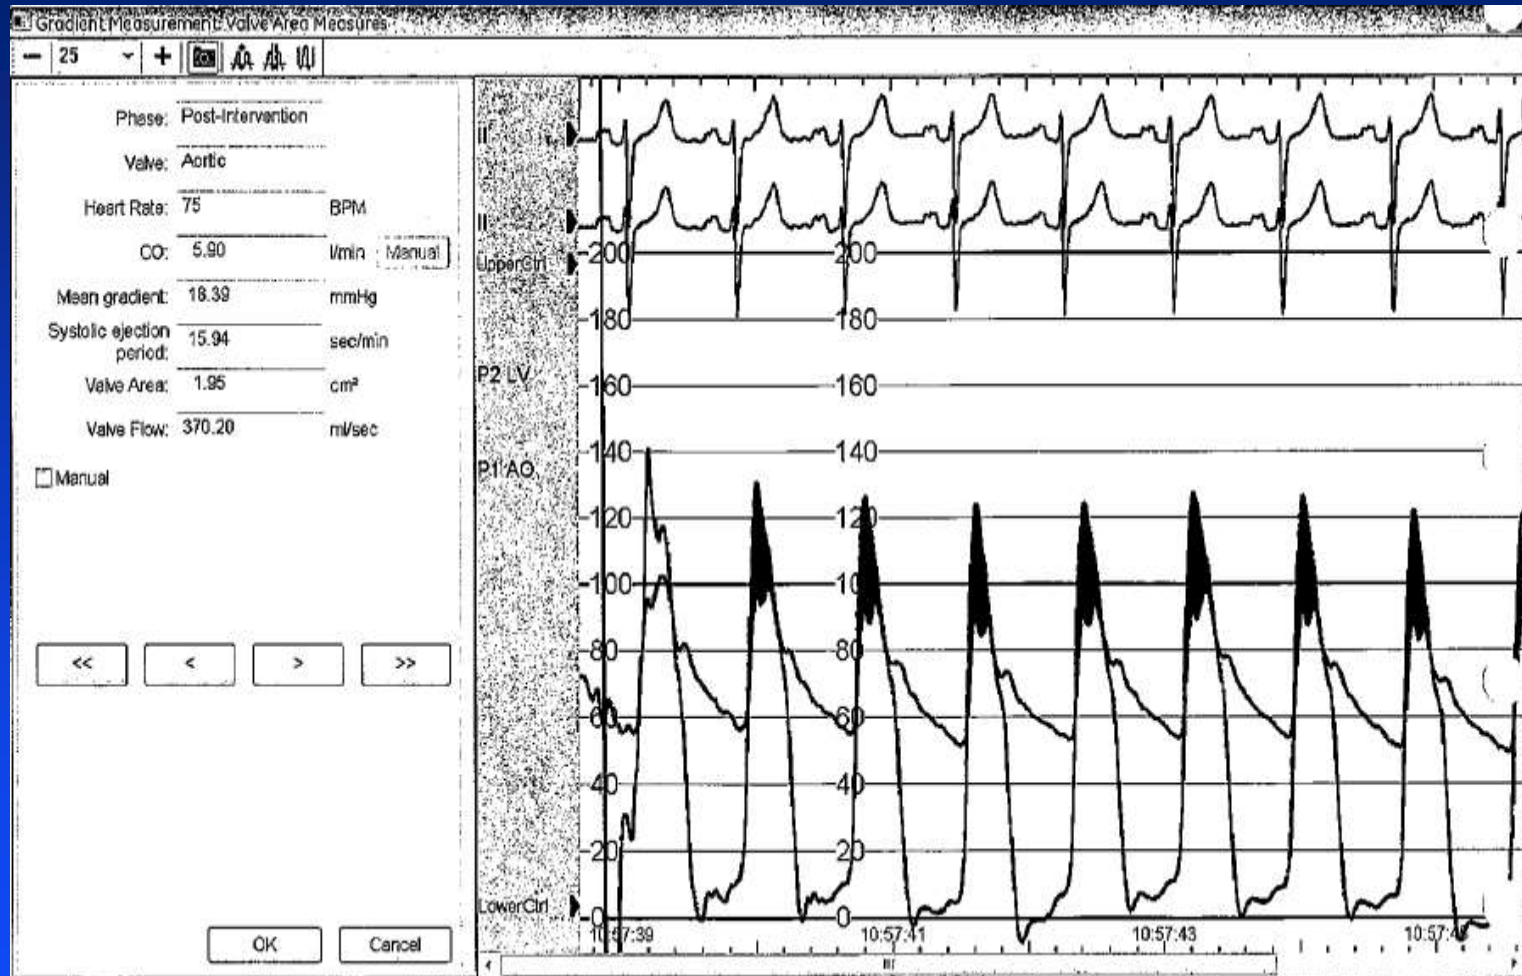
Post- 20 mm True Balloon (16 atm)

Mean gradient = 18 mmHg AVA 1.9 cm²

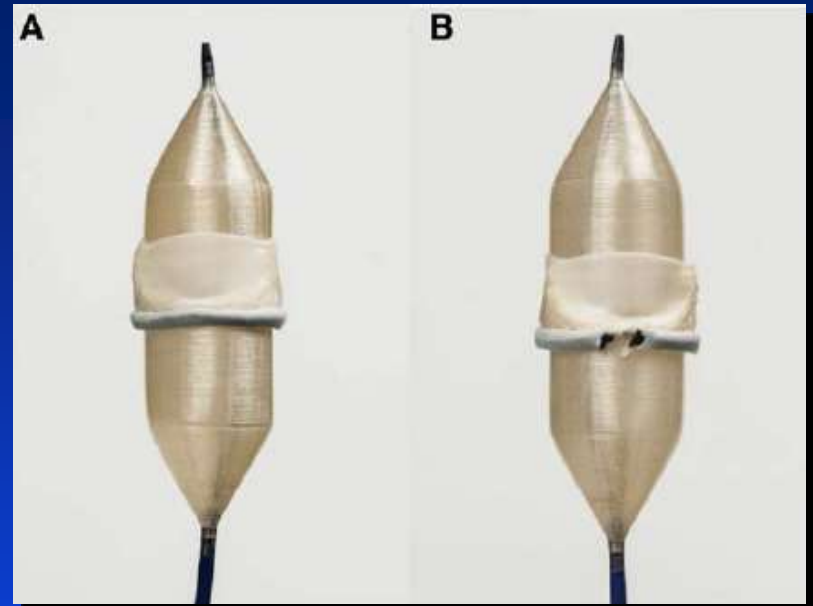
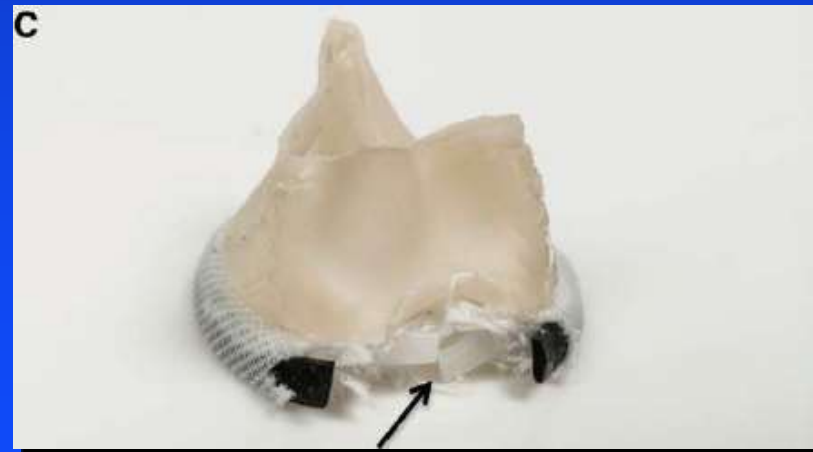
After in vitro testing and informed consent, we performed this procedure in 2 patients with small Mitroflow bioprostheses (19 and 21 mm) and high risk to redo surgery (Table). High-pressure balloon predilatation by an ATLAS Gold balloon led to fracturing of the stent ring of the Mitroflow valves with subsequent successfully ViV with an SAPIEN XT valve 20 mm (19 mm Mitroflow) and a SAPIEN III 23 mm valve (21 mm Mitroflow; Table). The procedures were performed in general anesthesia guided by fluoroscopy and TEE. Rapid right ventricular pacing (180 bpm) and cardiopulmonary support (CPS 2 l/min; right atrium to left femoral artery) were used during the high-pressure balloon predilatation and at the time of ViV implantation. The Mitroflow valve ring fractured at a pressure of 16 atm (Mitroflow 19 mm) and 11 atm (Mitroflow 21 mm) evident by a sudden drop in inflation pressure and resolution of the waist in the balloon with expansion to its full diameter (Figure 2, Movie 1 and 2 in the Data

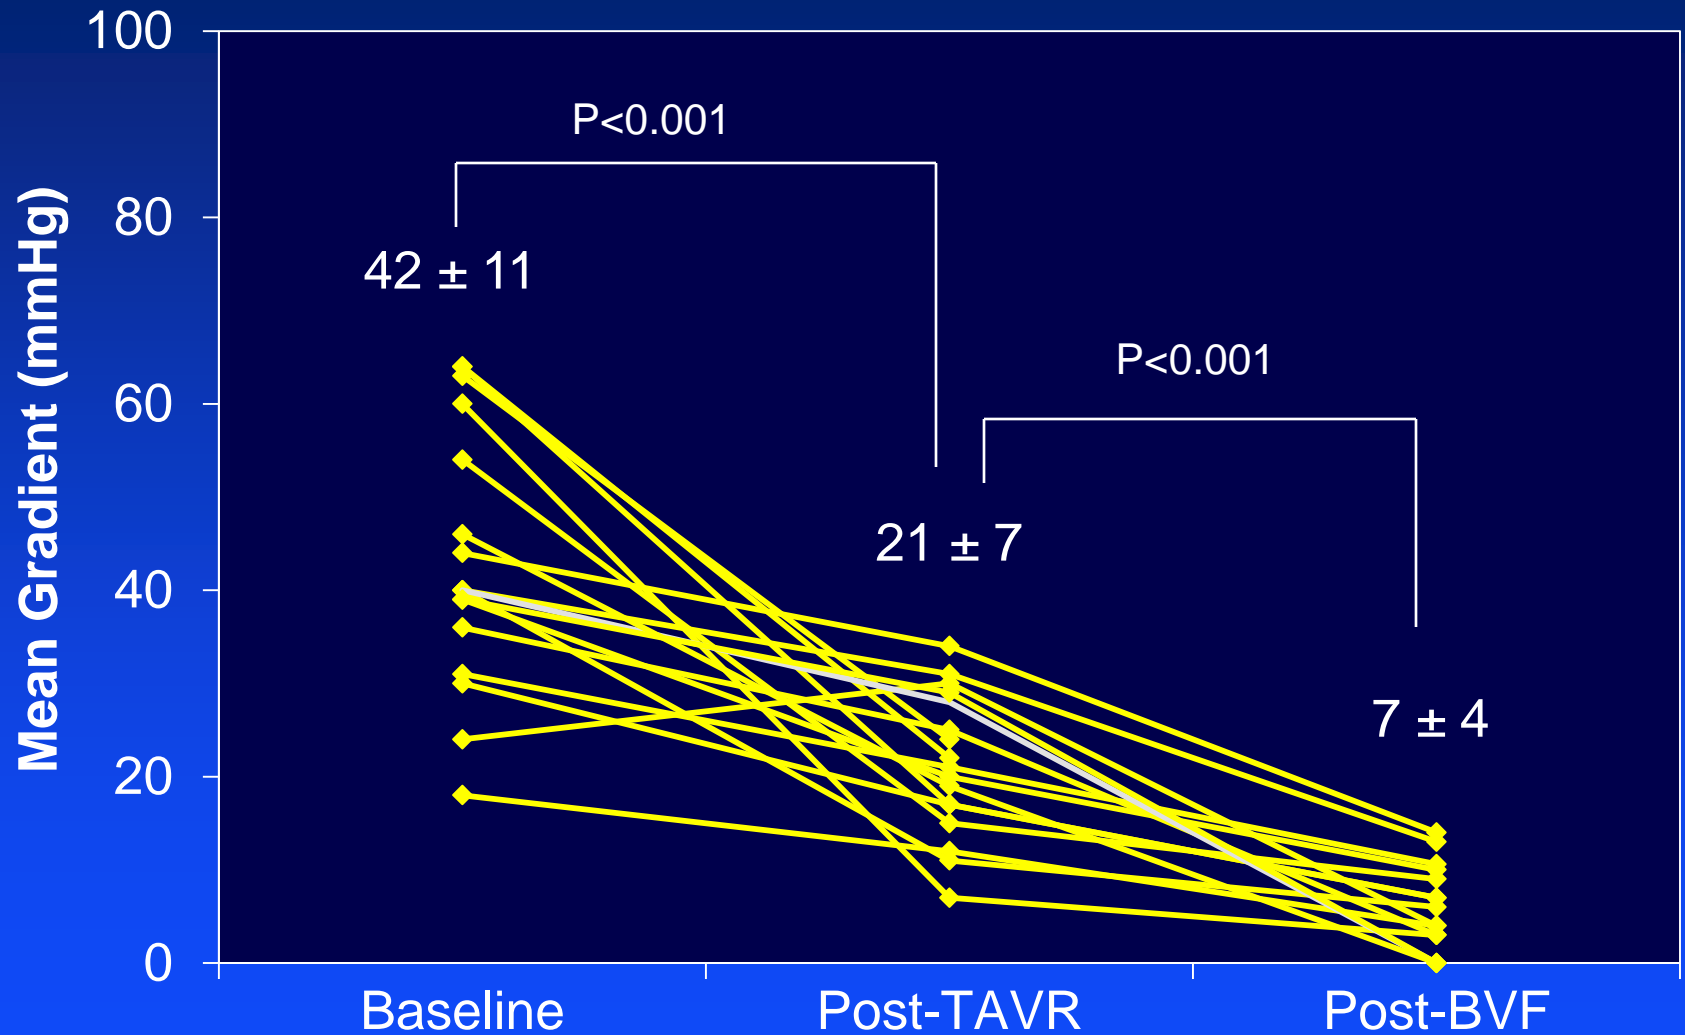
Mean Gradient

- 20 consecutive patients* from 7 US centers treated with bioprosthetic valve fracture at the time of ViV TAVR (8 at MAHI)
- Mean age 76 years; mean STS-PROM 8.4%
- Valves treated: Mitroflow, Perimount, Magna/Magna-Ease, Biocor Epic/Epic-Supra, and Mosaic
- Treated with both self-expanding (n=12) and balloon expandable (n=8) TAVR valves
- 15/20 underwent BVF after TAVR valve deployed

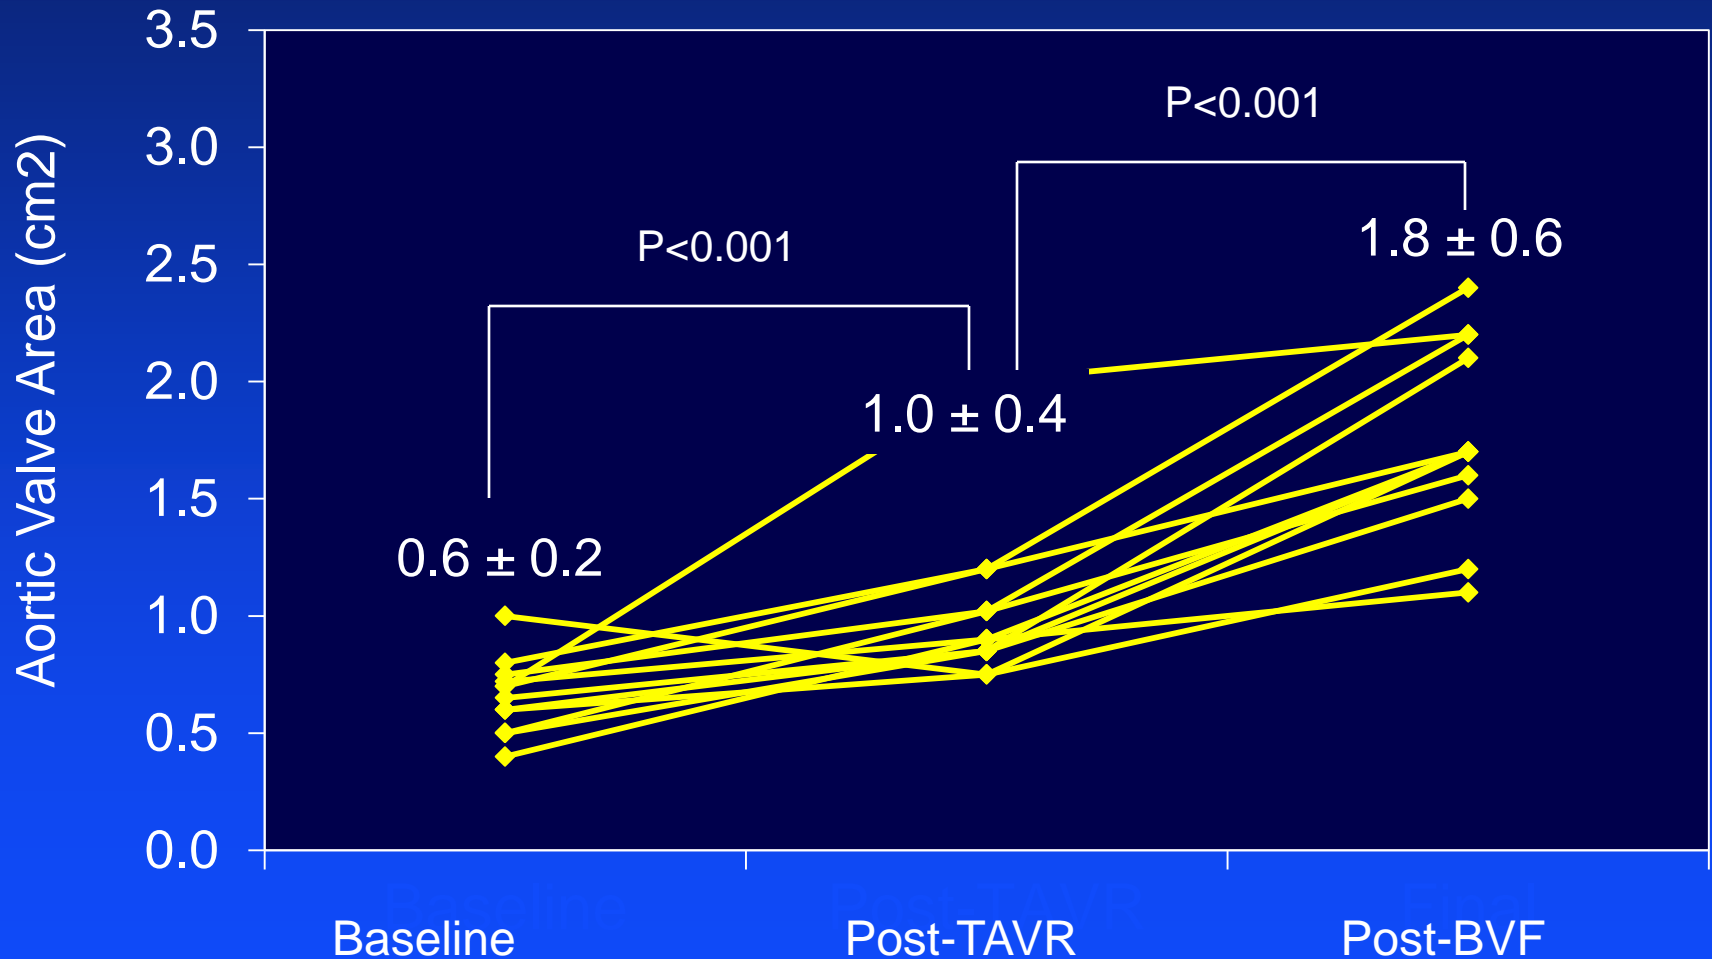
Effective Orifice Area

* Measurements only available for pts treated with BVF after ViV TAVR
