# **RCA CTO case difficult to keep side branch open after rCART**

**Hyogo Prefectural Amagasaki General Medical Center  
Cardiovascular Center  
Department of Cardiovascular Medicine  
Rei Fukuhara**

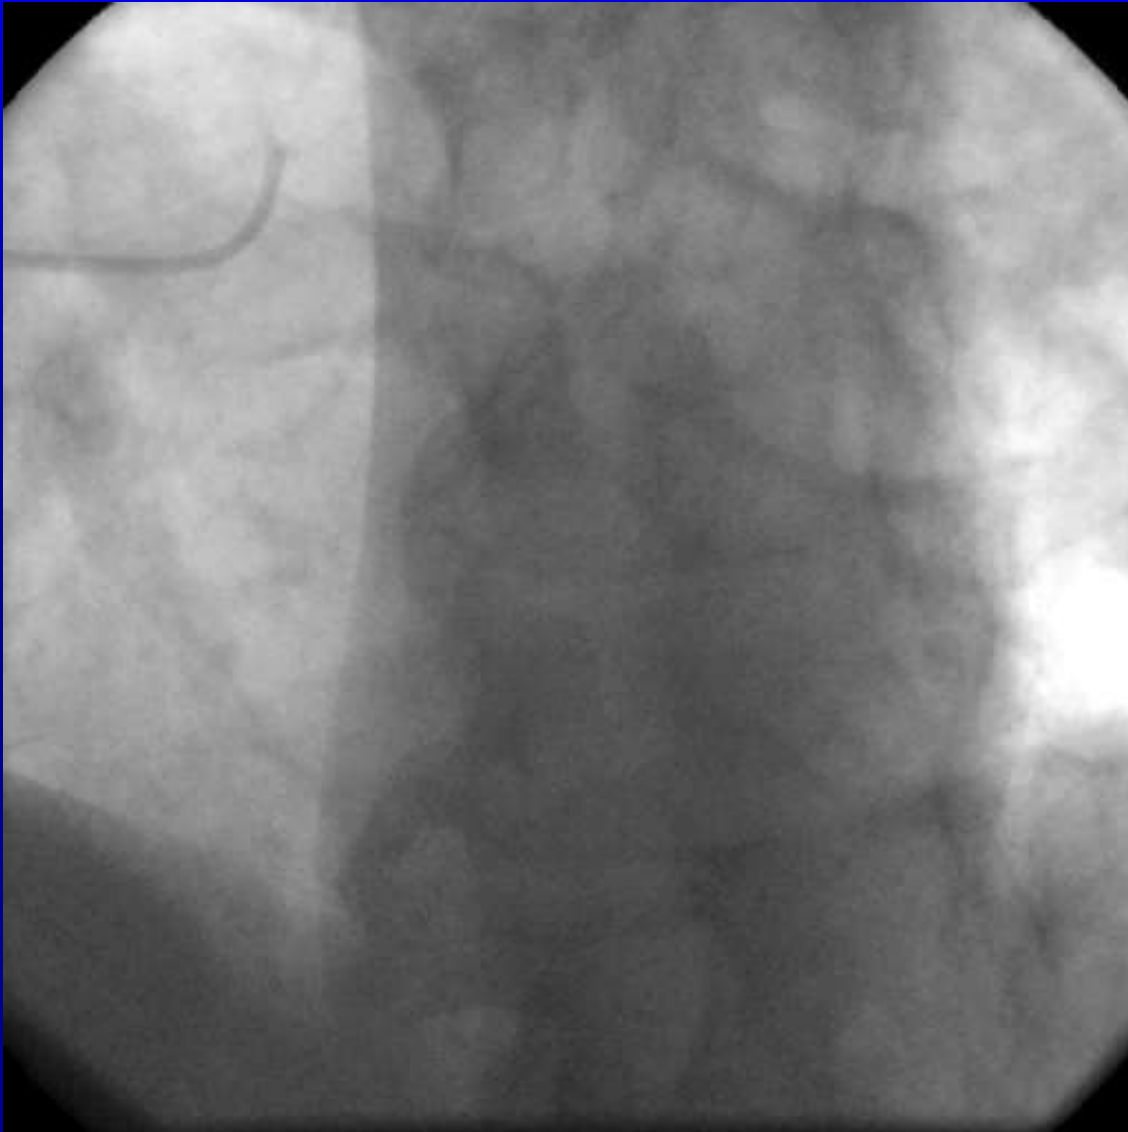
## LCAG

- ✓ Seg14 was totally occluded.
- ✓ LAD had moderate to severe stenosis.
- ✓ LAD was treated prior to RCA CTO PCI.

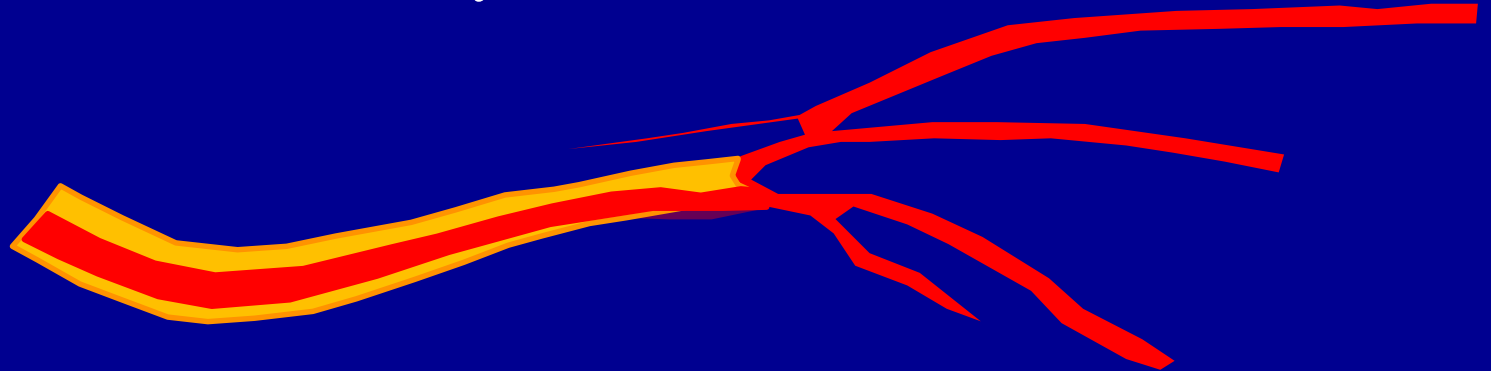
- ✓ A position of retrograde guide wire was not favorable to establish rCART.
- ✓ So, we changed an entry point of retrograde wire and it caused side branch short cut phenomenon.
- ✓ To avoid side branch occlusion, we tried to cross antegrade guide wire to Seg4PL with reverse wire technique but failed.
- ✓ Then we performed KBT with antegrade and retrograde balloon catheters to achieve carina modification.
- ✓ Enlargement of side branch opening area and lessen a severity of bifurcation axis were obtained by this method.
