Plaque Rupture at Left Main during Angiography

**Xiaofan Wu Hong Liu
Shuzheng Lv**

**Beijing Anzhen Hospital
Capital Medical University**

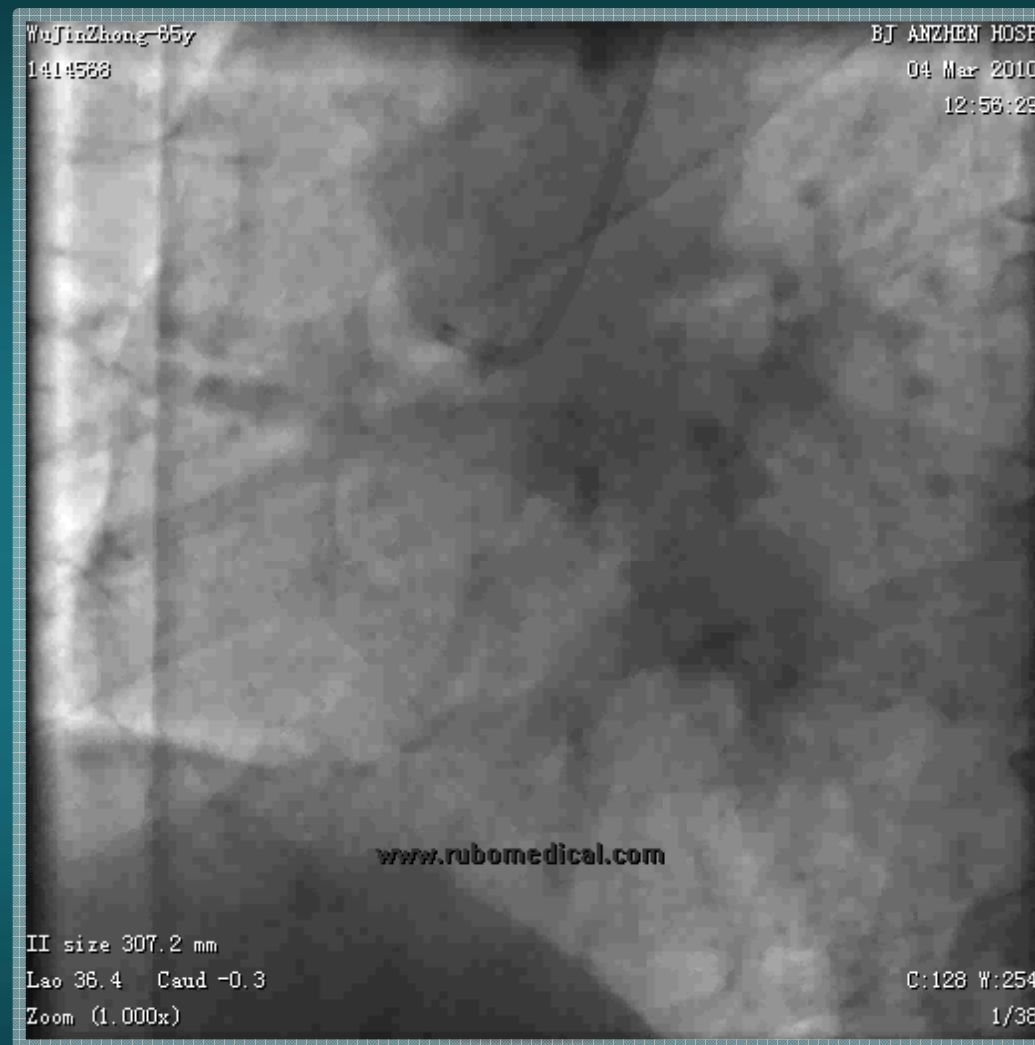
Baseline Angiogram

Stenosis at disRCA

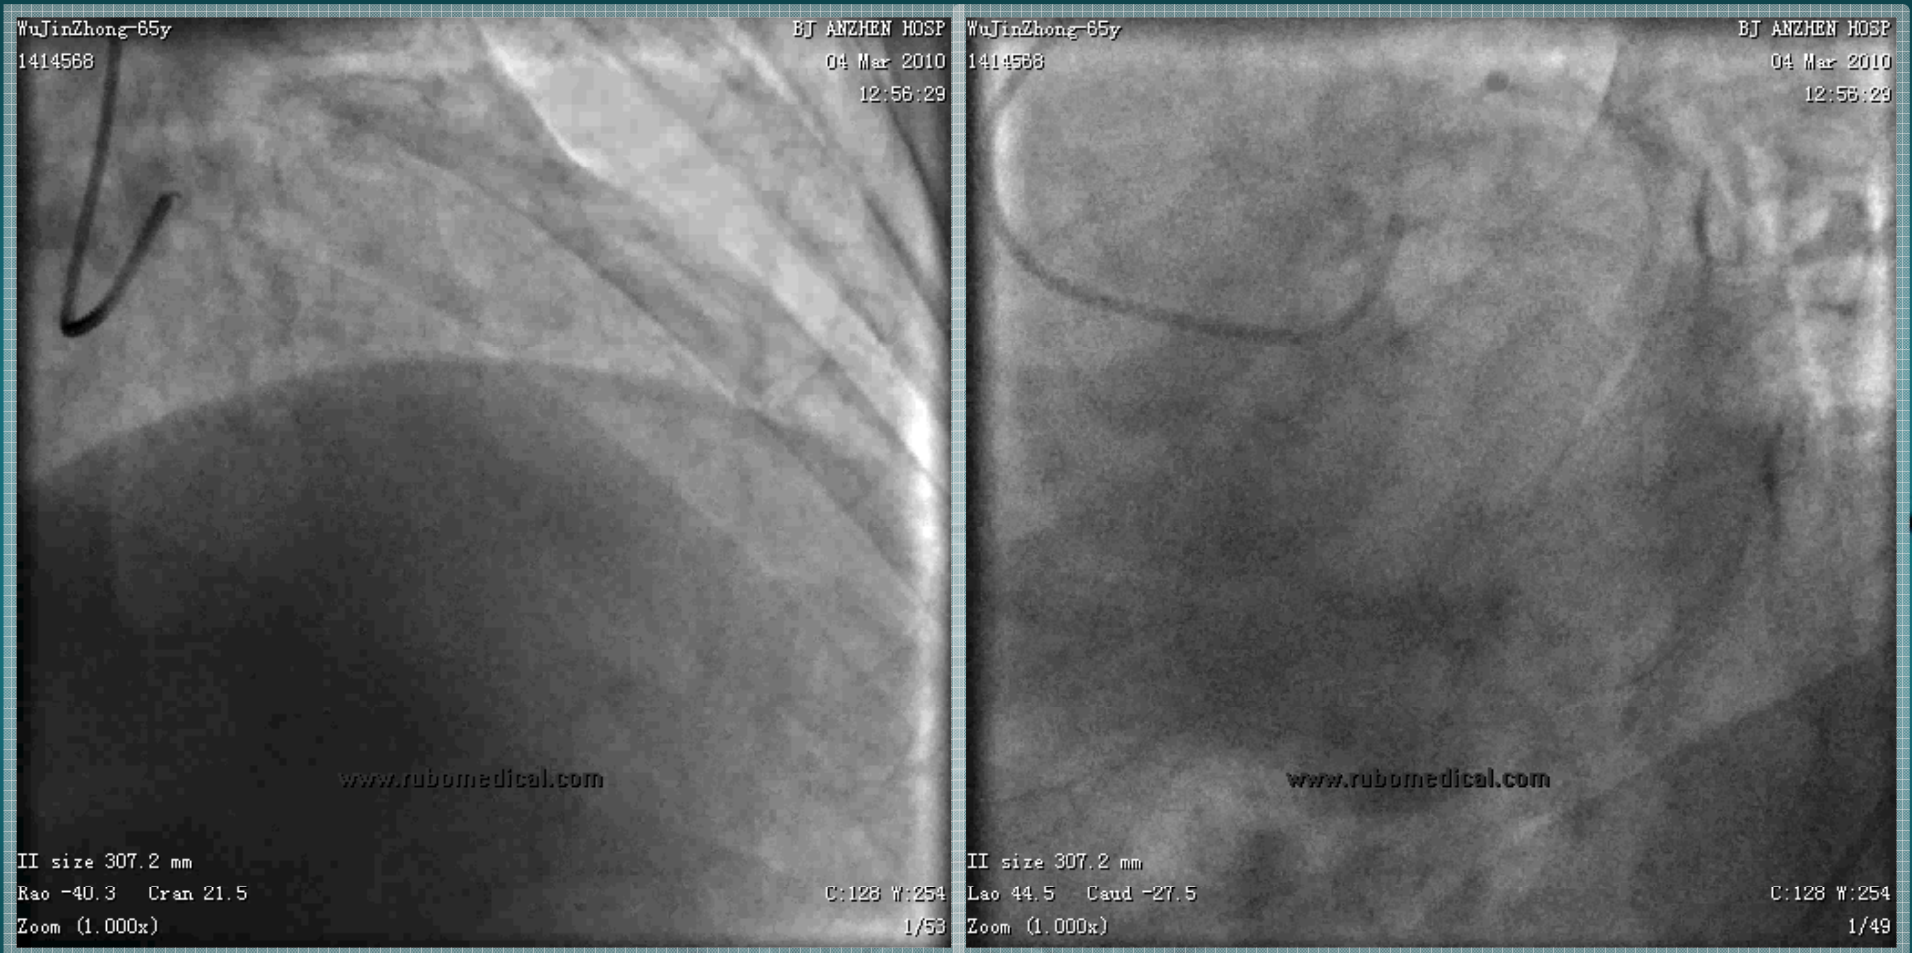
Baseline Angiogram

Stenosis at pLAD-D & Ramus

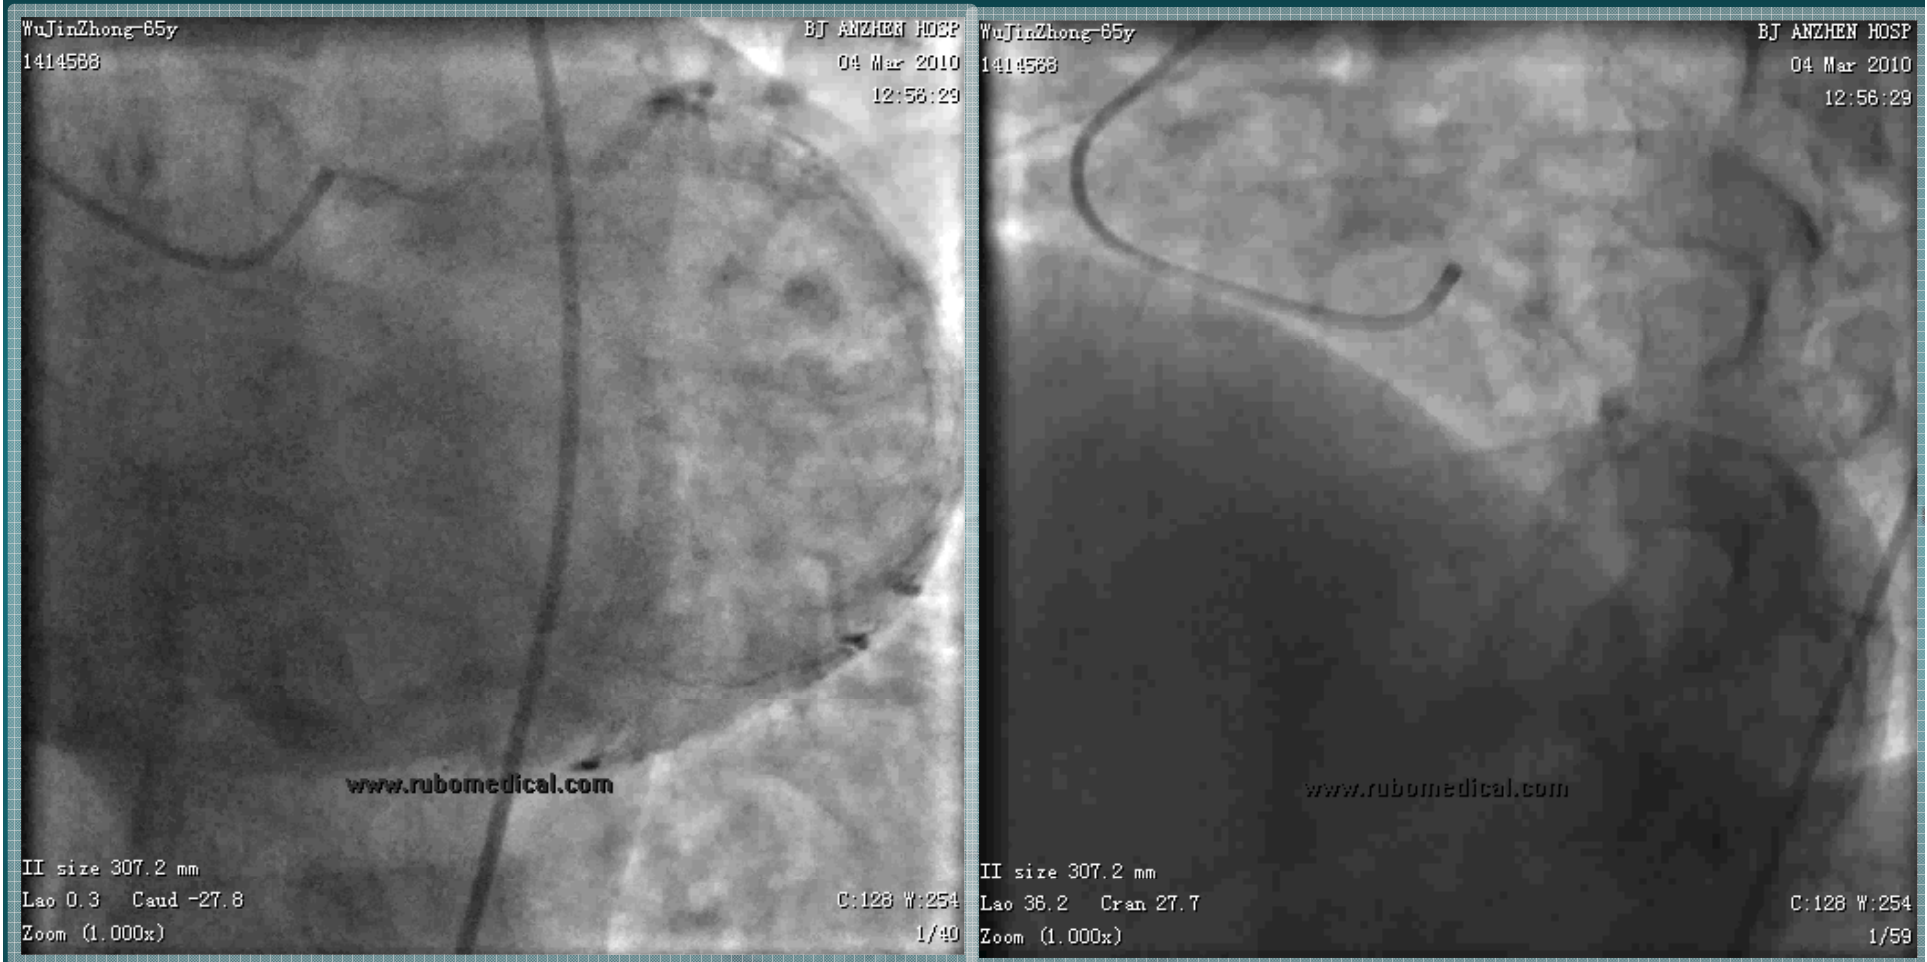
Baseline Angiogram

Circular masses flush from LM to LAD

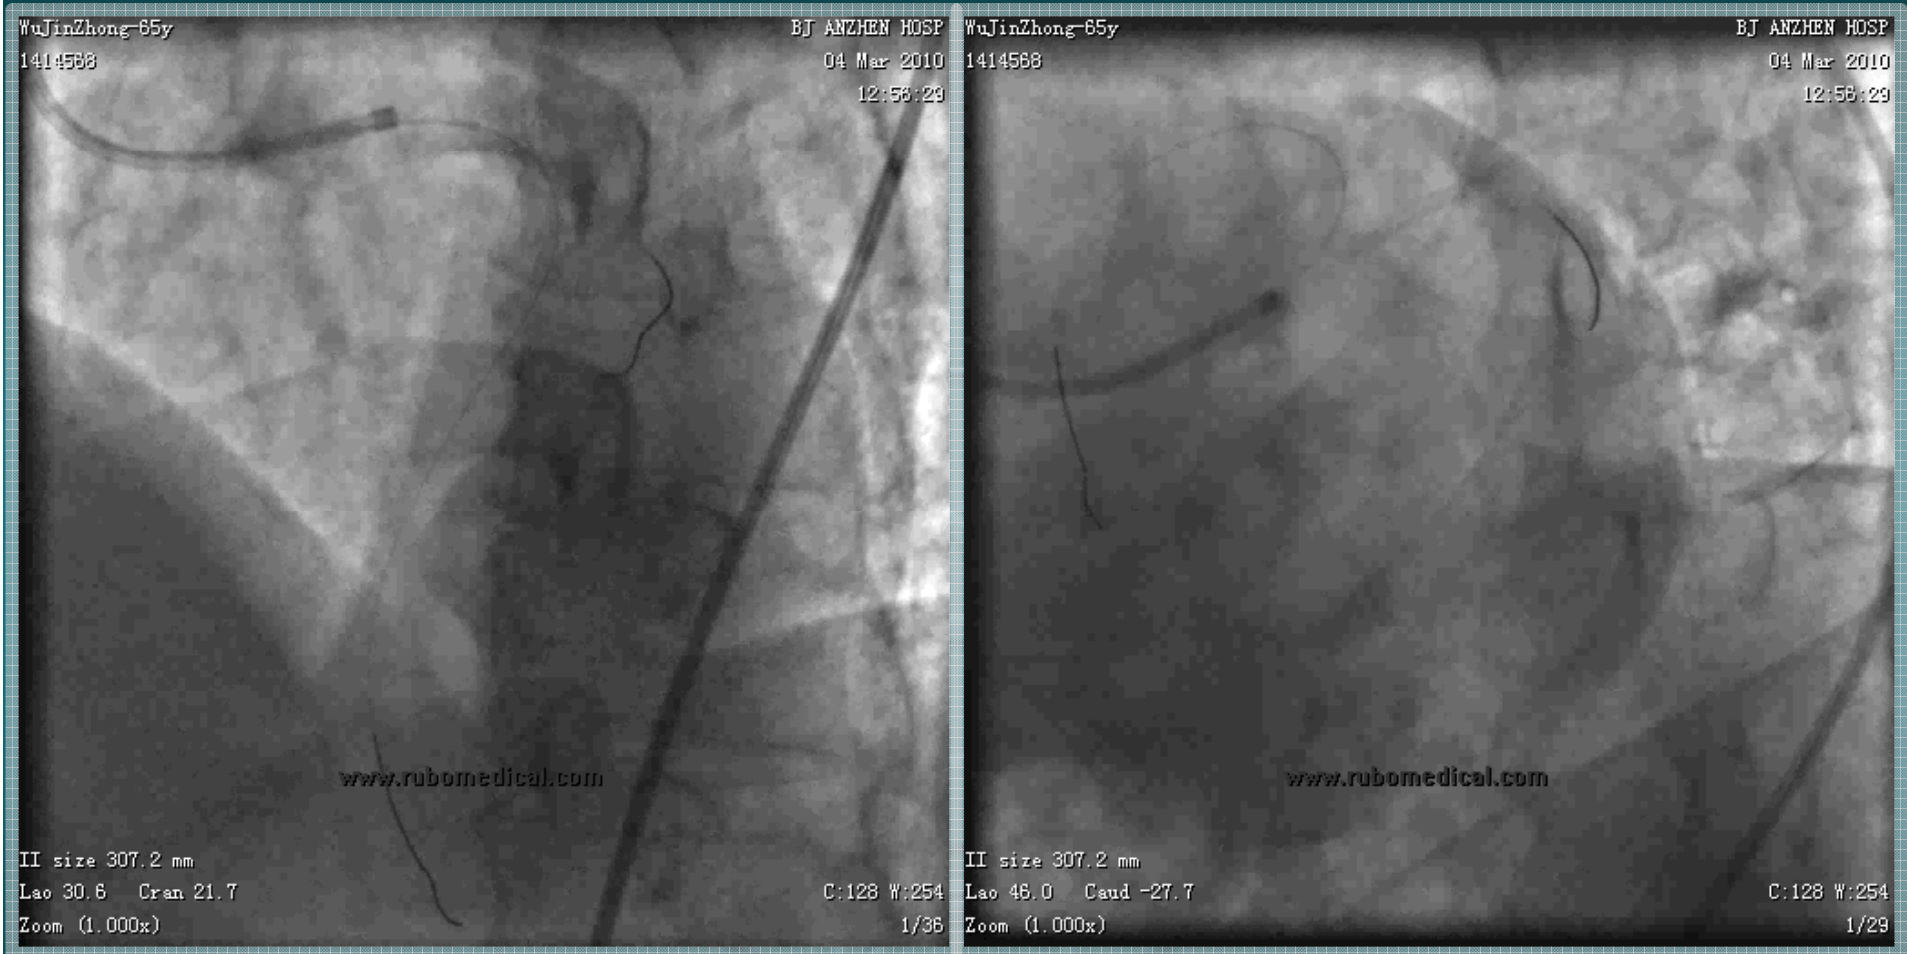
Coronary intervention

**Provisional Lepu 3.5*24mm (16atm) at LAD,
Excel 2.5*24mm (12atm) at Ramus**

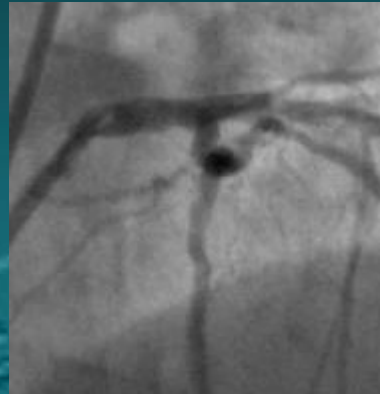
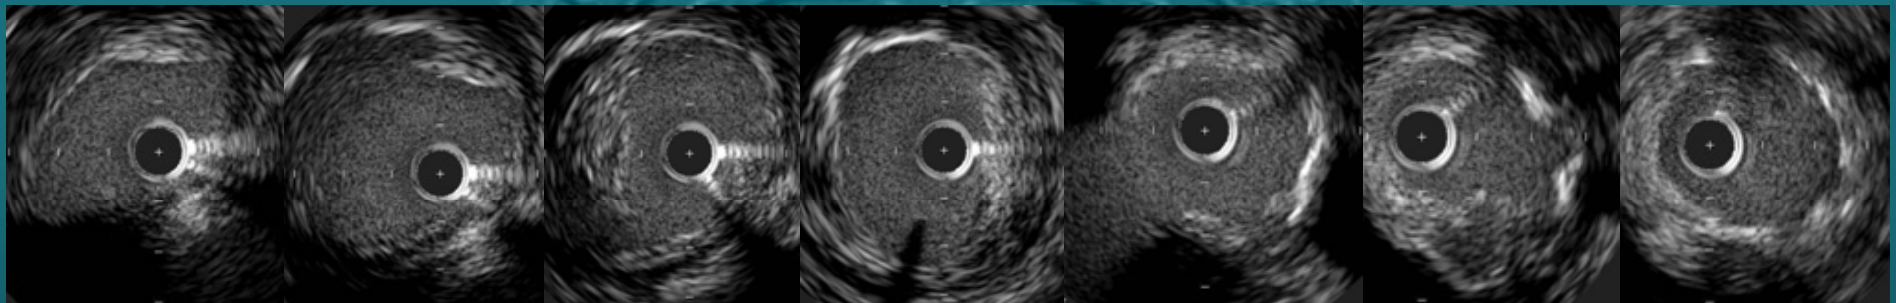
Baseline IVUS at LAD-LM

LA: 7.4 mm²
EEM: 24.6 mm²

LA: 6.2 mm²
EEM: 20.4 mm²

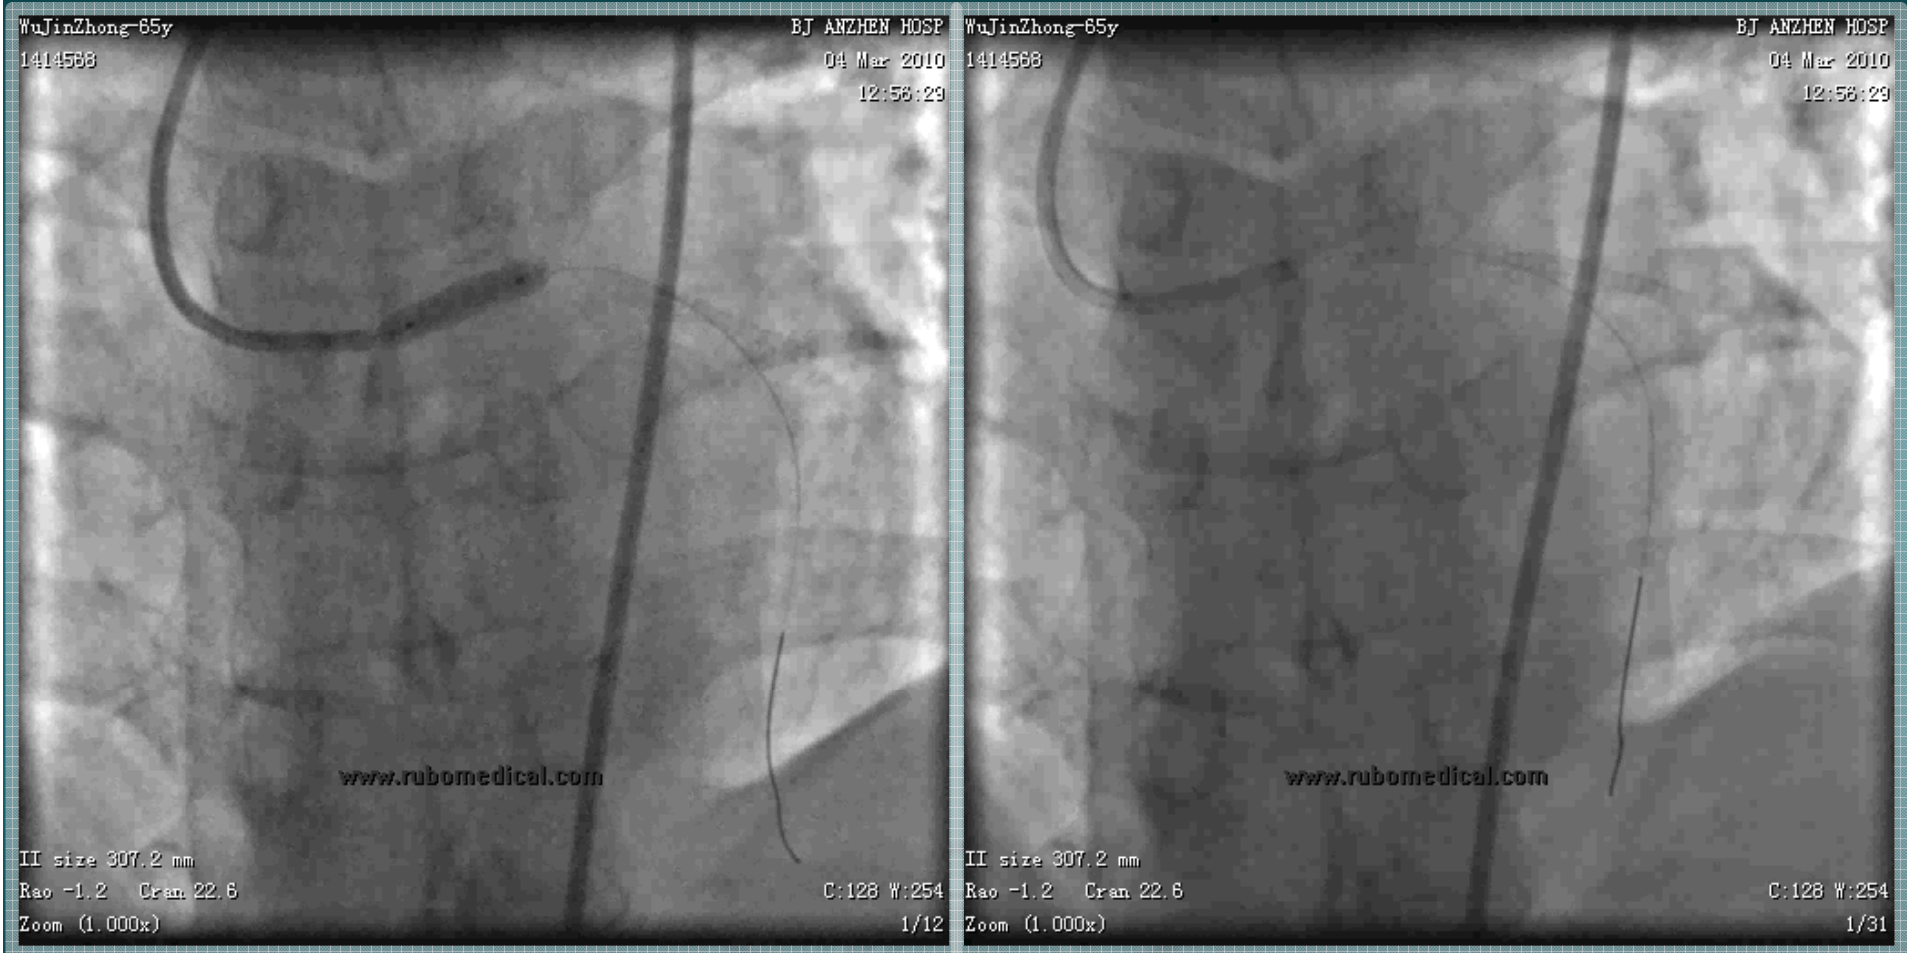
Coronary intervention

Lepu 4.0*12mm (18atm) at LM ostium
