Bioprosthetic Valve Fracture: In-Depth Techniques and Updated Data

David J. Cohen, M.D., M.Sc.

Director of Cardiovascular Research
Saint Luke's Mid America Heart Institute

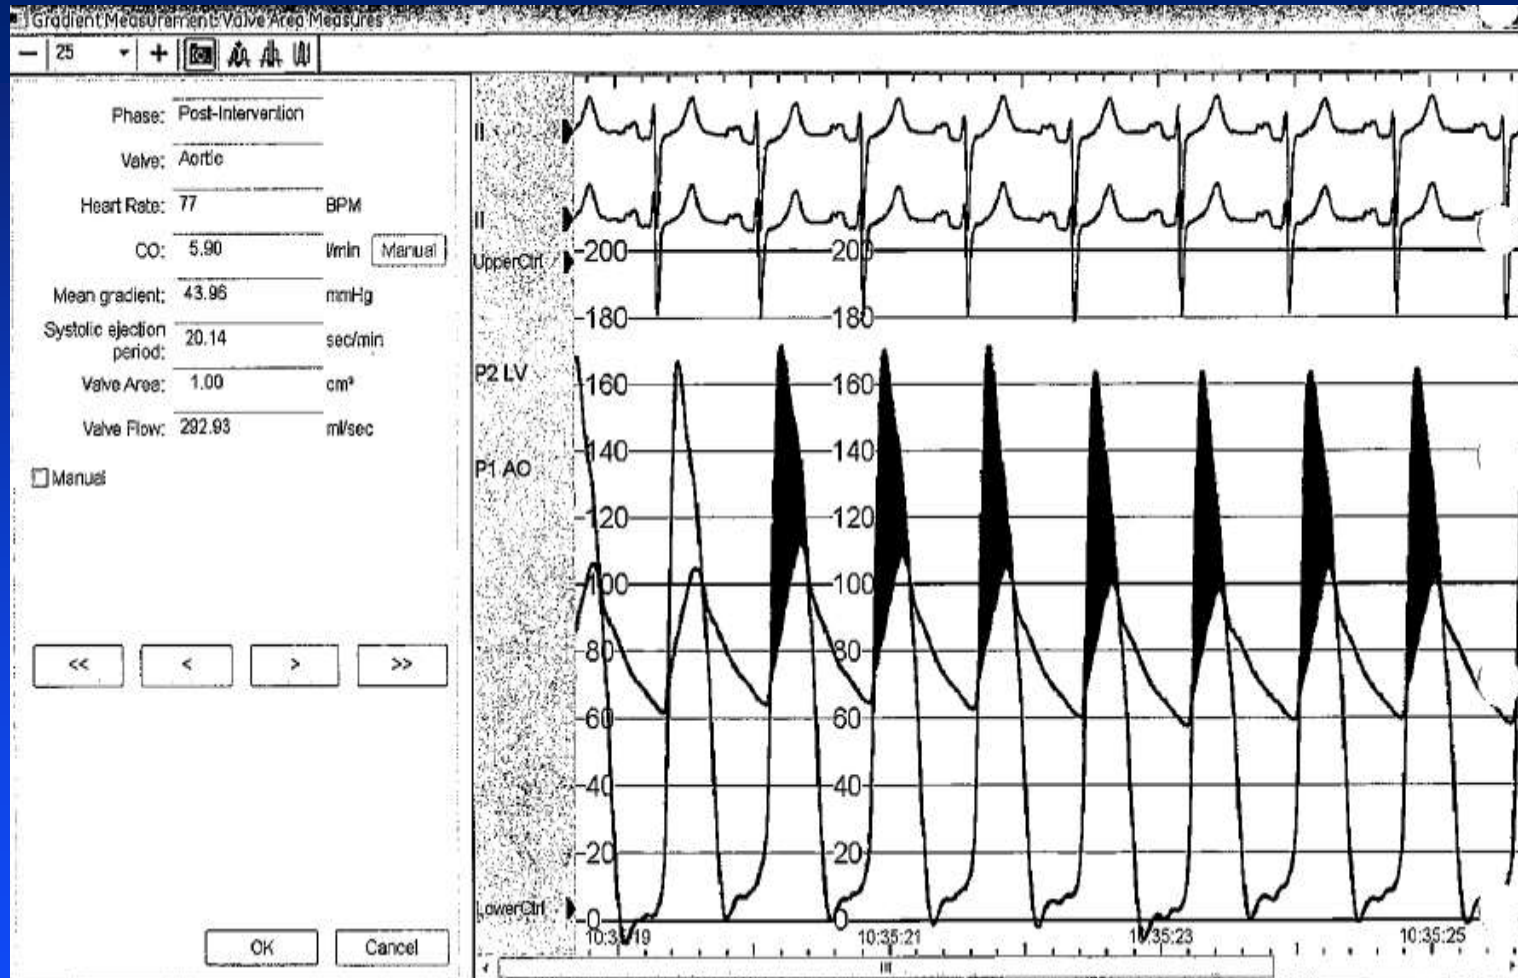
Post-TAVR and Post-Dilation

Mean gradient = 44 mmHg AVA 1.0 cm²

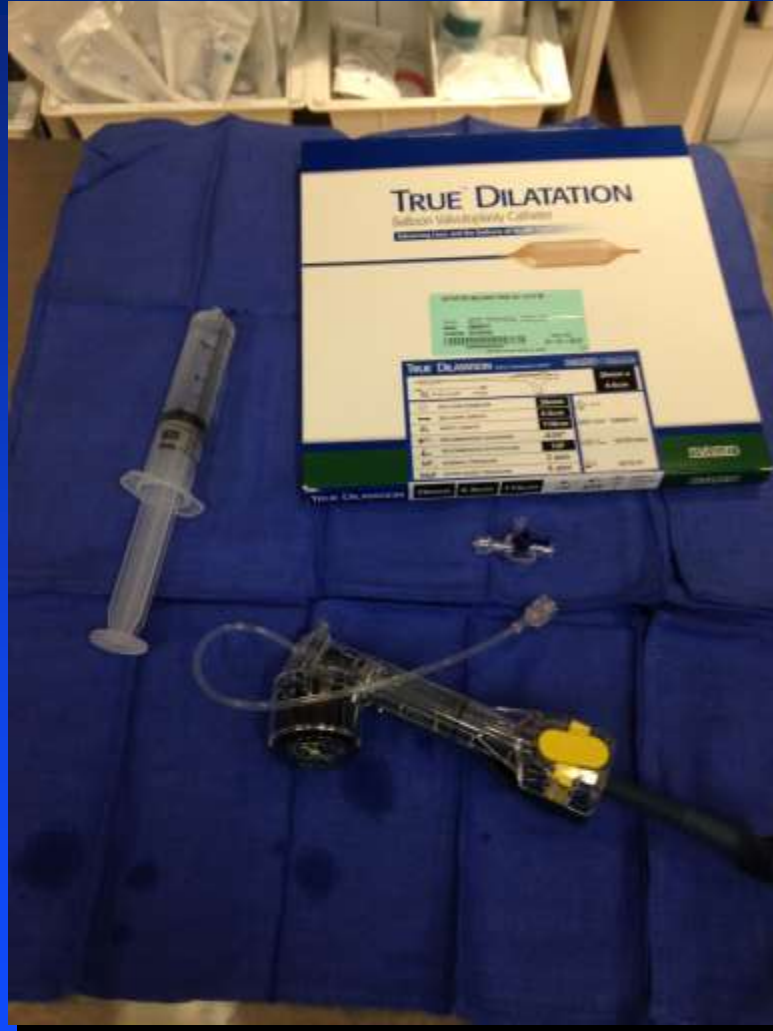
Here's what you'll need...

- 1 True Dilatation, ATLAS, or ATLAS-GOLD Balloon (Bard) → Kevlar wrapped
- 1 60 cc luer lock syringe filled with dilute contrast
- 1 PTCA inflator
- 1 high-pressure stopcock

** Disclaimer: This is 100% off-label use and may require exceeding balloon RBP considerably*

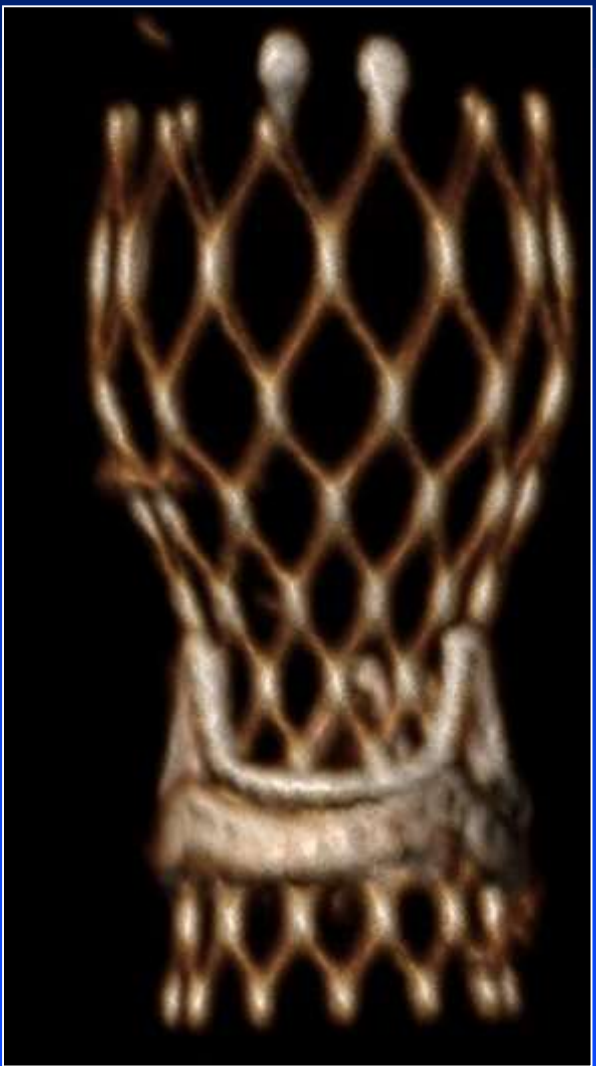
Sewing Ring Otherwise Intact
